The Challenge of the Slope Failure Problem and Its Remedial Considerations at Mileage 39km, Mt. Ali Road, Taiwan

Chang M., Huang R.
National Yunlin University of Sci. & Tech., Taiwan

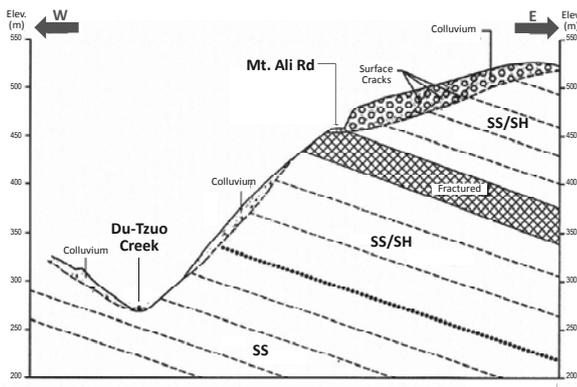
Figure 2. Geologic cross-section at the 39Km project site (CECI 2005).

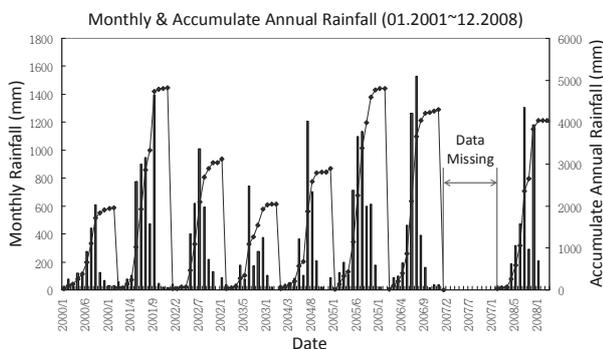
The monsoon season normally starts from early April to the end of September in the island. Annual precipitation is around 2150mm (Sinica 1999). Figure 4 shows accumulated rainfalls of the site in 2001 & 2005 were 4700mm & 4600mm, respectively. As will be discussed later, the abundance of rainfalls appeared to have contributed to the failures of slopes along the Mileage 39Km in 2001 & 2005.

Figure 4. Monthly and accumulated rainfalls at the site (Peng 2009).

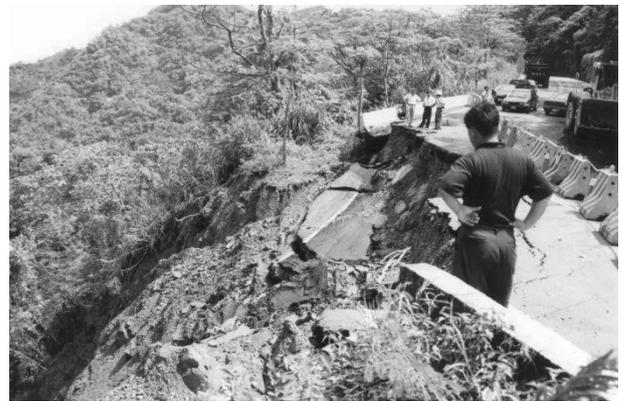
As the reconstruction work for the retaining structure was about to start in 8 months after Typhoon Nari, a failure in downslope of the road occurred (Figure 5). The failure was apparently due to the intense rainfall during the monsoon season. Recorded accumulated precipitation was greater than 1000mm within the two months prior to the failure.

Figure 5. Slope failure at Mileage 39Km due to 2002 monsoon rainfalls.

The original construction work had to be terminated and re-planned. In view of steep downslope and insufficient road width, DGH had once considered remedying the problem by cutting back and flattening the upslope. However, the plan was turned down due to unsuccessful negotiations with local ownerships of lands adjacent to the road.

The remedial plan was finally decided to limit within the extent of the road owned by DGH. Considerations of the road redesign had included a section of box-type concrete structure, as shown in Figure 6, which would provide a design with enough road width, structure rigidity, and relatively light-weight. The box structure was secured to the native ground by two rows of ground anchors, each of which with a total length of 35m, a horizontal spacing of 20m, and an anchor force of 45T. The

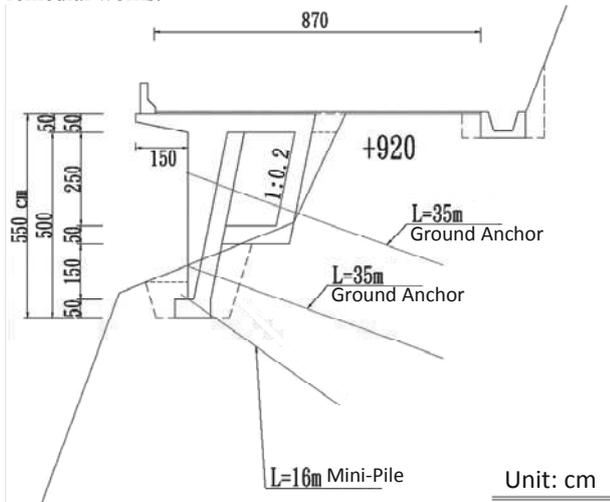
Figure 6. Box-type structure design for road section at Mileage 39Km.

base of the box structure was also fixed to the ground by a series of mini piles of 16m in length.
Figure 7 shows the rebuilt road section after completion of the remedial works.

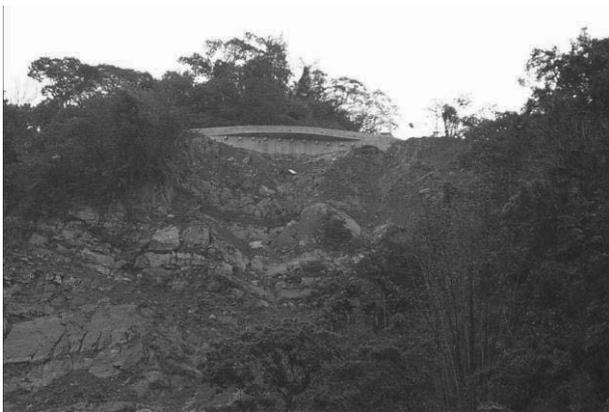
Figure 7. Completion of box-type structure at Mileage 39Km.

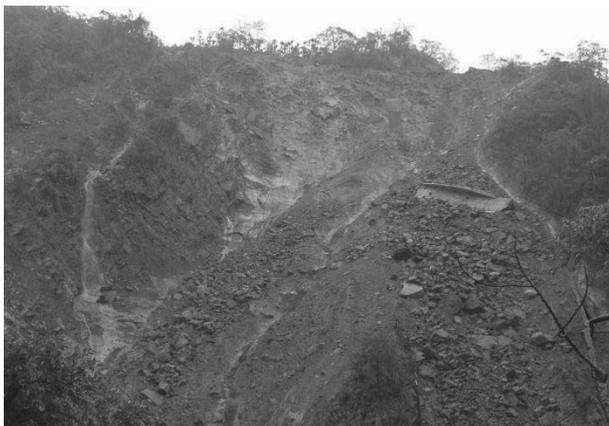
Figure 8. Failure of box-structure road section due to Typhoon Talim.

In late August of 2005, a severe Typhoon Talim slammed Taiwan. By considering a series of heavy rainfalls in the previous two months, the accumulated precipitation of the year at the site had exceeded 4000mm. As a result, the box-type structure finally gave up and the entire road section of about 100m in length fell into the valley (Figure 8).

Post-failure investigation had revealed that the loss of entire road section was due to the downslope movement of the uphill slope mass which pushed the box-type structure, tore down the ground anchor tendons, and sheared off the mini piles.

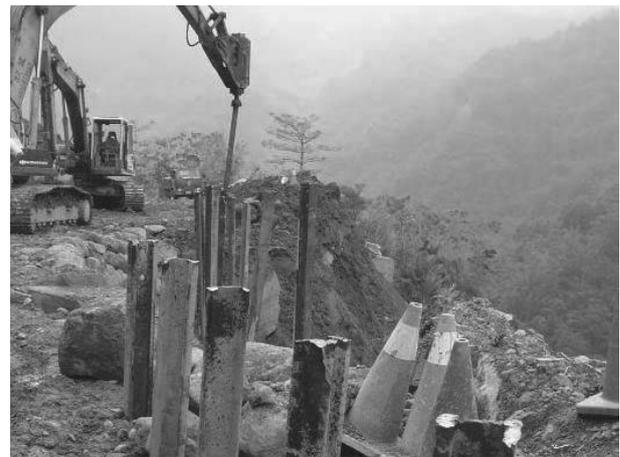
Figure 9. Emergency repair of the road section due to Typhoon Talim.

In late September, 2005, the emergency measure failed again one month after the attack of Typhoon Longwang. The temporary road lost 5m of its road width. Site reconnaissance showed significant tension cracks at the crest of uphill slope.

Emergency action was implemented right after the failure by constructing a temporary road to the uphill side and installing I-beams for the downhill support (Figure 9) in order to maintain the local traffic (DGH 2005).

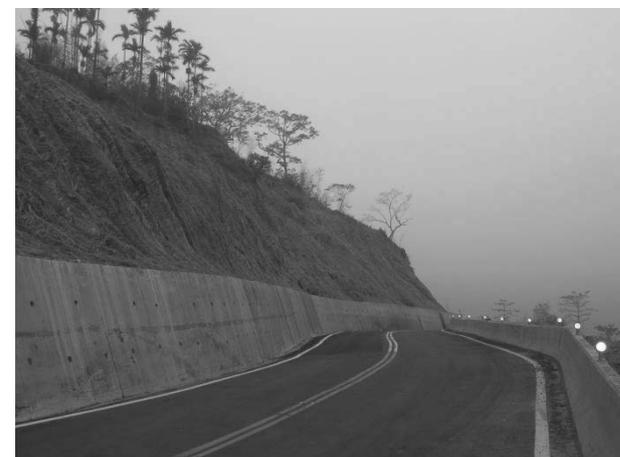
Figure 10. Completion of upslope remedial works at Mileage 39Km.

District V of DGH had to launch another remedial measure to mitigate potential impacts on the road section in the future. The plan had considered mostly the upslope protections that included filling of tension cracks, rechanneling surface drainage, installing subsurface horizontal drains, and surface vegetation, etc. Figure 10 shows the completion of upslope remedial works after Typhoon Longwang.

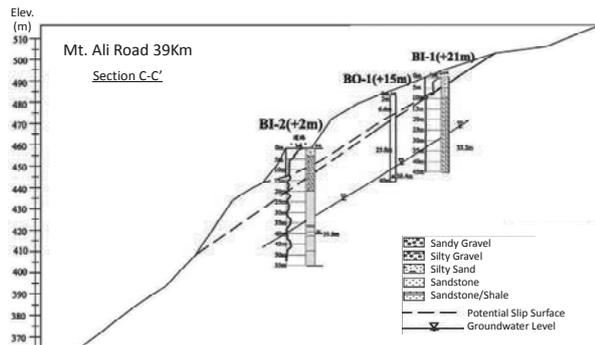
Figure 11. Material strata and potential slip surfaces at Mileage 39Km.

- The potential uphill sliding masses (Figure 11).
- The unprotected downhill slope surface that enhanced rainfall infiltration and surface runoff erosion.
- A long-term erosion of slope toe by Do-Tzuo Creek (Figure 12).
- The abundance of groundwater that was observed seeping out of the surface of downhill slope.
- The prolonged and intense rainfalls that infiltrated, saturated and softened the slope materials, increased the perched water level, and directly triggered the slips.

- Removal of potential sliding masses or reducing slope angle in the uphill.
 - Downhill slope protection including vegetation and drainage installations.
 - Road base and adjacent slopes strengthening by piling and anchoring.
 - Subsurface drainage installations in uphill & downhill slopes.
 - In-situ monitoring and warning system installation.
- The above measures appear to be sound from an engineering standpoint. However, the total cost and time for all of the above works would be extremely high, in view of difficulties in access for construction and generally incompetent subsurface materials at the site. Another option would appear more favorable as to reroute the Mt. Ali Road away from this difficult section.

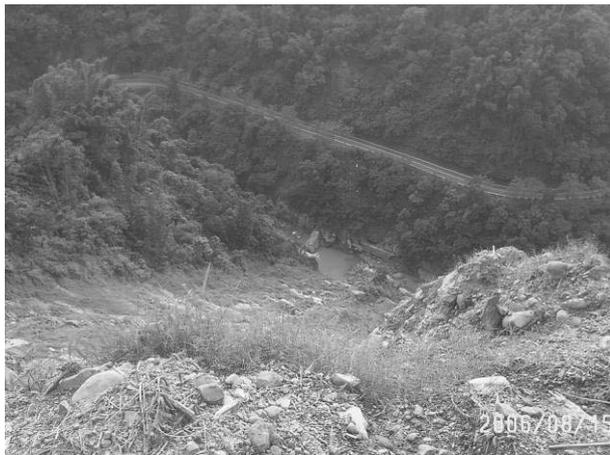
Figure 12. Downhill slope of Mt. Ali road section at Mileage 39Km.
