Geotechnical Characterization, Stability Analysis, and the Stabilization Process for a Landslide in a area of Barreiras Formation and Granite Residual Soils, Pernambuco

Coutinho R.Q.

Silva da M.M.

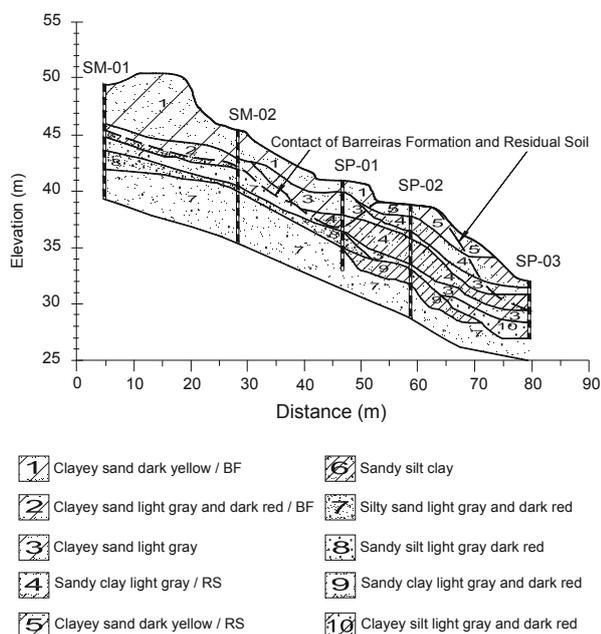
The presence of granite residual soil from the ground level in the SP-02 region demonstrated a profound influence on the landslide process, as evidenced later on in the study.

Figure 1. Typical Soil profile-cross section – post failure.

Results of the vertical readings from inclinometers confirmed the information obtained from the SPTs boreholes, showing that the failure surface seems to be very close to the contact between the Barreiras Formation, and the granite residual soils, measured to be located at a depth just over 7 m from the surface of the ground, the exception being the region around SP-02, where only residual soils are found.

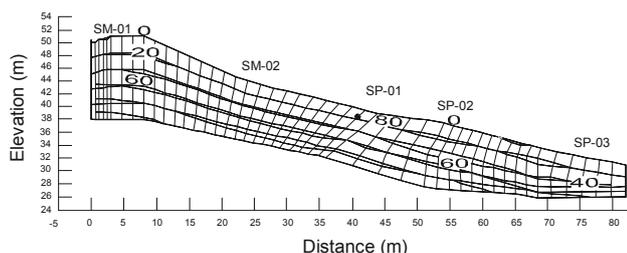
Flow analysis was performed for the failure condition, considering all the information from the studies, including the geotechnical profile, the geotechnical parameters of hydraulic conductivity for the materials composing the Barreiras Formation and residual soils, along with the rainfall and water level conditions. A summary of pore pressure distribution results is shown in Figure 4. Higher positive pore pressure values in the SP-01 and SP-02 regions were obtained showing ascends flow. These results are due to the variability of the soil profile and differences among the hydraulic conductivity values occurring for the materials. This condition is in conformity with water flow observed in this area during the period of intense rainfall.

With the flow analysis results that were provided, stability evaluation for global failure was initially performed (one-step failure) for the complete slope cross-section. The safety factor result was 1.278, showed not to be a condition for failure. Stability analysis was then performed considering the possibility of two-step failure, taking into account the concentrated high pore pressure values around the SP-01 region.

Figure 4. Flow Analysis – Pore Pressure Distribution.

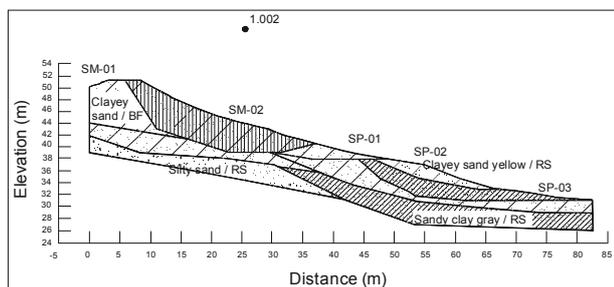
The first landslide occurred between the positions SM 02 and SP-01. For this case, the safety factor value was 1.002, for practical purposes, considered to be a condition of failure, and initiating the landslide mechanism in the area (Figure 5).

Figure 5. Back-analysis of the first slope failure – from SM-01 to SP01

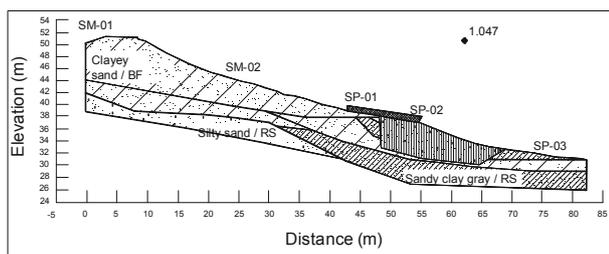
The mass that moved in this area (from the first failure) caused a surcharge estimated at 30KN/m between positions SP-01 and SP-02, which associated with pore pressure conditions, provoked the second step of the landslide. With this understanding, stability analysis was performed (back-analysis) using geotechnical information from the field and laboratory investigations. Figure 6 presents the minimum safety factor value obtained (1.047), confirming the displacements, and the failure mechanism considered to be the cause of the landslide that occurred in the area.

Figure 6. Back-analysis of the second slope failure – SP-01 to SP-03

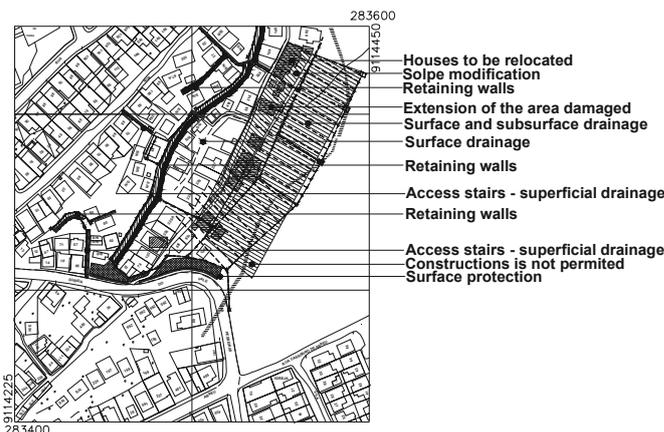
After three years, another intense rainfall period amplified the problem, with cracks forming in many other houses, and extending the area initially showing damage. See the right side of the two upper-center squares of Figure 7.

Figure 7. Measures Proposed for Mitigation and Control

The stabilization measures proposed for all damaged areas (initial and extended areas) included: surface and subsurface drainage (sub-horizontal drains), surface protection, placement of access stairs with surface drainage, modification of slope shape, installation of retaining walls, definition of areas where occupation was to be prohibited, definition of houses to be relocated, dissemination of information to the public, and raising overall awareness of the conditions, along with community consciousness. Figure 7 shows some of the mitigation and control measures proposed.
