Some Technical Aspects of the Tailing Dam Failure at the Ajka Red Mud Reservoirs

Mecsi J.

University of Pécs, Engineering and Information Technology, Hungary

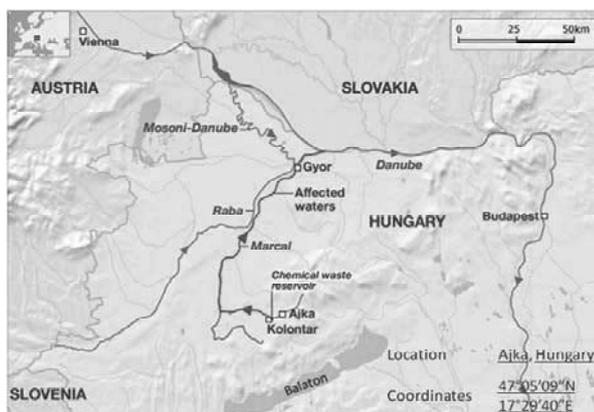
Fig.1. The site and affected localities, (<http://www.bbc.co.uk/news>)

On October 4, 2010 the northwestern part of the dam of red mud reservoir No. 10 has collapsed, and near one million m³

alkaline red mud mixed with water has plunged in the valley of the Torna stream. Fig. 1.-Fig4.

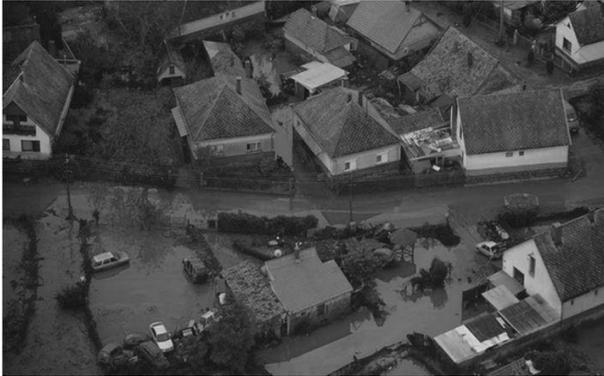
The red mud flooded the valley-side parts of the villages, then through the Marcal river it has reached the river Danube in very

short time. 10 people died, 123 injured, 260 houses became uninhabitable, and significant ecological damage occurred.

Fig.4. Aerial photo with the flooded territory of Kolontár (photo: MTI)

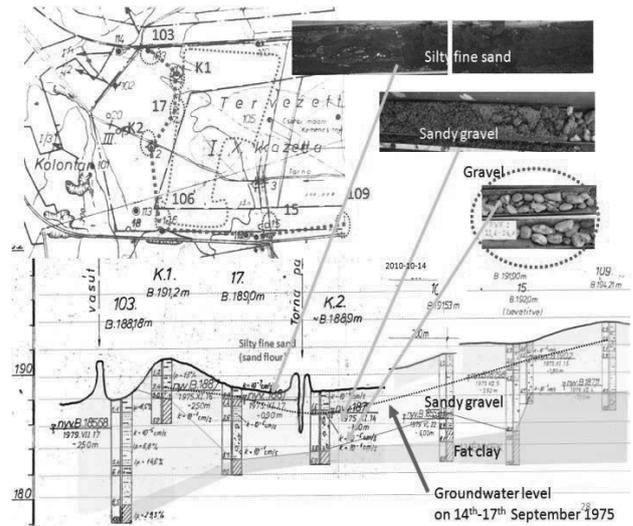
Figure 5 shows the subsoil conditions of the area based on detailed soil tests performed between 1975 and 1980. The territory had a basin-like character, fill with coarse gravel and sand and cover fine sand and silt, hence it had a swampy character, collected the water. The gravel terrace is gradually thinning towards the northern embankment. The „gravel basin” is bounded by a soft, easily liquefiable sludge layer of a plasticity index of $I_p=6.8-8.5\%$ and a water permeability of $k=10^{-5}$ cm/sec.

Fig.5. Illustration of the subsoil conditions of the reservoir system based on the original plans.

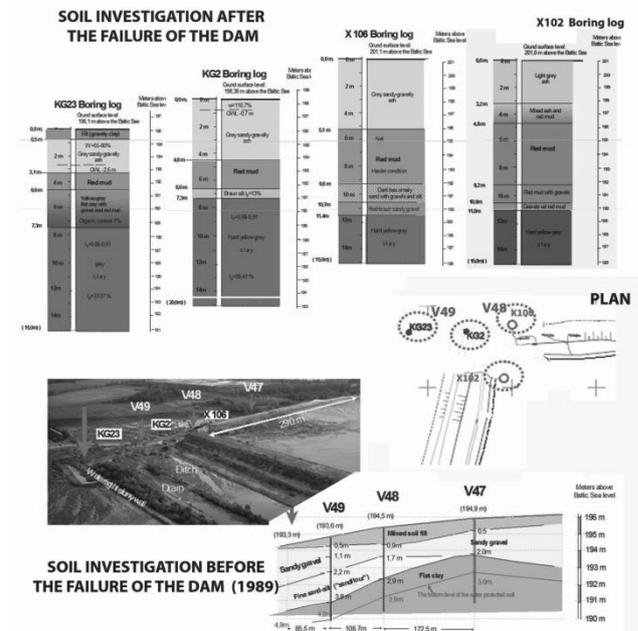
In the year 1989 soil excavations and geophysical measurements were conducted at the leg of reservoir No. 10's tailing dam, and the soil profiles were recorded. Figure 6 shows the soil profiles near the north-west corner. It is important to remark that near the north-west corner of reservoir No.10 sand-silt soils are to be found, and sandy-gravel layers above the fat clay. This soil layer unfavourable is that in fine sandy-silt fractions may move under higher water pressure conditions.

Fig.6. Soil profile near the West –North corner of the reservoir No. 10.

As a result, grain size becomes coarser on the inner side, while a „clay plug” may develop towards the edge of areas in motion. Such a clay plug is characterized by a sudden movement under a significant change in pressure and consequently a mudflow-like grain movement may evolve. Such a process may be extremely fast and unexpected.

The geotechnical conditions were determined by the fact that at the northern boundary embankment of the reservoir there are beds of easily liquefiable muddy fine sand (or sand flour as described earlier) in a layer of 3-4 m located in the closest vicinity of the critical corner of the reservoir, adjacent to a sandy-gravelly layer.

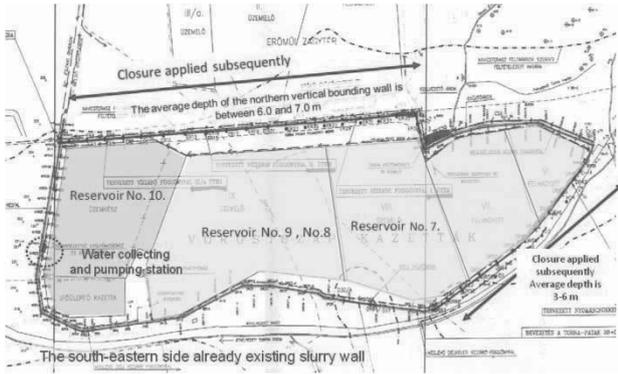
Water pollution was detected in the groundwater monitoring wells near the reservoir system in the 1970s–1980s. In compliance with the regulatory requirements, a watertight slurry wall was constructed to close down the southern and the western sides of the reservoir. Figure 7.

Later, as the pollution spread over towards the north, the construction of a new type of grout curtain was started around the reservoir system in 1999. Depths of 6.0-9.0-12.0 m appear on the south-eastern side.

Fig. 7. Soil profile near the West-North corner of the reservoir No. 10.

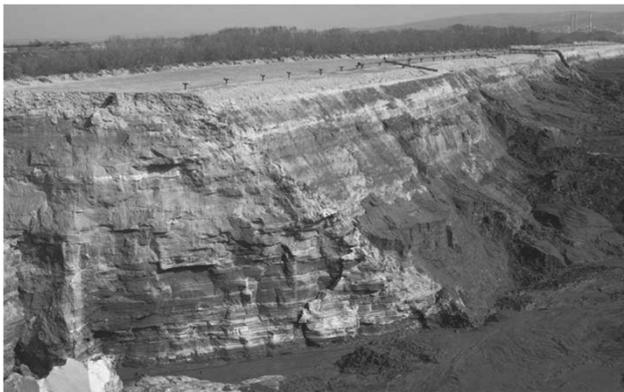
The boundary embankments show some special features. As they were made of slag and ash from the power plant, their weight is relatively low. Fig. 8.

Fig. 8. Material of the northern embankment of Reservoir No. 10 after the embankment failure.

Their average density is $\rho = 1.5-1.55 \text{ gr/cm}^3$, while their dry density is $\rho_s = 0,7-0,8 \text{ gr/cm}^3$, which is lower than that of water. The embankment is quasi-saturated with water. Due to the hydraulic chemical bond, the embankment is characterised by a relatively large strength. As a result of the construction technology applied, the embankment is layered and is of inhomogeneous structure, which manifests both in its strength and its water permeability characteristics.

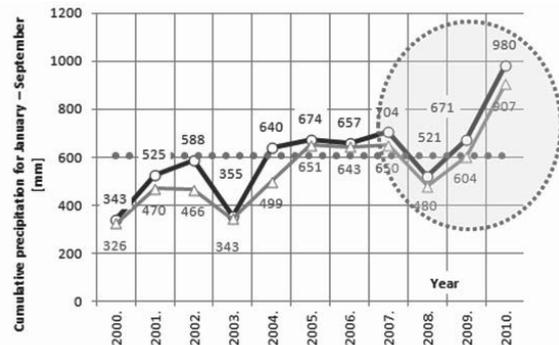
Comparing the total precipitation of the period between January and the end of September 2010 was 907÷980 mm, comparing the average of the 2000-2009 years data 513÷567 mm with 121÷131 mm standard deviation. (Fig 9.)

Fig. 9. Total precipitation data in the 1st-3rd quarter year between 2000 and 2010.

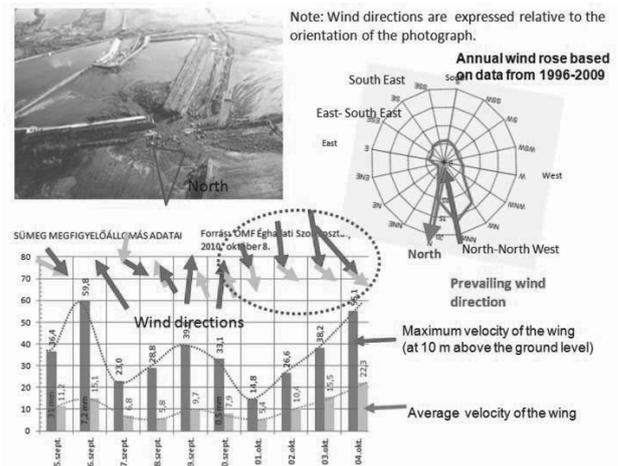
The prevailing wind direction in the vicinity of Reservoir No. 10 is northern-north-western as shown in the wind direction frequency chart. Wind parallel with the direction of the embankment failure is very rare (Figure 10).

Fig. 9. Vectors of prevailing wind directions and wind speeds between September 25.

Peculiar wind conditions were observed in the area between September 25 and October 4. Between October 1 and 4, a gradually strengthening, unfavourable wind speed toward the direction of the embankment failure was accompanied by casual wind gusts (Weather data services, National weather Services, October 8, 2010). The observations of the wind direction and speed were at 10 m over the ground surface, but the top surface the reservoir is 23-24m. It is mean that the wind speed in site should be significant more than the measured value. The highest wind speed values were measured on October 4, with an average of 22 km/h and occasion wind gusts of 60 km/h. There is reason to assume that these unusual wind direction and wind speed conditions contributed to the development of the embankment failure. The sucking effect of the wind on the northern side of the embankment must be taken into consideration.

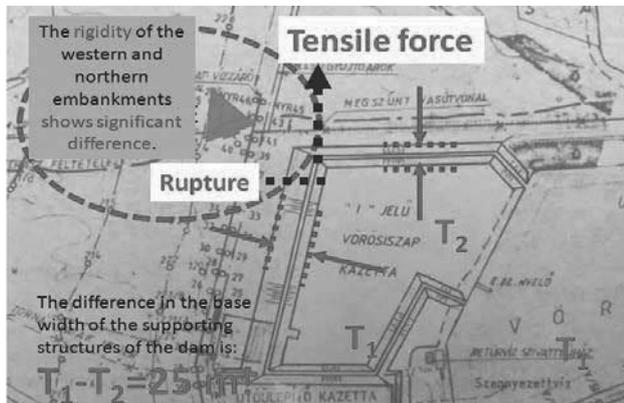
The base width of the northern embankment is significantly different from the size of the other embankments, as it was considered a temporary structure, bearing in mind the possibility of a future extension. The slightly more than 20 m height of the solid part of the embankment is lower than the 26–27 m heights of the other embankments. Its effect manifested at the northern embankment – being by 25 m less in base width than the western embankment – as the resistance against displacement here was significantly lower, and also because the rigidity of the western and northern embankments showed significant difference at an unfavourable connection at the corner of the reservoir. (Figure 10.)

Fig.10. Dimensions of the western and southern dams.

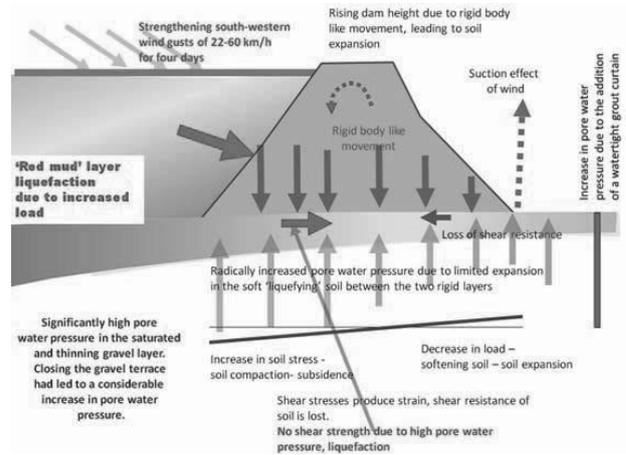
Significant pore water pressure may have developed in the soil layer underlying the embankment as a result of the geological properties of the enclosed gravel terrace functioning as a drainage basin and due to extremely high precipitation levels causing high water pressure conditions.

The increase of load on the slope surface of the embankment might have contributed to the excess load – and the increase of soil stress – in the subsoil on the inner side and as a consequence, to excess subsidence, while it probably caused a slighter rate of expansion on the outer side due to the rigid body like movement of the embankment.

The extremely rigid but light embankment and the soft, liquefiable subsoil provided highly unfavourable static conditions.

The extremely unfavourable wind direction and wind speed conditions may have given a final push toward the very sudden embankment failure.

Fig.10. Summarizing some effects for the dam failure

The list of contributing factors could be further extended and it will readily be conceived that it is the accumulation of unfavourable conditions that led to the sudden rupture of the embankment.
