Importance of Shear Stress Anisotropy and bottom drainage on Tailings Dam Stability: a Case History

Jean-François Vanden Berghe,
Fugro Engineers SA/NV, JFVandenbergh@fugro.be

In February 2007, a tailings dam used as sedimentation pond of lime particles failed. As a result, an estimated volume of 150,000m³ of tailings flowed from the breach in the dam slope. Forensic investigations were carried out to determine the causes of failure, so that suitable changes could be made for the future safe operation of the tailings disposal facility. The investigation identified several features of the tailings material and dam behaviour that it is considered contributed significantly to the slope failure. Among them, a marked anisotropy in the effective shearing resistance of the tailings material and the water accumulation in the tailings were identified as important factors in the failure. The origin of the anisotropy is the method of tailings deposition per layer, and results in a much lower shearing resistance on horizontal planes. The water accumulation was the consequence of a permeability of the tailings being higher than expected due to shrinkage fissures and a significant reduction in

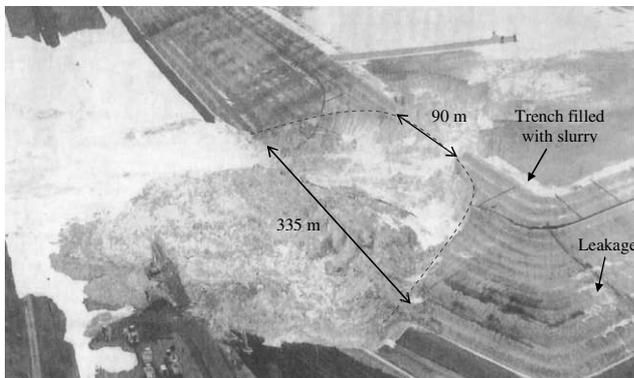
Figure 2 – Aerial photograph of failure

It has been deduced that the failure started by an outward sliding of rigid blocks over a well defined and substantially horizontal shear surface. There were 2 blocks of the dam slope that apparently moved almost horizontally by about 30m to 40m and remained almost intact. The presence of distinct blocks that remain intact, and a steep back scarp, suggests an initial “blocky failure”, or rupture of essentially intact material over distinct shear surfaces.

The failure apparently happened quite suddenly and quickly. The dam material at the slope surface, which is brownish due to oxidation with the air, slid and displaced but remained essentially intact. The part of the sliding block that suddenly came to rest on the Pioneer Dam broke into pieces with the shock loading, while the pioneer dam itself remained in place.

The initial slip failure was confined to the slope of the dam itself, rather than extending behind the dam crest. The shape of the initial failure mechanism is illustrated by the red dotted line on Figure 2. The failure mechanism is about 335m wide at the toe and 90m wide at the crest of the dam.

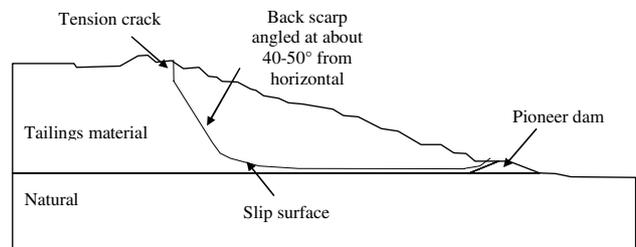
Figure 3 – Schematic view the initial slip surface

A cross-section of the initial failure mechanism is shown in Figure 3. The slip surface is composed of a vertical segment of about 3.5m and another segment inclined at about 40-50° from the horizontal. The vertical segment is likely to be due to tension cracks that developed before the failure occurred.

The base of the failure mechanism was hidden by the flow of liquefied tailings that took place following the initial failure, but this was investigated by trial pits and cone penetration tests, as well as simple excavation of the slide material. A clear junction was found between disturbed and undisturbed tailings material, and this slip surface was substantially horizontal and located within the tailings just above the natural terrain.

The Pioneer Dam remained in place and was not part of the initial failure. This implies that the failure surface did not follow the natural soil all the way to the toe of the slope but rose up to avoid the (relatively strong) Pioneer Dam.

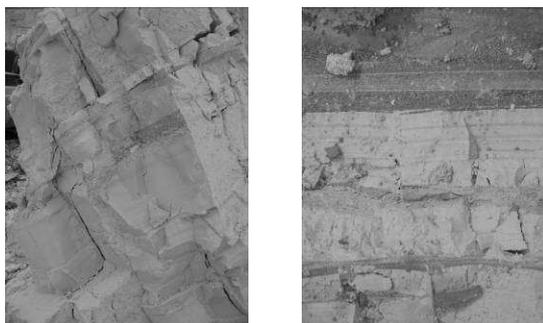
Figure 4 – Layered and blocky structure of the tailings material

A strong horizontal layering was apparent in the intact tailings material exposed by the slope failure. Many planar discontinuities can be observed in the material, both in broadly horizontal and vertical orientations, as illustrated in Figure 4. This tendency for the material to “break” or “cleave” on well defined planes and surfaces is likely to be a result of the deposition process used for the tailings, or it may be an intrinsic characteristic of the tailings material itself. This structure would suggest possibly anisotropic shear strength conditions. A lower shearing resistance on near horizontal planes through the tailings would also be consistent with preferential sliding along a bedding plane.

By analogy with fissured clay, it should be expected that the tailings material might have an “intact” shear strength, and a lower shear strength applicable for shearing on a fissure or horizontal bedding plane. Taking the analogy further, the main difference between the two shear strength values might be a “cohesive” component of shearing resistance present in the intact material and largely absent along a fissure or bedding plane.

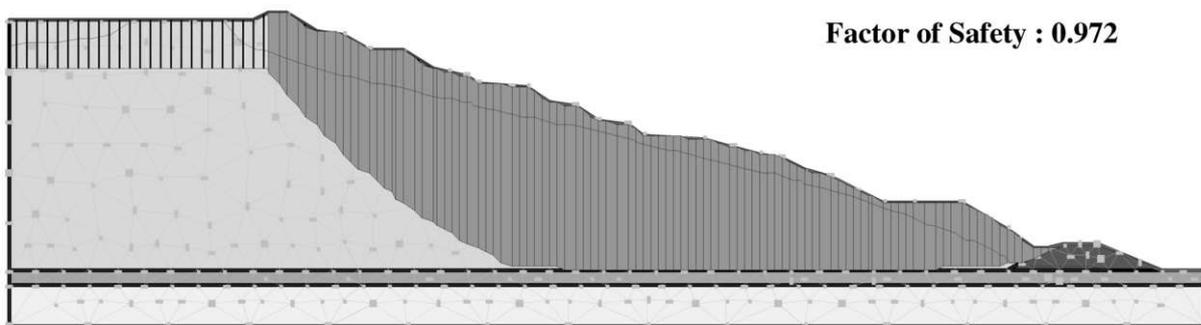
Figure 6 – Failure back-analysis

The position of the water level resulting from the steady-state seepage analysis is close and mainly parallel to the dam slope, as shown on Figure 6. This is in line with the observations made on site (i.e. leakage at about mid height of the dam, traces of water at about 3.5m from top of dam).

The slip surface found from stability analysis (assuming the pore water pressures computed from the seepage analysis) captures many observed features of the slope failure. The slip mechanism is illustrated on Figure 6 and the important features include:

- A slip surface within the slope of the dam rather than extending behind the dam crest,
- A steep inclined back-scarp,
- A horizontal plane following the natural soil, and
- A Pioneer Dam that remains in place

Most importantly, the stability analysis indicates a minimum factor of safety close to unity (0.972) for the slope implying limiting equilibrium and expected failure conditions.

If no strength reduction on horizontal planes is considered, with all the other parameters and assumptions unchanged, then the safety factor increases to about 1.7. The most critical failure mechanism is then rather circular and does not look like the deduced failure mechanism.
