Failure of a highway embankment on soft clay foundation – A case study with remedial measures

RKM Bhandari* & Pinaki Roychowdhury

LEA Associates South Asia Private Limited

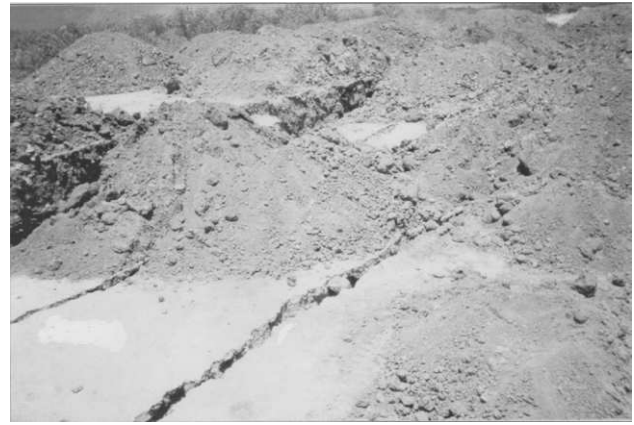
For constructing the remaining height of embankment in section A, some 30 truck loads of the fill material were deposited on its 170m long stretch in stockpiles of approximately 1.8m height spaced nearly 1.5m c/c placed across the entire width of the road crest. The dumping was completed around the afternoon of April 23, 2003 and during inspection the same evening, a longitudinal crack running precisely along center line of the embankment in Section A was observed, see Figure 1.

Figure-1. Distressed Embankment Section at km. 4+260 as on 24.04.2003 (AN), Vizag Port Road Connectivity Project

A comparison of the cracked section A loaded relatively quickly with other sections B and C where no fill was deposited, conclusively established overstressing of the soft clay stratum by temporary stockpiled fill material as the main cause of failure of embankment. Though severity of ground movement could be suspected to lead to some folding of drains, Miura et al. (1998) observe that folding of drain does not influence discharge capacity significantly as it does not change significantly both the length and the cross sectional area of the drainage path. Effectiveness of the discharge capacity of the existing band drain was accordingly considered to remain uninhibited. However, to achieve early strength gains, which, in turn, will discourage initiation of rotational failure, fresh installation of band drains at centroid of each triangle was recommended. This resulted in a reduced band drain spacing of 1.15m centers invoking a hexagonal pattern in those sections where band drains already existed at 2.0m centers. In virgin sections of the proposed highway, a triangular spacing of 1.15m was adopted.

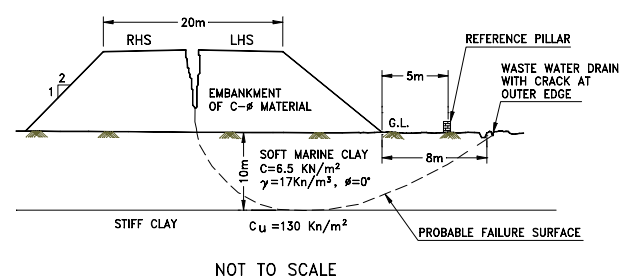
Figure 2 shows that left side of the embankment suffered damage although the material was stockpiled on either side of the centerline. A week after development of the crack, the left side of the embankment was found to have settled 500mm relative to the right side which suffered an average settlement of around 100mm and the latter became apparent only when the damaged section was opened for repairs several months after the failure incident.

- Horizontal and Vertical measurements made on the pillar (refer Figure 2) indicated its horizontal movement of about 80 cm from its original location and that it also suffered a heave of 20 cm. Also, the outer edge of the drain exhibited a crack of 25 to 50mm width.

Figure-2. Failure Pattern of Embankment, Vizag Port Road Project

Taking cognizance of the significant strength differential that existed between the soft marine clay and the very stiff clay stratum and also the observed horizontal and vertical displacement of the two structures mentioned above, a plausible configuration of the failure surface drawn tangential to the stiff clay layer in Figure 2 points out to the probable deep seated rotational failure which engulfed the embankment and the soft clay down to the top of the very stiff clay layer to emerge beyond the left toe of the embankment.

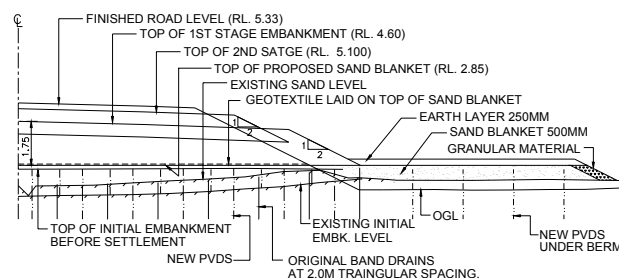
Figure-3. Corrected Embankment Profile with remedial measures after failure – Typical Section at chainage 4+300 km.

A high strength high modulus woven polyester geotextile with an allowable tensile strength of 180 KN/m was recommended to be interposed at the interface between the embankment and the top of the sand blanket. Placement of the geotextile at such a level was done with a view to avoid formation of the mandrel holes in the geotextile due to installation of band drains through it.

In view of the possibility of water logging taking place during monsoons of the low lying lands on either side of the embankment, provision of a 10m wide and 1.33m thick berm commensurating with top level of the sand blanket, was also made. Due to the low height of embankment at the berms, the band drains under them were spaced at 2.0m c/c without any geotextile.

The damaged section was dug down to a level till the triangular pattern of previously installed band drains became clearly visible over the entire failure stretch. This required some 20 cm excavation down below to the top of the sand blanket besides first removing the 2.0m height of embankment built earlier over the sand blanket. The exposed part of drains was lapped wherever so required. The installation of drains at centroid of each triangle was then undertaken. Subsequent to this, the sand blanket was made up to the required grade of RL = 2.85 m and this was followed by spreading the high strength geotextile in strips running transversely to the length of the embankment. Ends of the geotextile were firmly secured before taking up the em-

bankment construction over it. The layered system followed for reconstruction of the embankment is depicted in Figure 3.
