Failure of a hangar built in embankment on soft clay Rupture d'un hangar construit sur argile molle

This paper presents the case of a hangar that was built in an embankment having 2000 m² and 6 m high. The subsoil is formed by a layer of organic clay and peat having 12 m of thickness. The hangar was constructed without knowing the bearing capacity and compressibility parameters of the clay under the embankment. The construction started with the ground being covered by a mixture of waste and remains of others constructions. A retaining wall of gabion was executed having 3 to 6 m of variable height in order to contain the embankment. During earthmoving operations, there was a slide in one corners of the ground and the soft clay and peat appeared upward. Several cracks were observed in the floor parallel to the retaining wall. Some fissures appeared in the masonry of the hangar. After some months later, the movement grew up accelerating and the complete ruin of the hangar occurred. The geotechnical characteristics of the clay deposit was made by borings (SPT), vane test and laboratory tests (oedometer and triaxial) in undisturbed Shelby samples. The results of this investigation are

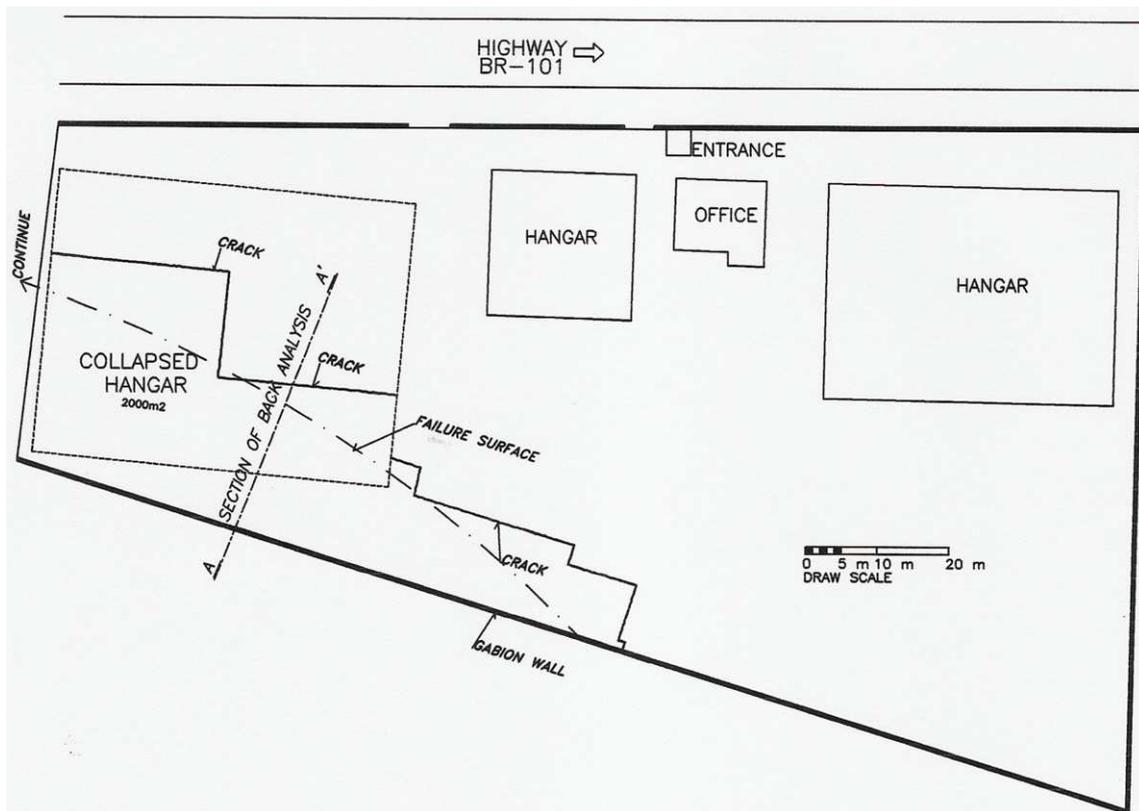
Three industrial buildings have been constructed. The biggest of them has an area of 2,000 m² and it is near the boundary of the area. Figure 1 shows the situation of the area when the works started.

Figure 1 – Plan of the site with the failure surface.

The adopted section for the back analysis is shown in Figure 1. The beginning of the failure surface was defined by the opening joints in the hangar floor, and the final of the surface was admitted where the ground moved upward. The correction proposed by Bjerrum (1972) was considered and the correction factor is 1.0 because the plasticity index is 19%.

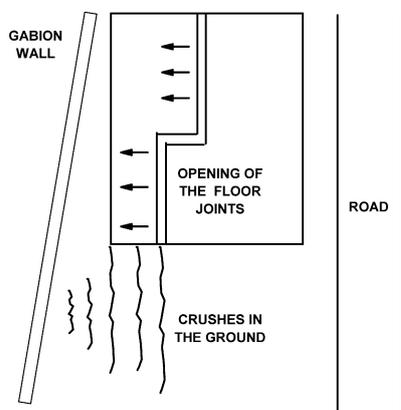
cracks started to appear on the ground parallel to the retaining wall since the beginning of the construction (Figure 2).

They have been closed immediately. Some fissures occurred in the masonry of the largest building that was situated next to the wall (Figure 3). There were also many openings of joints in the floor.

One was the vertical movement of settlement of soft clay and peat due to the loading by the own weight of the fill. The other was the horizontal movement of these layers in the direction of the unevenness of the ground.

These lateral movements reflected on the structures showing cracks in the ground and openings of joints in the floor. The vertical movements from settlement caused fissures in the masonry when the columns settled.

Figure 2 – Horizontal movements of the ground before the ruin of the hangar.

With the damage diagnosis concluded, the consulting firm proposed two separate solutions. For the horizontal movement, it was recommended the construction of a berm in the lateral side of the area.

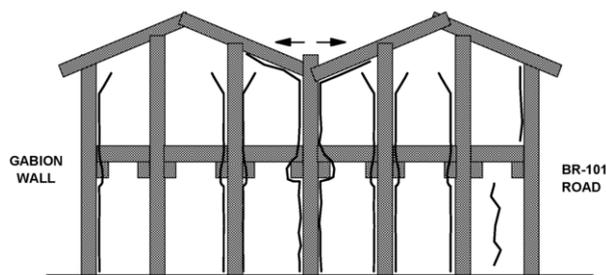
Figure 3 – Fissures occurred in the masonry of the hangar.

For the vertical movement, it was proposed to reinforce the foundations with steel piles.

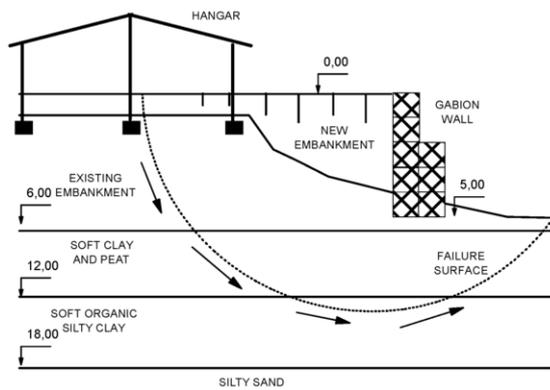
However the berm and the foundation reinforcement were not done and the movements grew every day. After some time later, there was an acceleration of the movement of the ground and the complete ruin of the hangar (Figure 4).

Figure 4 – Mechanism of the ruin of the hangar.

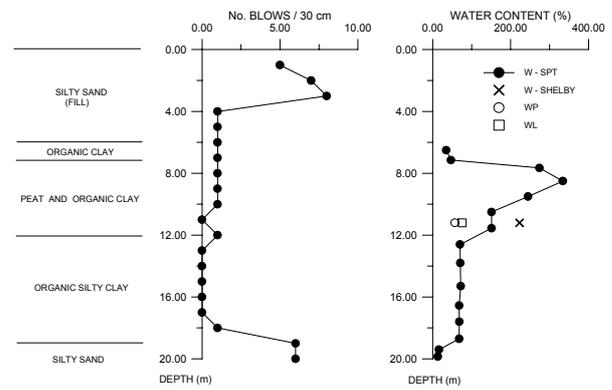
Figure 5 shows a typical subsoil profile obtained with boring (SPT), including the natural water content of the soils that was determined by SPT sampler.

It can be observed the existence of two sublayers with different geotechnical characteristics (7 to 12 m and 12 to 18 m). It is also observed that the water content obtained by SPT sampler is smaller than that obtained by shelly sampler.

Figure 5 – Profile of the subsoil with SPT and natural water content.

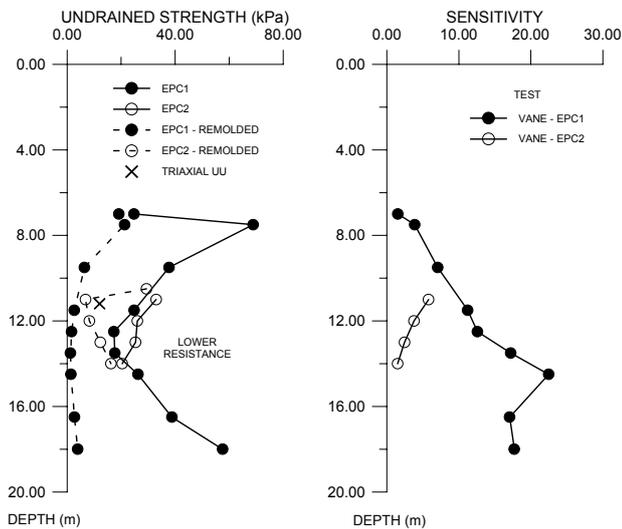
Triaxial compression tests UU and CU were done to define the undrained strength (S_u) and the angle of internal friction of the soil. Vane tests were also made in the field whose results are shown in Figure 6.

It is observed that the undrained strength in triaxial test UU has a value of 12 kPa that is below the value 33 kPa obtained by the vane test in the natural soil. However, it is very close to the vane test in the remolding soil (6.8 kPa after a large rotation in vane test). This proves that the laboratory samples were disturbed and their laboratory results should be used with special care. The effective angle of friction ϕ' was found equal to 15° in CU test.

It is also noted that the deposit of soft soil presented a lower value of undrained strength around 12 to 14 m of depth ($S_u = 20$ kPa). This indicates that the surface of rupture possibly passed at this depth. The result helped to have the back analysis of the problem with the stability of the fill to the bearing capacity of the maximum load.

Figure 6 – Strength parameters obtained by laboratory and vane tests.
Table 1 – Compressibility parameters.

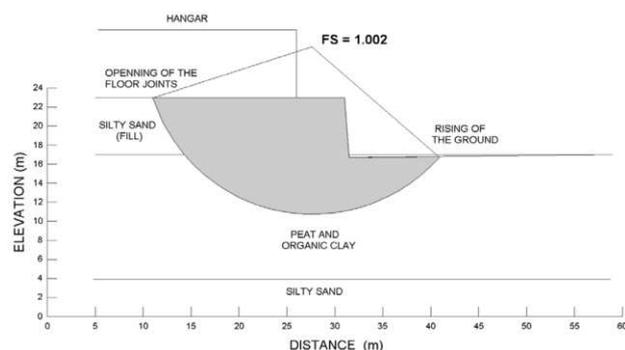
Table 2 shows the parameters used in the back analysis. Figure 7 shows that $FS = 1$ and the circular surface passes at 12 m deep and it confirmed the vane test results, where it was noted a lower strength of the deposit at this depth.

This fact was explained with the history of the slide. After the first slide, the place was refilled to get leveling the floor. As a result, the place was submitted to a high loading without to offer an expressive increase in the bearing support of the soft soil. Then the fill collapsed sometime later.

Figure 7 – Failure surface obtained from back analysis.
