Slope failure movements controlled by unloading Glissement de pente contrôlé par déchargement

S. Cavounidis

M. Bardanis

ABSTRACT

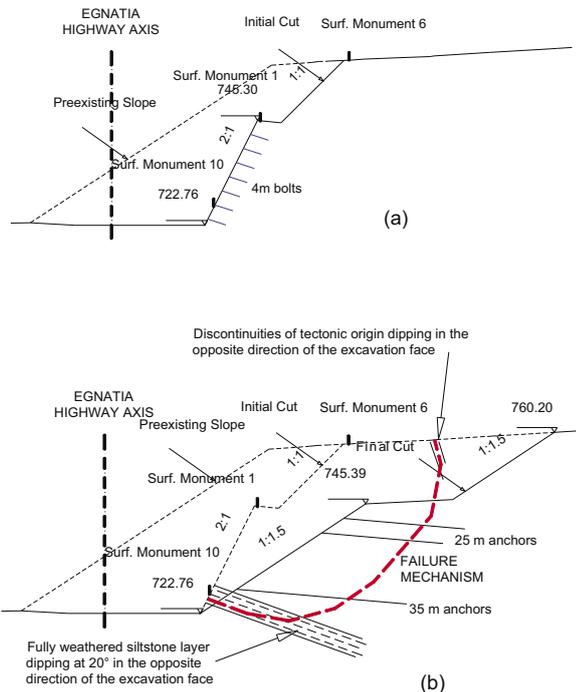
The Cut & Cover Tunnel S2 is located uphill of the landslide in area D3 of Section 3.1 (Fig. 1). Given that the flysch layer dip direction was opposite to the temporary cut slope direction and strength parameter estimations on the basis of GSI values led to satisfactory values ($c'=50\text{kPa}$, $\phi'=30^\circ$), a relatively steep cut slope was initially designed. The maximum height of the temporary cut was 33 m with the upper 11 m high part having a slope 1 over 1 without any support measures and the lower 22 m high part having a slope of 2 over 1 (vertical over horizontal) with 10cm thick fibre-reinforced shotcrete and 4m bolts as support measures (Fig. 2a). A 5m wide bench separated the two parts of the cut and excavation for the lower part was to proceed

Figure 2. a) Section of the temporary cut with initial slopes, and b) section of the temporary cut with initial and final slopes, fully weathered siltstone band, uphill faults and positions of surface monuments 1, 6 and 10.

In order for the temporary cut's factor of safety to reach an acceptable level for the construction of the twin concrete tunnels, support measures in addition to the unloading excavation included decrease of the slope to 1 over 1.5 (vertical over horizontal) and three rows of prestressed anchors. The upper two had 25m long anchors at 2m spacings and the lower one 35m long anchors at 2m spacing. Such lengths were required in order for the fixed length of the anchors to lie certainly beyond the failure surface. Locally placed horizontal drainage holes (a total of 25 20m holes were drilled) were also placed in order to cope with possible new perched water tables. After the implementation of these additional support measures, construction of the twin concrete tunnels and placement of fill on top of them continued as initially designed. A photograph of the S2 Cut & Cover Tunnel and the D3 Area landslide as stabilized can be seen in Figure 6.

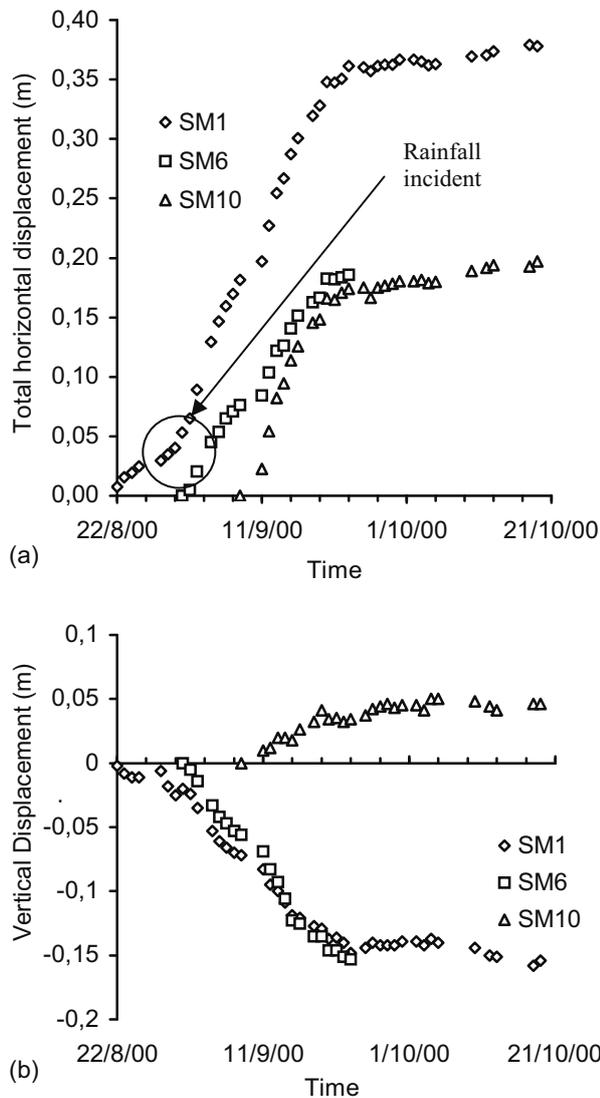
The excavation of the upper part of the slope faced no problems. When the excavation of the cut had proceeded down to the first 10m of the lower 2 over 1 slope part, a small volume wedge failure occurred. Support measures were increased at the time and a dense grid of surface markers was installed in order to monitor possible large movements. By the time only 4 m of excavation remained, two additional wedge failures and a larger scale instability recorded by the measurements from the markers and surface cracks occurred, following heavy rainfall for two days. This rainfall incident (26-27/8/2000) apparently allowed for the creation of temporary perched water tables –no ambient water table was found above the excavation bottom at any stage. Movement rates started climbing rapidly (Fig. 3). The initial rate of approximately 2 mm/day on the markers in the middle of the instability climbed to 16 mm/day with displacement vectors from markers on the same cross-sections indicating that a deep-seated slope failure surface had formed in the very weak rock mass. Surface markers like SM1 and SM6 shown in Fig. 2 recorded movements dipping downwards while surface markers like SM10 in Fig. 2 recorded movements dipping upwards. Markers placed beyond the toe of the slope recorded no movements at all. Azimuth of movements recorded on all markers coincided with the direction of the slope face. Subsequent additional geotechnical investigation indicated that instability was geometrically helped by the orientation of fully weathered siltstone layers at the toe of the cut and discontinuities of tectonic origin at the scarp. Movement vectors on surface markers like SM10 were parallel to the dip direction of the fully weathered siltstone layer but with an opposite direction. A general view of the temporary cut at that stage may be seen in Figure 5.

Figure 3. a) Magnitude of movements on the horizontal plane, and b) on the vertical plane (positive outwards and upwards respectively).

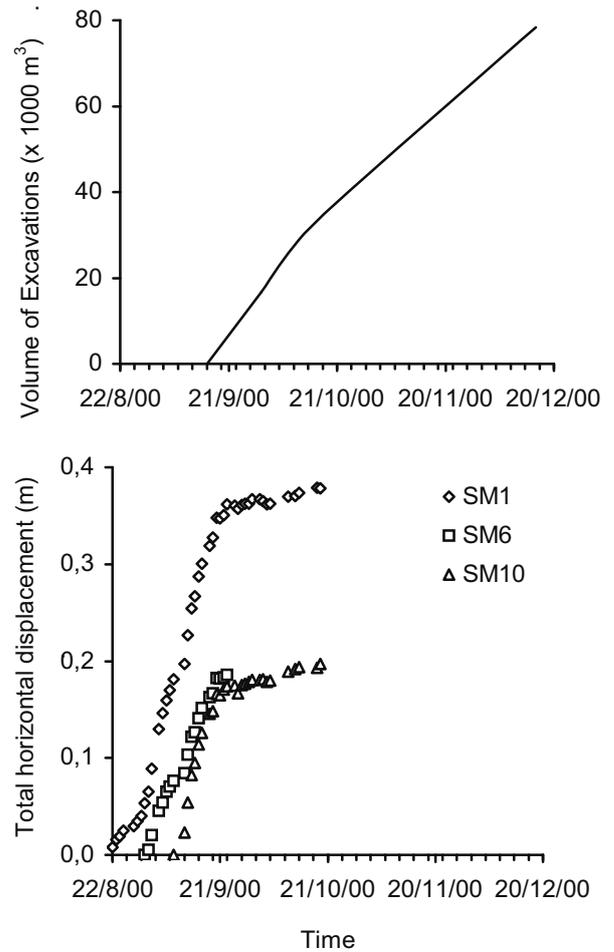
Figure 4. a) Uphill excavation volume, and b) magnitude of movements on the horizontal plane.

Rapid increase of movement rates called for immediate support measures and unloading of the scarp was selected as such while continuing monitoring. Stability analyses on the same sections and failure surfaces that back analyses were performed, determined the size and extents of the unloading excavation. As it can be seen in Figure 4 excavation of approximately 10,000 m³ proved sufficient to bring movements to a gradual but well defined halt (movement rates dropped even below the values measured before the rainfall of 26-27/8/2000). Given the approximately determined failure surface and the width of the instability, this volume amounts to approximately 10% of the volume of the sliding mass (estimated at 100,000m³). Unloading excavations were continued until the movements halted. This relieved immediate danger of collapse of the temporary cut, leaving only the need for final stabilization, given the existence of the failure surface inside the slope.

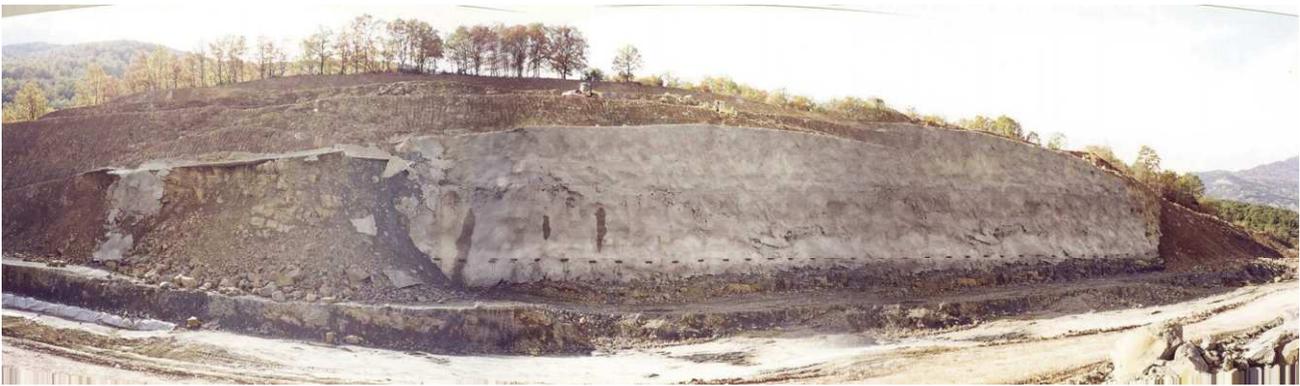
Figure 5. General view of the temporary cut face with local failures on the left. The sliding mass extended from the left limit of the local failure to the right limit of the shotcrete-covered area.

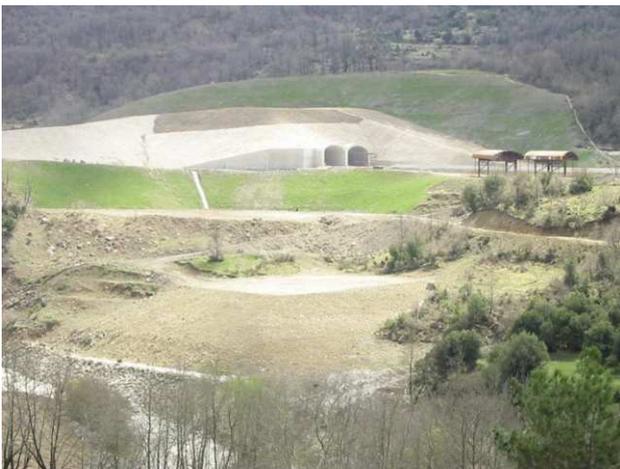
Figure 6. General view of the S2 Cut & Cover Tunnel and the D3 Area Landslide downhill of it as constructed.
