Observations on groundwater leakage through cracks and segment joints in a concrete segmental tunnel lining

V. Tellioglu

Senior Tunnel Engineer, CH2M HILL, Abu Dhabi, UAE

ABSTRACT: Facing with the combined challenge of aging sewer infrastructure and rapid population growth, the Abu Dhabi Sewerage Services Company (ADSSC) embarked on a bold approach to build an enhanced sewer infrastructure with a deep gravity sewer tunnel at the center. The primary lining of the new 41 km-long deep sewer tunnel has been completed by tunnel boring machines (TBM). The concrete segmental lining has an internal diameter varying from 4 m to 5.5 m internal diameter, and is located at depths of 20 m to 80 m below the ground surface. This paper attempts to quantify the results of observations made on groundwater infiltrations and response to repair works experienced at different stages in construction of concrete segmental lining for deep sewer tunnels. The observations presented below have been based on the actual data obtained from a total of 10,872 rings installed in three TBM drives in Contract T-02 of Abu Dhabi's Strategic Tunnel Enhancement Programme (STEP).

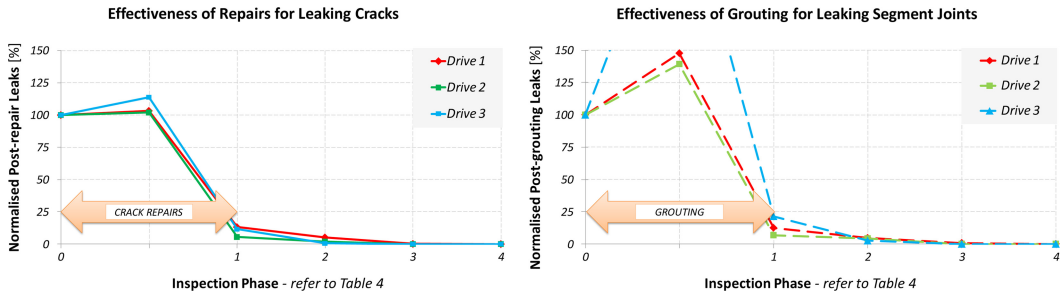
Figure 3. Post-rectification improvements on tunnel leakage.

In the time interval between the pre-repair to pre-CPL inspections, 39 to 45 weeks elapsed as minimum in construction. All repair works, including the trials, took place within this time span. The repair and grouting works were regularly monitored through three passes of post-repair and post-grouting inspections (Table 4).

The apparent redistribution of water pressure and the leaks caused more cracks and segment joints to be sealed. Despite the unexpected increase, the repair and grouting works were completed efficiently. 87% of the leaking cracks and more than 79% of the leaking segment joints were sealed in the first pass (Figure 3). 95% of all leakage was stopped in the second pass. The third pass resulted in very minor infiltrations below 1%. Between the third and fourth pass, no repair or grouting work was required.

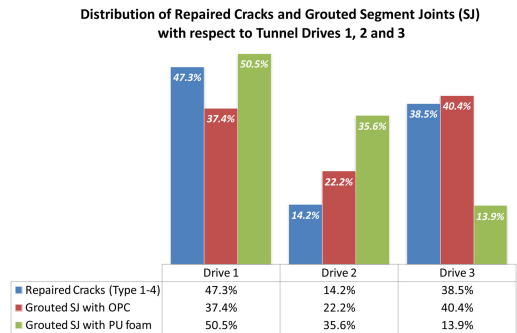
Figure 4. Distribution of actual crack repairs and grouting works with respect to tunnels.

The distribution of all completed crack repairs and grouting works with respect to tunnels is summarized in Figure 4. Drive 2 had the least number of cracks and of major leaks hence delivered the best performance among the three. Due to the limited leakage observed, the least amount of the total OPC grouting took place in Drive 2 to seal the segment joints. However, the ratio of PU foam application realized to 35.6% being the second in order among the three. This is most likely because a number of minor leaks experienced through segment/ring joints distinctly so each of them had to be treated individually.

Drive 1 was the very first tunnelling operation in the programme, and the majority of the defects and leakages occurred within the initial drive during the learning curve. Drive 1 underwent the largest number of crack repairs, and that of PU foam grouted segment joints.

Drive 3 experienced the most intensive leakage through the defects due to the hydrogeological conditions. It was built under the "Al Wathba Wetland Reserve", through a non-intact zone in which fissures

and fractures reported in boreholes were apparently interconnected and enabled full hydrostatic conditions to develop quickly in front of the TBM. The average face pressures in the second half of the drive length increased by five times and nearly reached to full hydrostatic pressure. Drive 3 took the largest share of OPC grout up to 40.4% to its segment joints, being 3% in excess of that of Drive 1. Major water inflow were experienced over more than half of the alignment length in Drive 3 although crack repairs were less than in Drive 1 by 9%.
