AN ASSESSMENT OF THE FAILURE OF THE WADI DERNA DAMS AND LESSONS FOR ENHANCING DAM SAFETY

Attribution. Please cite the work as follows: World Bank, UNESCO, The Netherlands and ICOLD. 2024. *Breaking Point: An Assessment of the Failure of the Wadi Derna Dams and Lessons for Enhancing Dam Safety*. Washington, DC: World Bank. <https://hdl.handle.net/10986/42940>

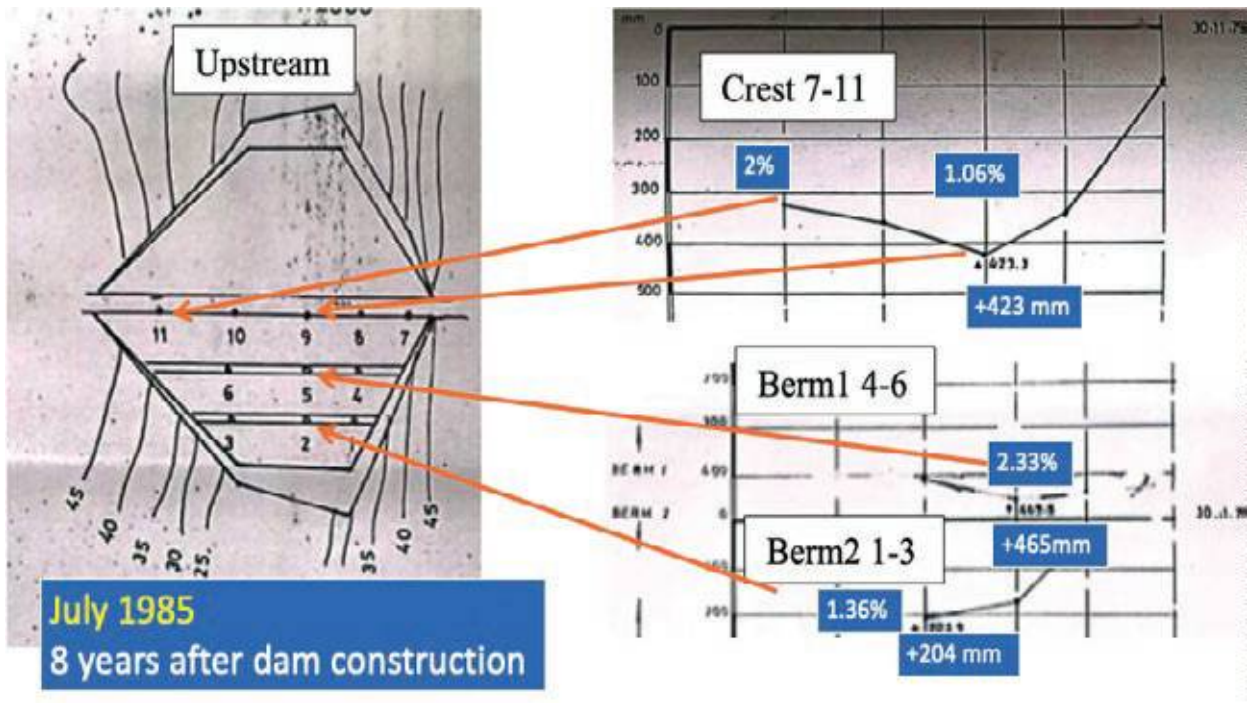
FIGURE 2.3. The settlement of the crest and the two berms in Derna dam.

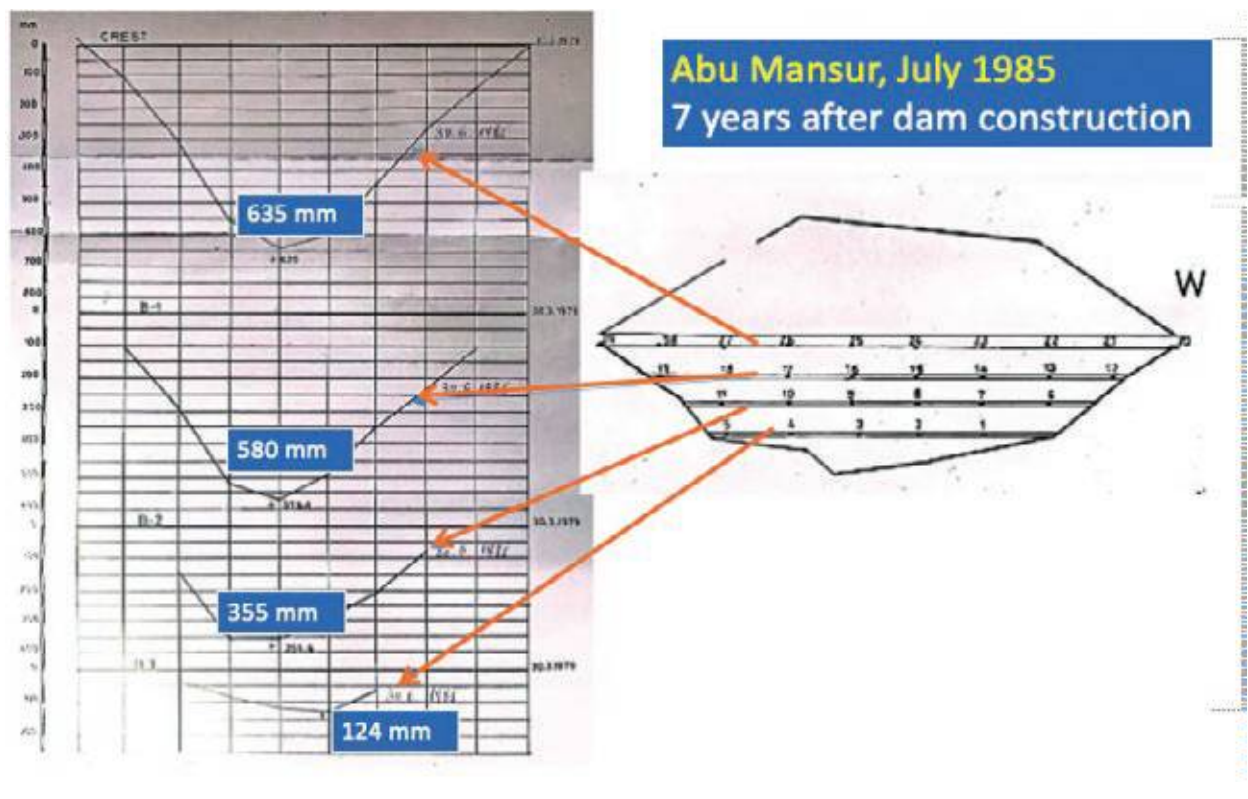
FIGURE 2.4. Abu Mansur dam settlement measurement (30 June 1985).

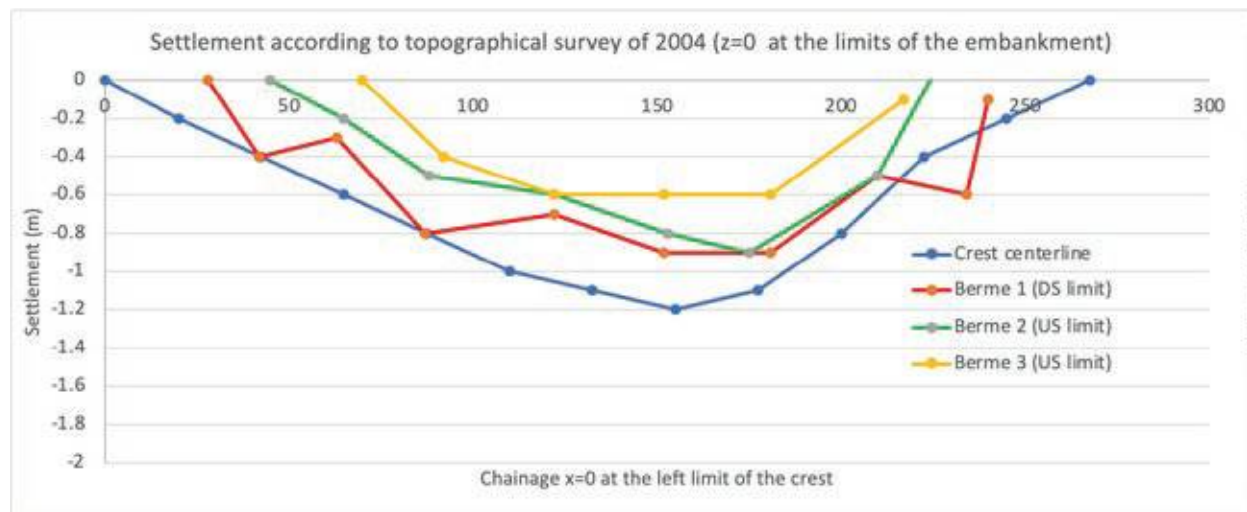
FIGURE 2.5. Settlement of the Abu Mansour Dam according to the topographic survey in 2004 (z=0 at the limits of the embankment).

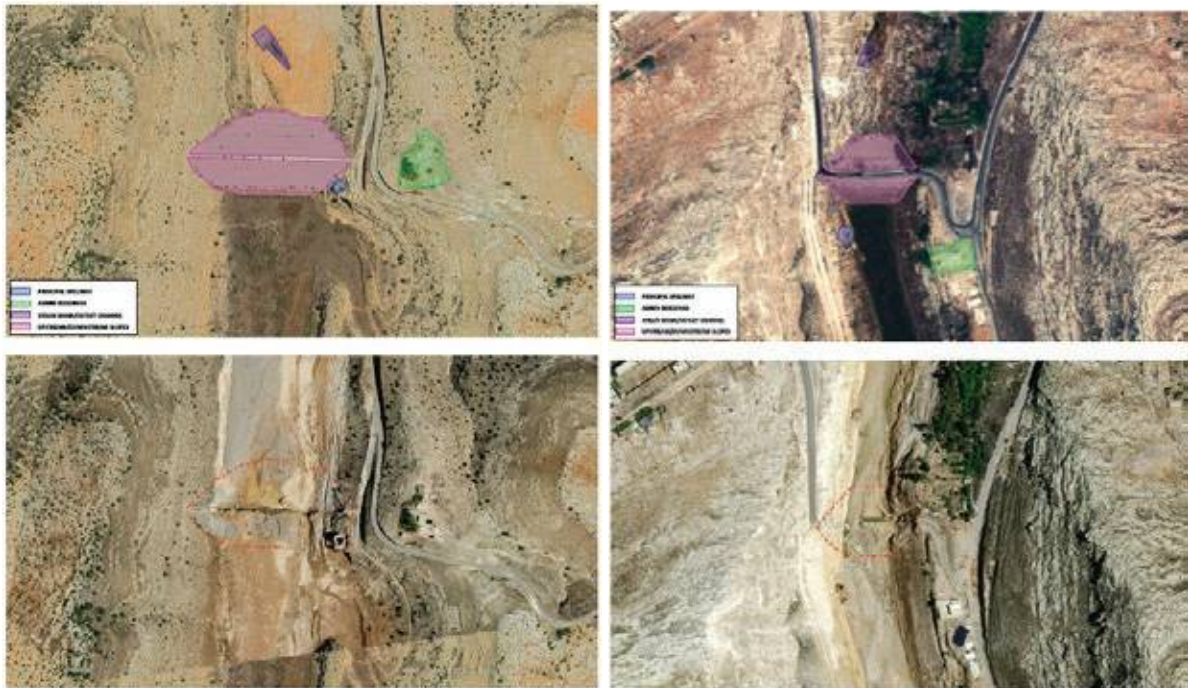
FIGURE 4.3. Abu Mansour Dam (left) and Derna Dam (right) before and after the floods.

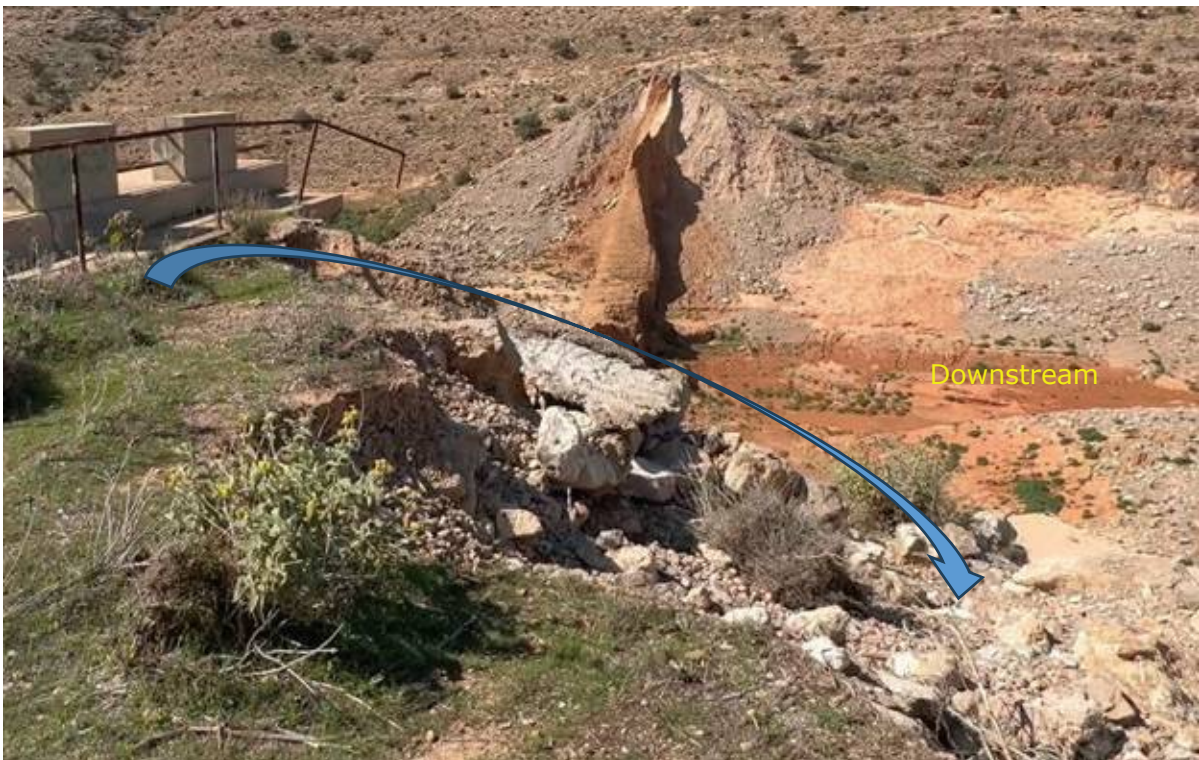
PHOTO 4.1. Erosion due to the water overflowing the right abutment of the Abu Mansour Dam.

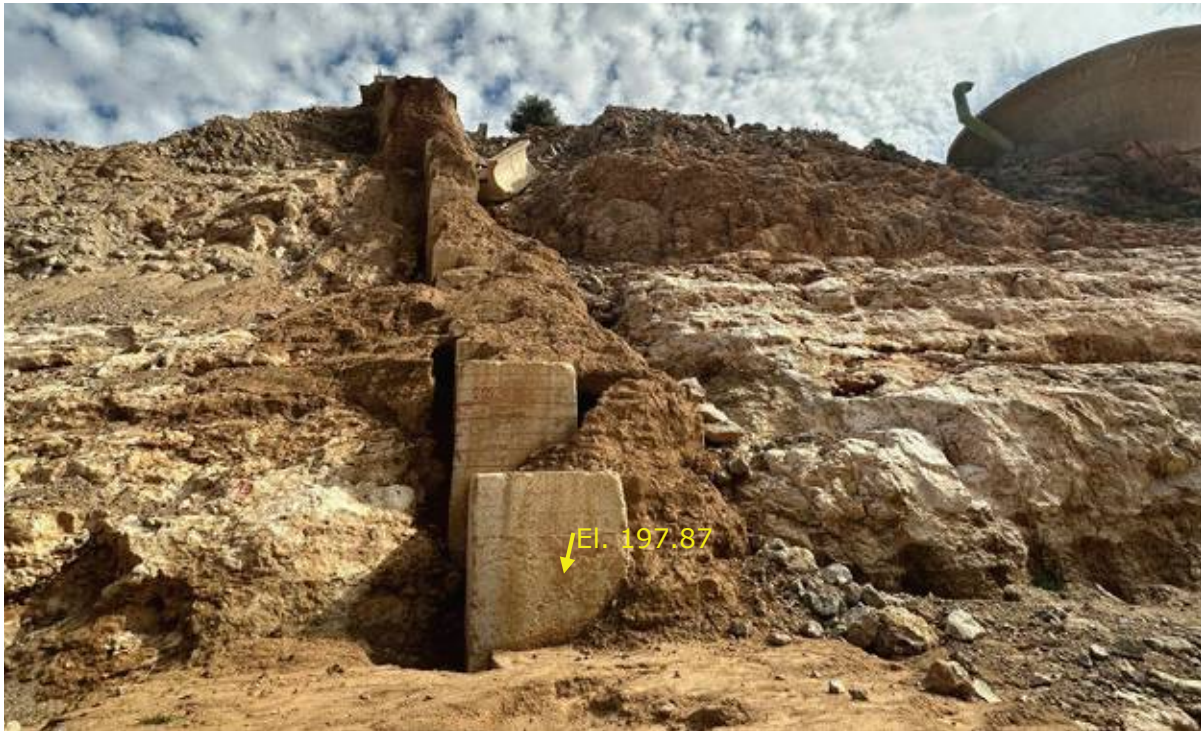
PHOTO 4.2. View of the right abutment of the Abu Mansour Dam where the embankment was totally washed away. Concrete blocks correspond to the centerline of the core foundation and the grout curtain drilling.

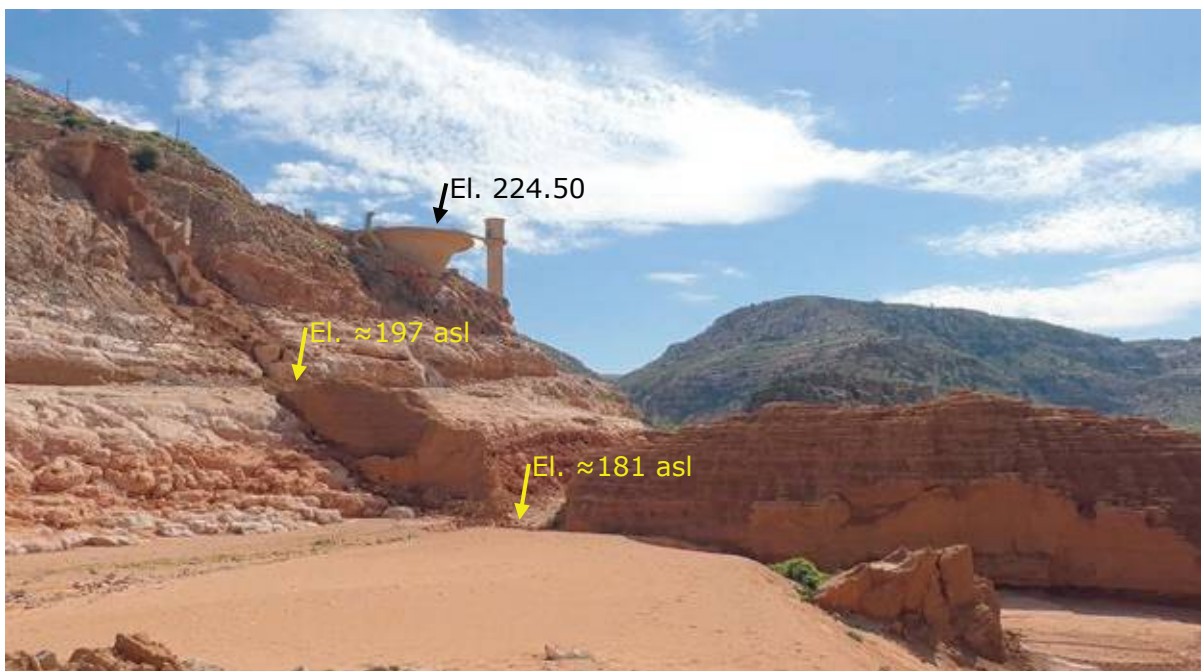
PHOTO 4.3. Downstream view of the right abutment of the Abu Mansour Dam.

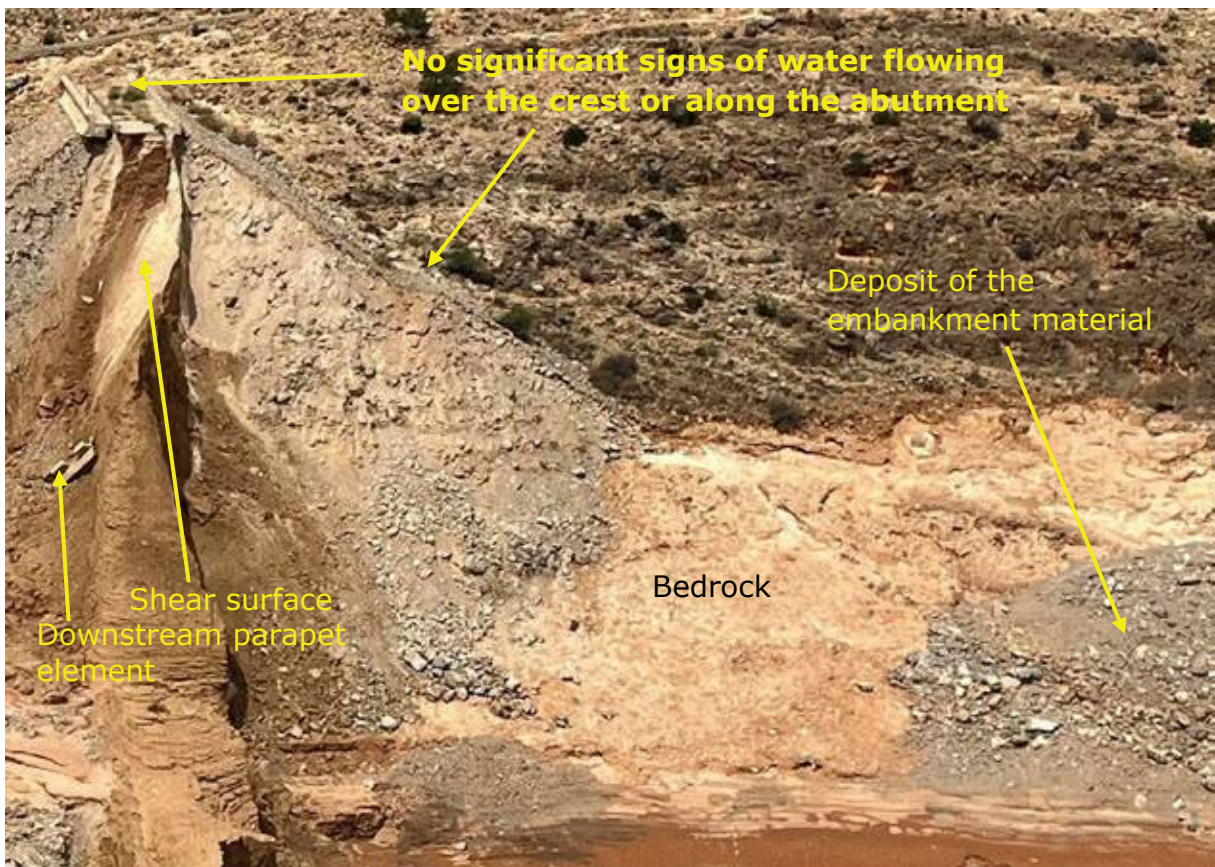
PHOTO 4.4. View of the remains of the dam's left abutment of the Abu Mansour Dam.

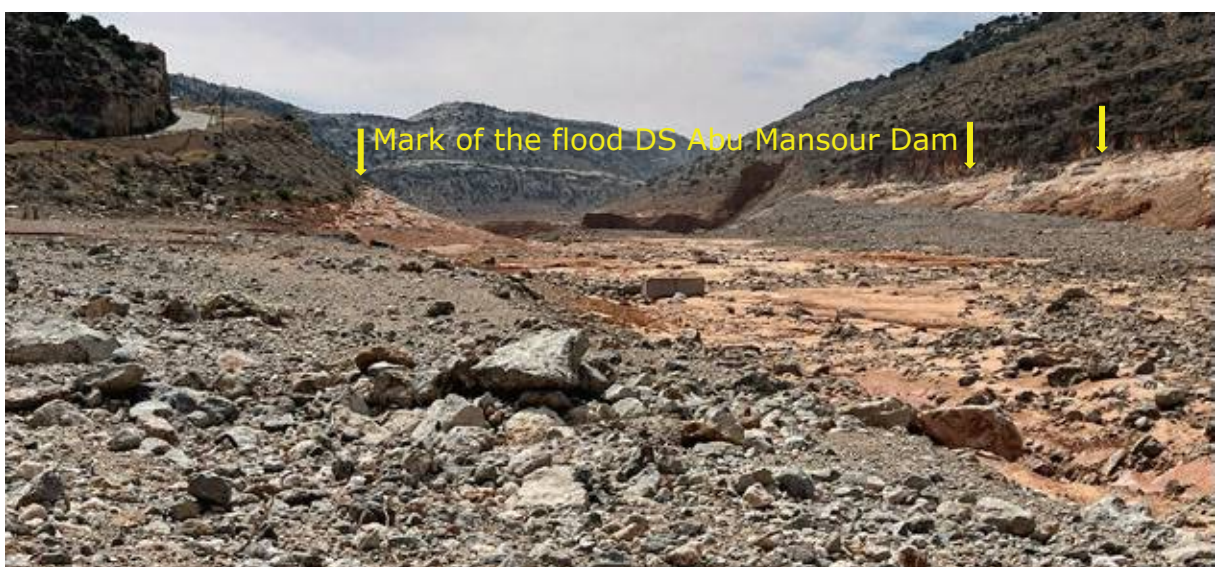
PHOTO 4.5. The view of the downstream of Abu Mansur dam.

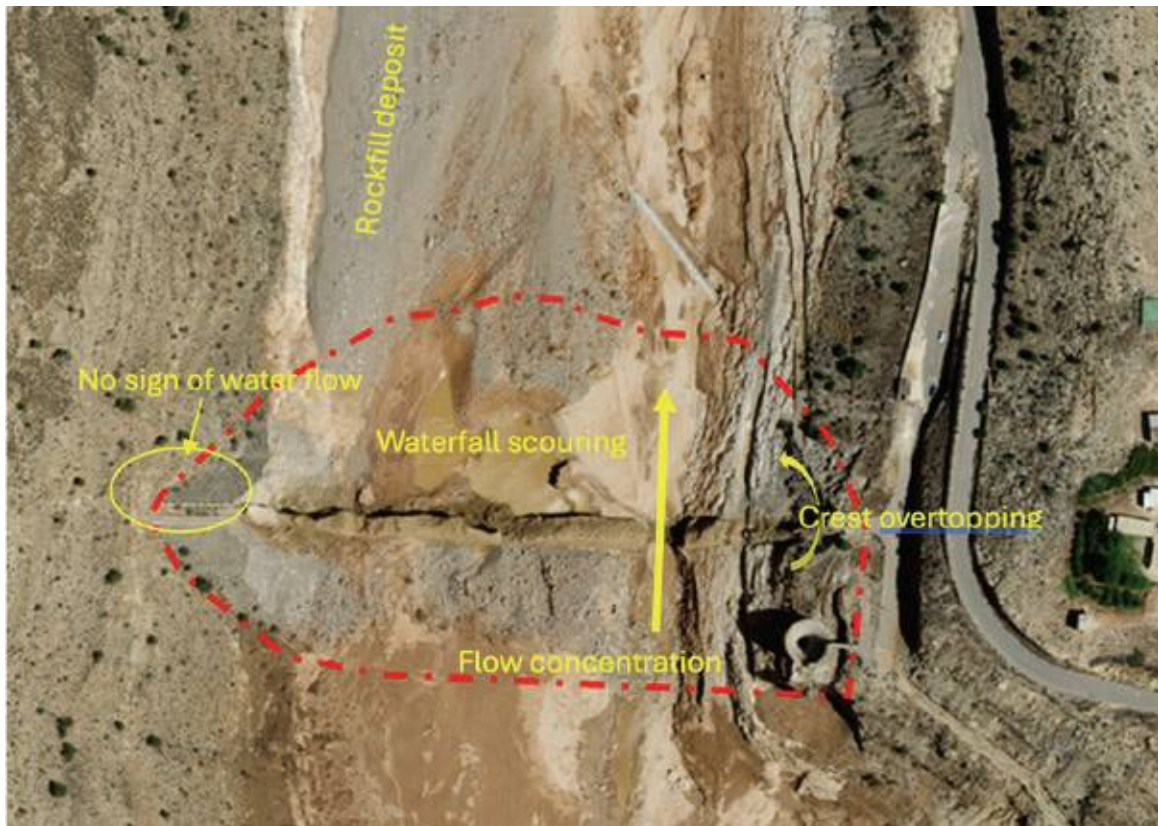
PHOTO 4.6. Satellite view of Abu Mansur dam (13 September 2023).

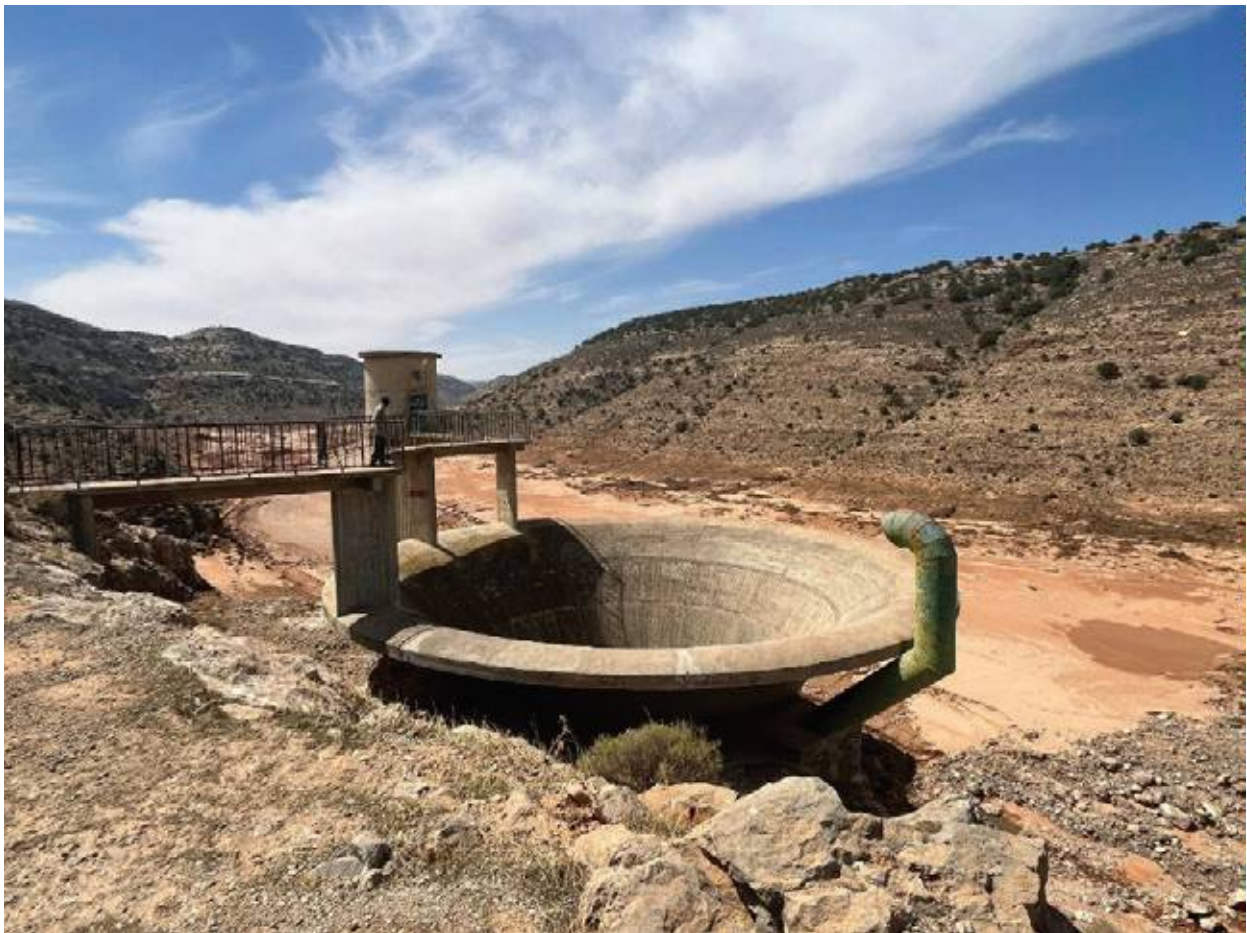
PHOTO 4.7. Morning glory spillway at the Abu Mansour Dam.

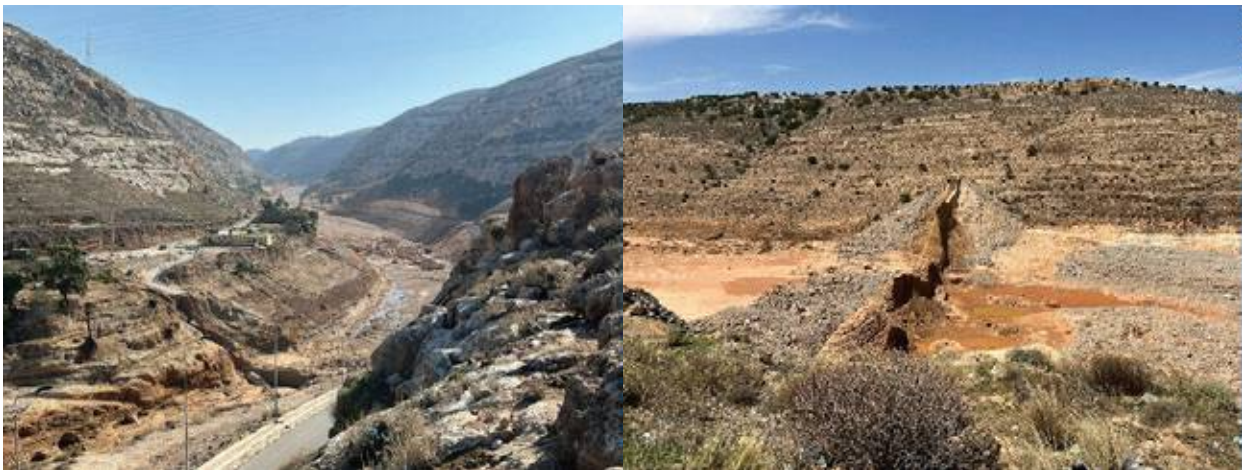
PHOTO 4.8. Remains of clay core in collapsed dams: the Abu Mansour Dam (left) and the Derna Dam (right).
