# Disaster Reports

## Damage Caused by the 2025 Myanmar Earthquake and Lessons Learned

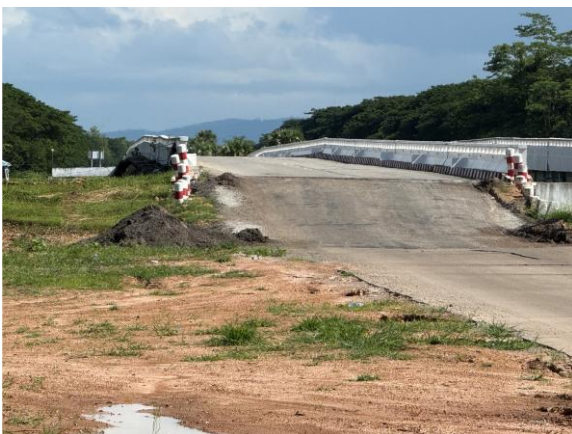
The earthquake severely impacted Myanmar's transportation network, especially the Yangon-Mandalay Highway (Asian Highway No 1: AH1). Extensive liquefaction-induced settlement was observed in a location near Pegu along the Yangon-Mandalay Highway, leading to uneven road surfaces and distorted alignment (Photo 1). Bridge abutments were damaged due to lateral spreading of soils, resulting in severe structural failure (Photo 2). In adjacent farmland, utility poles had toppled, further illustrating the extent of lateral ground displacement.

Photo 1: Liquefaction induced damage to road

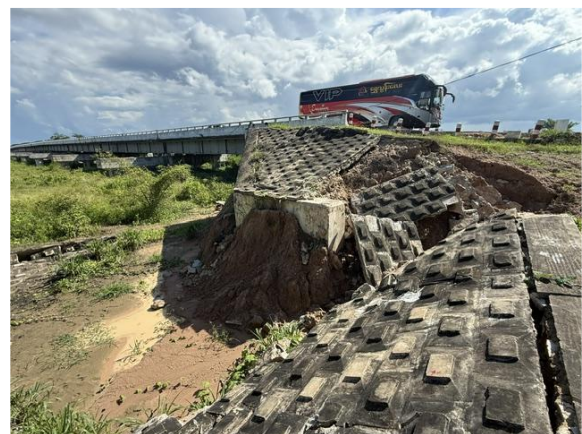
Photo 2: Abutment damage

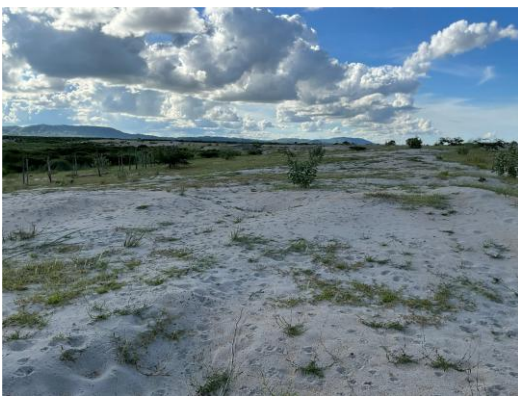
In Mandalay City, the construction site of a new shopping mall in Amarapura township exhibited traces of liquefaction despite reported countermeasures such as groundwater lowering (Photo 3). This suggests that the countermeasures were insufficient under strong shaking conditions. Nearby road also suffered extensive damage (such as lateral spreads, cracks and voids beneath roads) due to liquefaction and slope failures, with kerb displacement measured up to 2.5 meters. Such large-scale soil movements indicate that the road embankment possible was constructed using loose river sands, which are highly vulnerable to liquefaction (Photo 4).

Photo 3: Sand boils at shopping mall site

3. **Design Weaknesses:** The collapse of pilotis-style buildings and the ineffectiveness of groundwater lowering measures show that structural and geotechnical design standards must be revised.

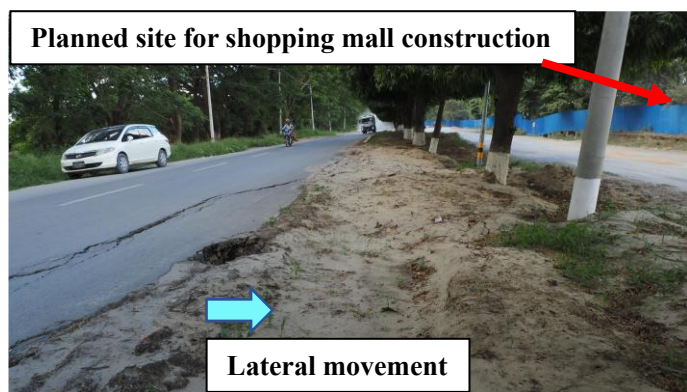
Photo 4: Liquefaction-induced damage to the nearby road surface

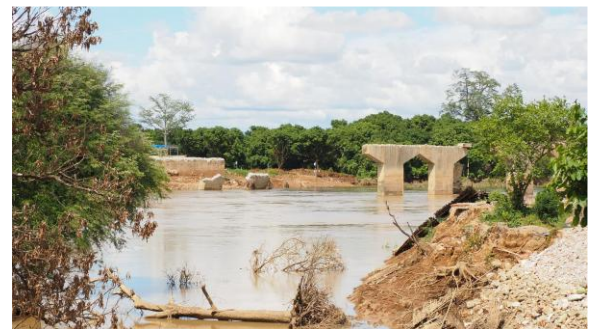
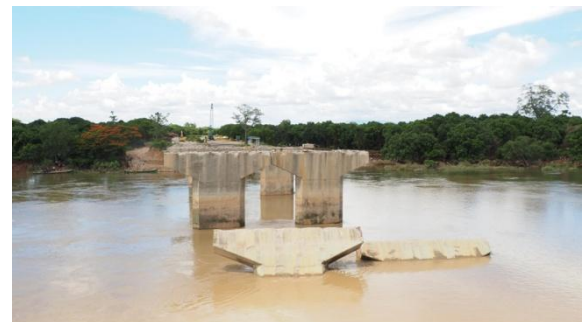
Mandalay City is surrounded by two major rivers: the Ayeyarwady River to the west and the Myitnge River to the south (Fig. 4). The Myitnge River embankments experienced large-scale failures, leading to toppling of bridge piers and completely blocking the AH-1 (Photo 5). In some locations of the river embankment, fluidized flow exceeding 10 meters destroyed as many as 30 houses and resulted in human casualties (Photo 6).

(a)View from the north

(b)View from the south

Photo 5: Riverbank landslides and bridge pier collapse

4. **River Embankments:** The failures along the Myitnge River demonstrated the extreme vulnerability of embankments constructed of loose fill. Strengthening and monitoring of riverbanks are necessary to prevent similar disasters.

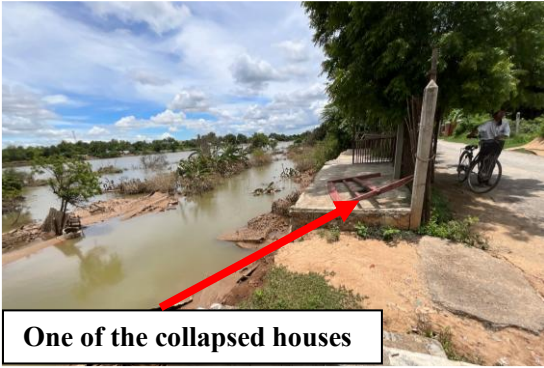
One of the collapsed houses

Photo 6: Landslides and collapse of houses

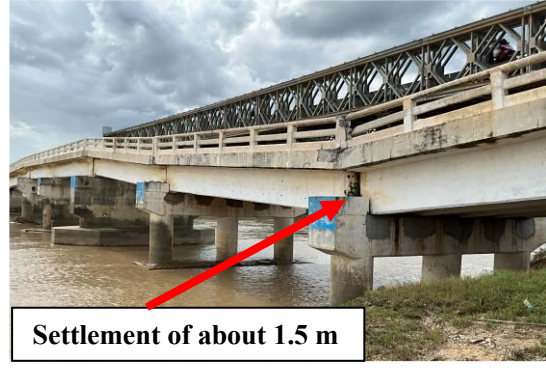
In another location of Mandalay city, the damage of bridge piers was observed, with one pier settling by about 1.5 meters (Photo 7). Insufficient embedment of foundations could have contributed to the scale of the damage. These failures highlight the combined effects of liquefaction, weak foundation soils, and hydraulic influences, which pose serious risks to riverine infrastructure in Myanmar.

Settlement of about 1.5 m

Photo 7: Bridge pier settlement

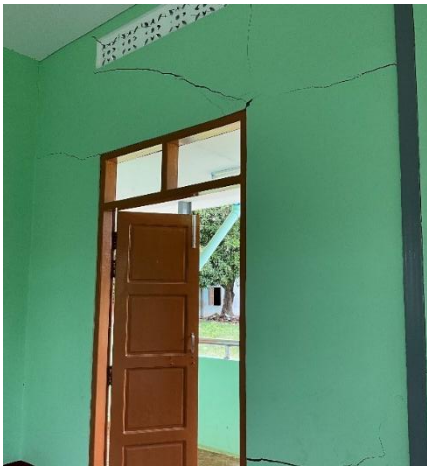
In Nyaung Pin Gyi Su Village, near Naypyidaw, an elementary school experienced significant differential settlement due to liquefaction. Cracks developed in the walls, and misalignment of rain gutters was observed (Photo 8). Widespread sand boiling occurred throughout the village (Photo 9). Dynamic Cone Penetration Tests (DCPT) performed by the authors revealed that the soil at the investigated site was very loose, with a converted N-value of less than 5, and a shallow groundwater table approximately 1.2 meters below the ground surface. These findings confirm the high susceptibility of the site to liquefaction and associated ground deformations.

Photo 8: Damage to school buildings

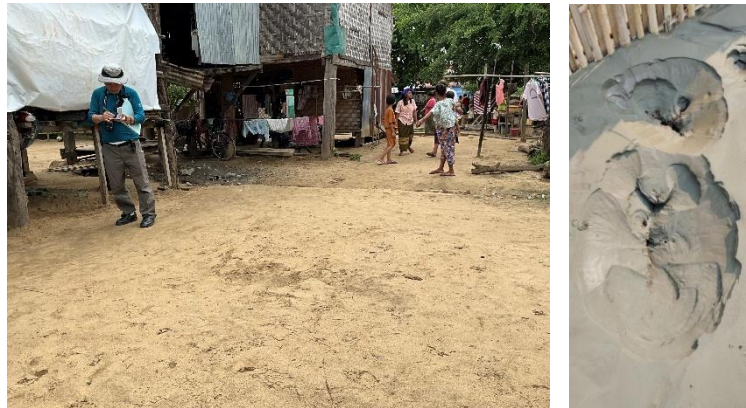
Photo 9: Traces of sand boils in the village

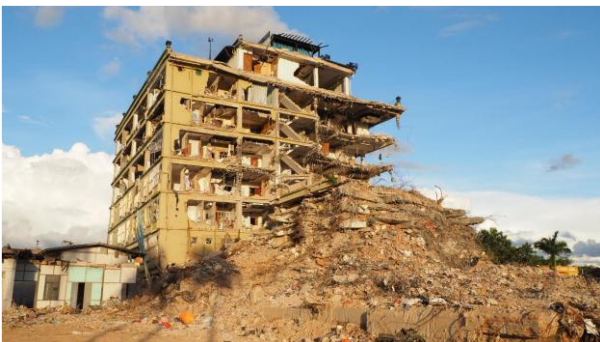
Photo 10: Sky Villa condominium in Mandalay

In Mandalay city, the 12-storey Sky Villa Condominium, constructed in 2017, collapsed completely, with its lower stories (up to the 4th floor) crushed (Photo 10), resulting in 207 fatalities. The building featured a pilotis-style design, where the ground floor consisted primarily of columns with very few shear walls. This

configuration is known to exhibit poor seismic performance, as observed during the 1995 Kobe Earthquake in Japan. Similar patterns of soft-storey failure (Photo 11) were observed in several other apartment and hotel buildings, where severe cracking and crushing were concentrated in the lower floors, while the upper floors remained relatively intact. The repeated occurrence of such soft-storey collapses highlights a fundamental design deficiency that must be urgently addressed in future seismic design codes and retrofitting programs, particularly for reinforced concrete buildings in high-risk areas.

- Strengthening foundations and embankments against liquefaction.
- Retrofitting vulnerable soft-storey structures.
- Expanding seismic monitoring networks.
- Developing regional hazard assessments that incorporate long-period seismic impacts.

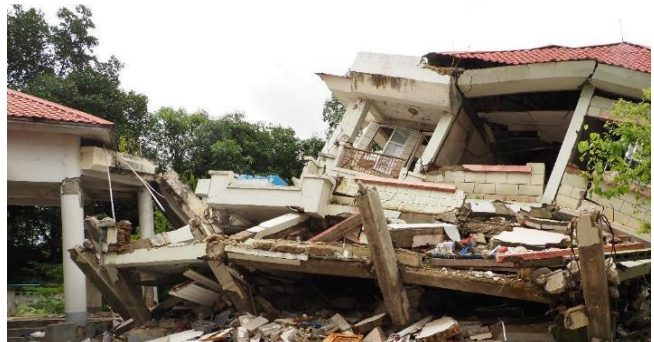
Photo 11: Structural damages in lower storeys of buildings (Nyaung Pin Gyi Su)

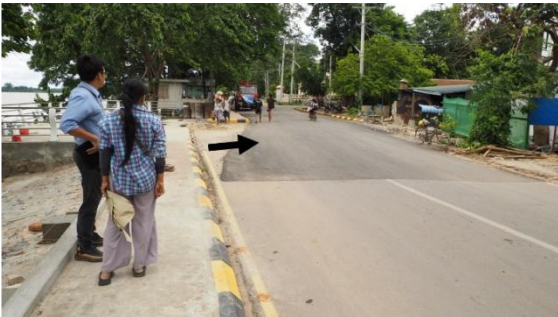
Fault-induced dislocations were observed at numerous locations during the field survey. Photo 12 illustrates one such example in Sagaing, near Mandalay, where the displacement was purely horizontal with no vertical component.

Photo 12: Right-lateral fault dislocation in Sagaing (Left bank of the Ayeyarwady River, near Mandalay)

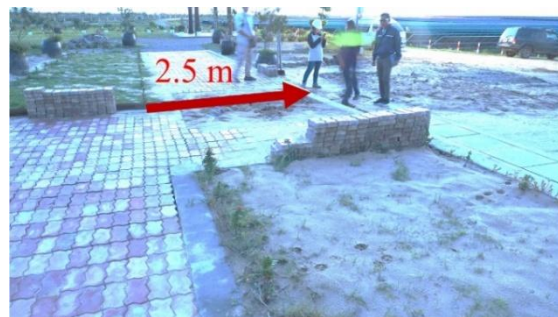
An important observation on fault rupture was obtained approximately 140 km south of Mandalay (Photo 13), where a surveillance motion camera captured both the ongoing ground shaking and the onset of fault rupture. This video footage was made available on the web shortly after the event. Interestingly, there was a time lapse of about five seconds between the beginning of strong shaking and the initiation of fault displacement. This delay appears to contradict the previously mentioned supershear hypothesis, in which rupture propagation exceeds the shear-wave velocity. It is possible, however, that the supershear behavior was a localized phenomenon, as suggested by Ye et al. (2025), who reported that the rupture became supershear only after it had propagated approximately 200 km south of the epicenter, near Mandalay.

Photo 13: Fault dislocation in a solar power station

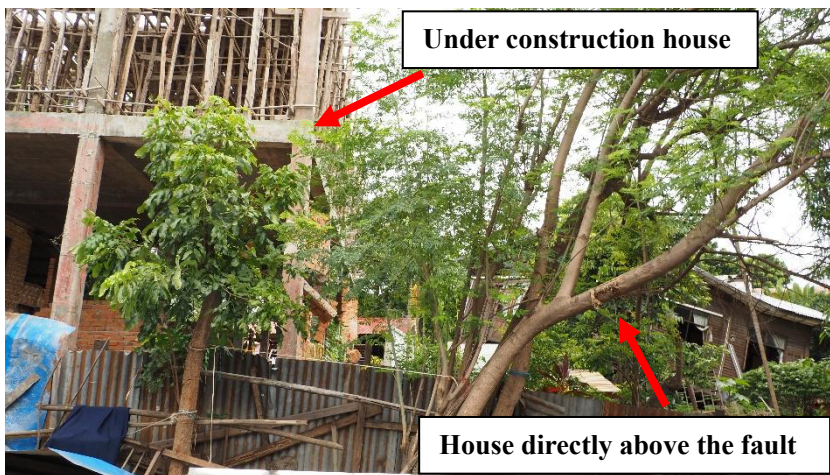
Photo 14: Contrast of damage of two adjacent houses on the opposite side of fault dislocation in Photo 12

Notably, in Sagain area, building damage was concentrated within approximately 50 meters of the fault trace (Photo 14). An under-construction building (left to the damaged house) remains unaffected. This observation implies that the damage was primarily caused by surface soil deformation rather than strong ground shaking.

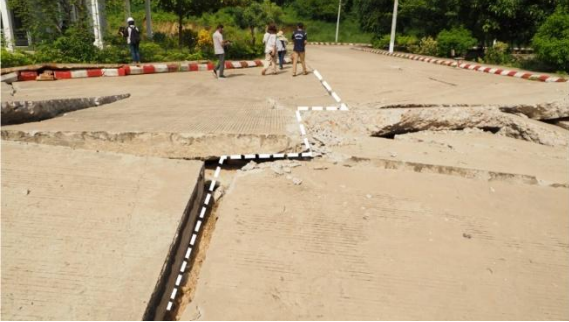
Photos 15(a)-(e) show the fault dislocation and its impact on surface structures in Naypyidaw, where the observed ground motion intensity was high (Fig. 3). Photo 15(a) shows a right-lateral displacement consistent with that observed in Sagaing (Photo 12), accompanied by significant shear deformation of the ground surface. Photo 15(b) displays a building situated directly atop the fault rupture that sustained severe damage, as further evident from the interior shown in Photo 15(c). In contrast, a room located about ten

(a) Right-lateral dislocation (looking eastward)

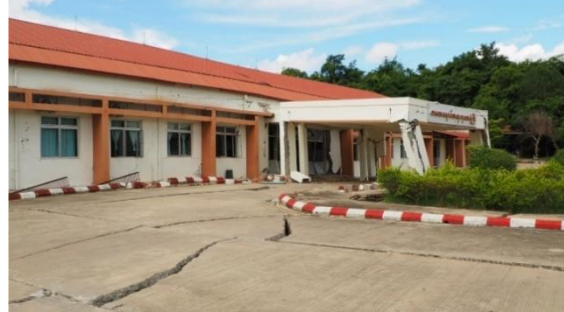
(b) Main building resting directly on the fault dislocation

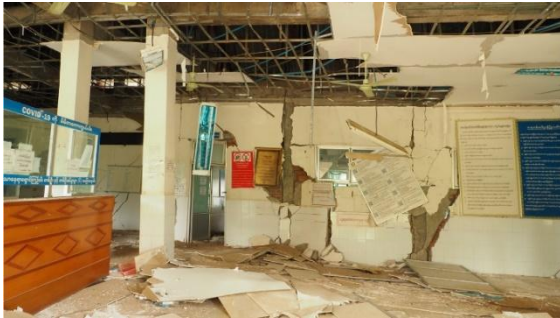
(c) Damage inside the main building

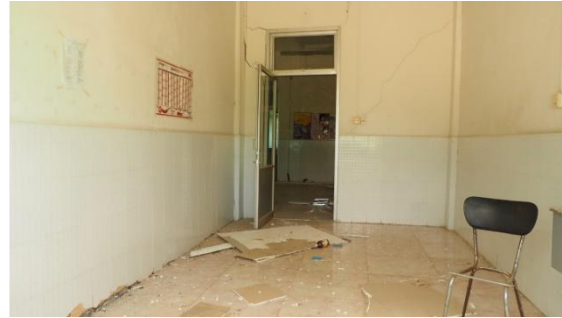
meters away from the rupture (Photo 15(d)) suffered much less damage. This again confirms that the primary cause of fault-induced damage was surface deformation rather than ground shaking.

(d) The same building ten meters away from the fault (leftward in (b))

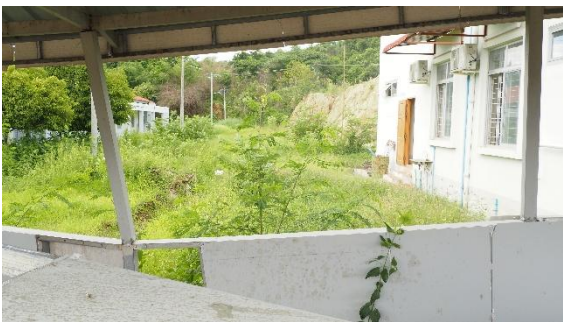
A noteworthy finding during the survey was the absence of landslides on natural slopes. Photo 15(e) depicts the continuation of the fault rupture toward the north of the site. Despite extensive damage to buildings and numerous failures in man-made slopes and fills, the small natural cliff in this photograph remained intact. This lack of failure in natural hill slopes was consistently observed at many other sites as well.

(e) Continuation of fault rupture on the northern side of the site

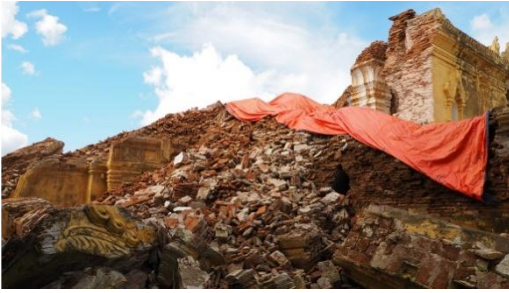
The earthquake caused devastating losses to Myanmar's rich cultural heritage. Temples, pagodas, and historic buildings collapsed or were severely damaged. Photo 16 shows one such damage of a pagoda constructed during 19<sup>th</sup> century. The reconstruction of these heritage sites raises a fundamental question: whether to prioritize authentic restoration using original materials or to focus on rapid recovery using modern methods. Authentic restoration is time-consuming and technically demanding, but it preserves cultural and spiritual values. Rapid reconstruction ensures continuity of cultural practices but risks diminishing historical authenticity. This dilemma was also faced in Japan after major earthquakes, where ancient temples were restored using modified designs. The Myanmar case underscores the need for policies that balance heritage preservation with seismic safety.

Photo 16: Destroyed Me Nu Brick Monastery in Inwa.
