Detailed Study Report on Rainfall induced disaster in the district of Mandi, Himachal Pradesh

Prof. Neelima Satyam D.

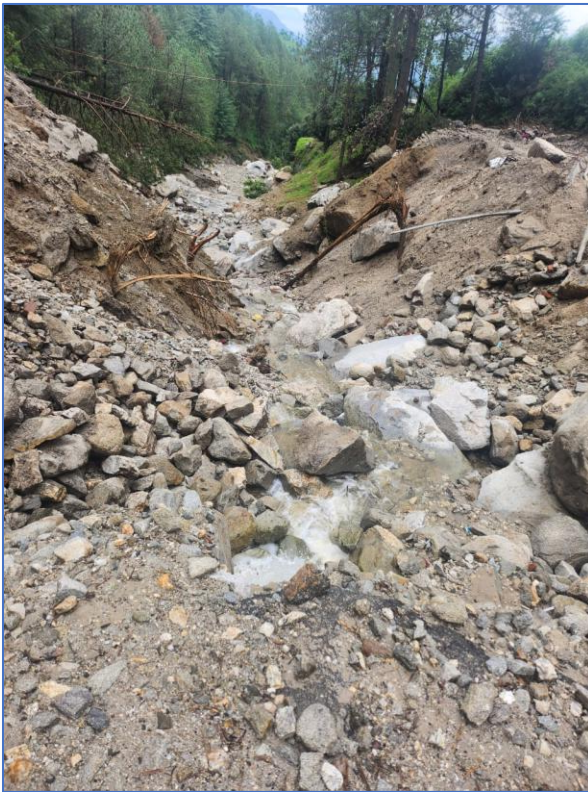
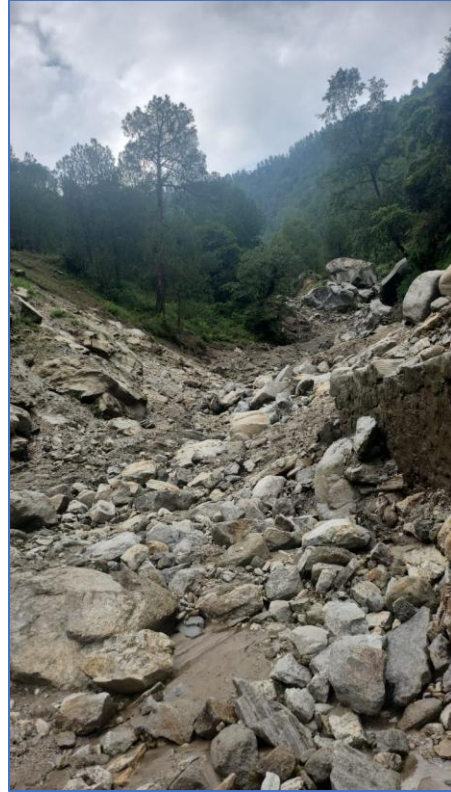
Location 1: Sarkol Nala (Fig. 5)

This site primarily exhibited dry granular flow, with minimal presence of fines or saturated slurry. The failure here was dominated by mechanical entrainment and downslope movement of colluvial material. Scrapping of surface layers exposed bedrock, while the gully system served as the main transport path. There was little evidence of cascading processes; the flow was mostly limited to a single-stage event. Figure 5a shows the exposed bedrock surface due to scouring, while 5b highlights entrainment of material within the narrow gully system.

Fig:5 Granular flow in Sarkol Nala a) Scrapping and exposed bed rock b) entrainment over the gully

Location	Coordinates	Type of Failure	Dominant Process	Probable Cause
1. Sarkol Nala	31°24'06.0"N, 77°11'06.0"E	Dry granular flow; minor landslide	Scraping, entrainment of colluvium	Intense rainfall loosened surface colluvium; dry flow moved through gullies without major water saturation. Minimal cascading.

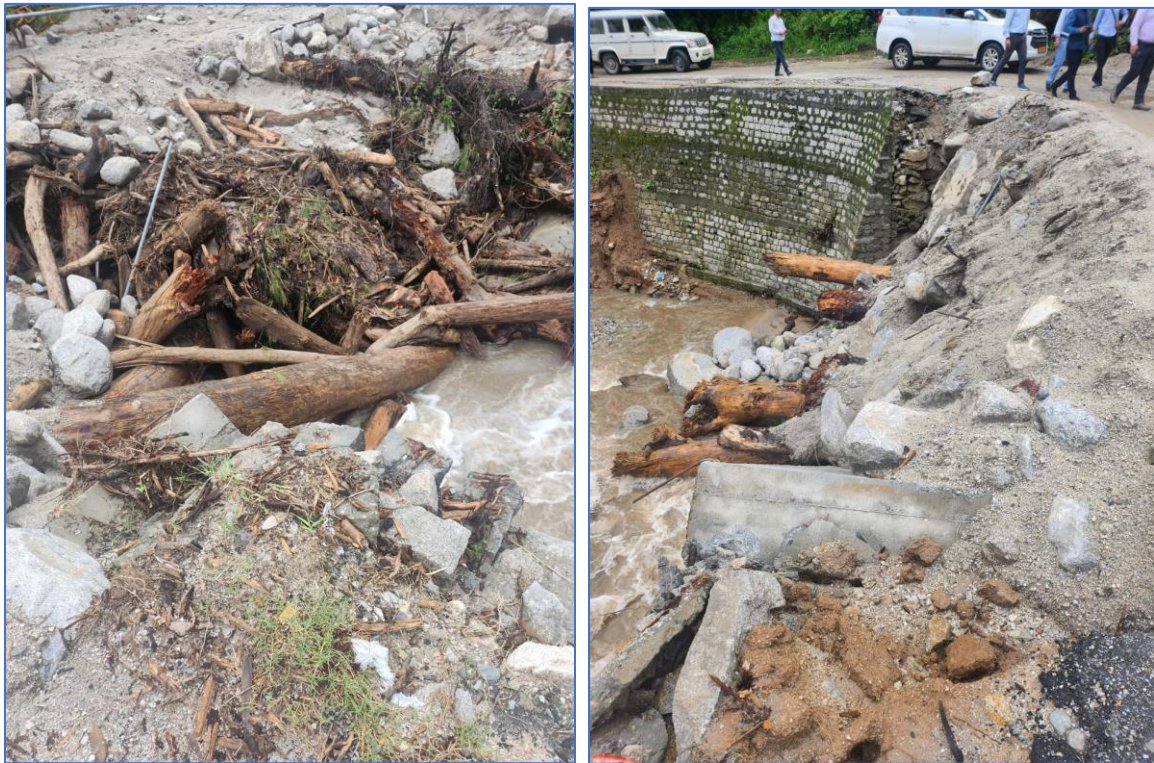
Location 2: Shankar Dera (Fig. 6)

At Shankar Dera, the interaction between mass movement and vegetation was significant. Uprooted tree trunks, broken roots, and other organic debris blocked multiple culverts, suggesting a prominent flow-structure interaction. This led to the redirection and accumulation of flow, aggravating the failure. The presence of both debris and flowing water suggested partial saturation. Figure 6a depicts the uprooted vegetation, and 6b illustrates the blockage of the culvert, which contributed to local flooding and terrain instability.

Fig:6 Landslide in Shankar Dera a) uprooting of vegetation b) blockage of culvert due to flowing trunks/roots of vegetation

2. Shankar Dera	31°25'39.4"N, 77°11'58.5"E	Landslide with debris flow	Flow-structure interaction; culvert blockage	Vegetation and tree trunks obstructed culverts, leading to local water impoundment and failure; interaction with built drainage.

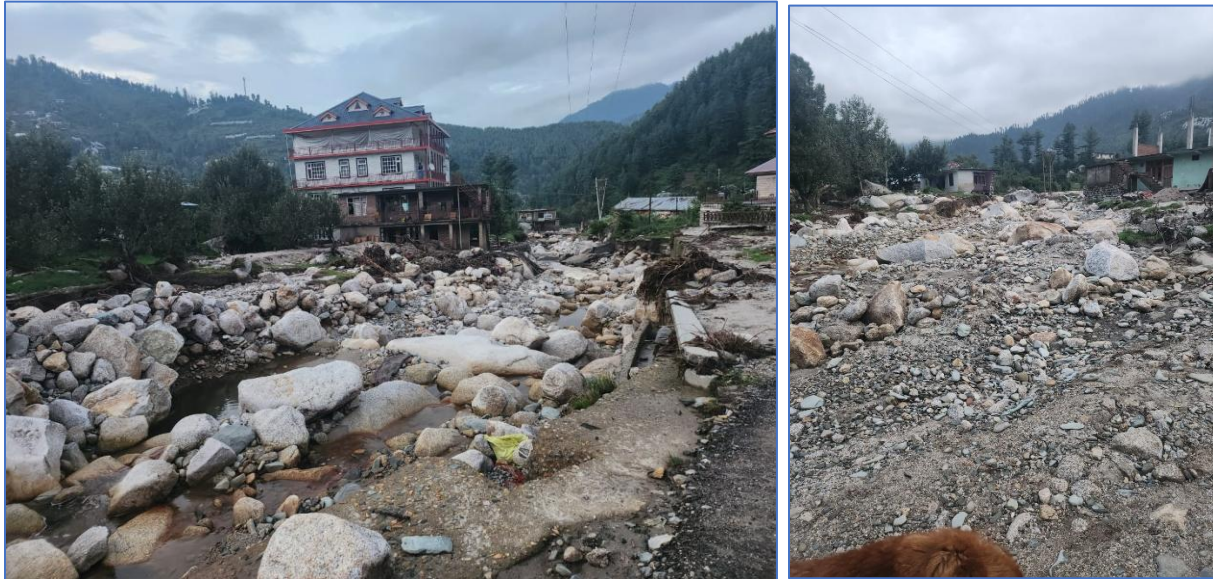
Location 3: Janjehli (Fig. 7)

This area demonstrated a typical cascading scenario, where coarse particles, including large boulders, were transported and deposited across dry and semi-active gulleys as well as into the riverbed. The interaction of dry flow over existing channels suggests intermittent flow activation. Exposed bedrock and the collapse of multiple houses were observed in the deposition zone. Figure

7a captures the rocky terrain and mobilized boulders, while 7b shows the remnants of housing structures buried in debris.

Fig:7 Landslide in Janjehli a) exposed bed rock with big boulders and rocs b) multiple houses collapsed with left out deposition of debris over bed

3. Janjehli	31°30'24.6"N, 77°12'46.0"E	Cascading landslide and boulder flow	Boulder runoff, saturated and dry channel flows	Combination of dry and wet flows in active and inactive drainage channels; coarse debris caused structural collapse.

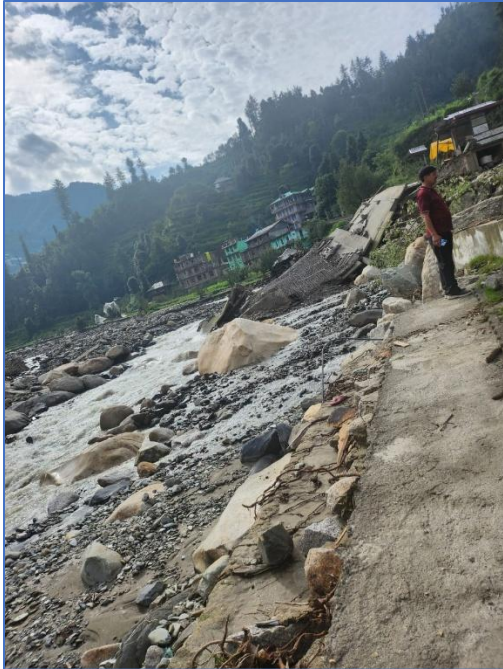
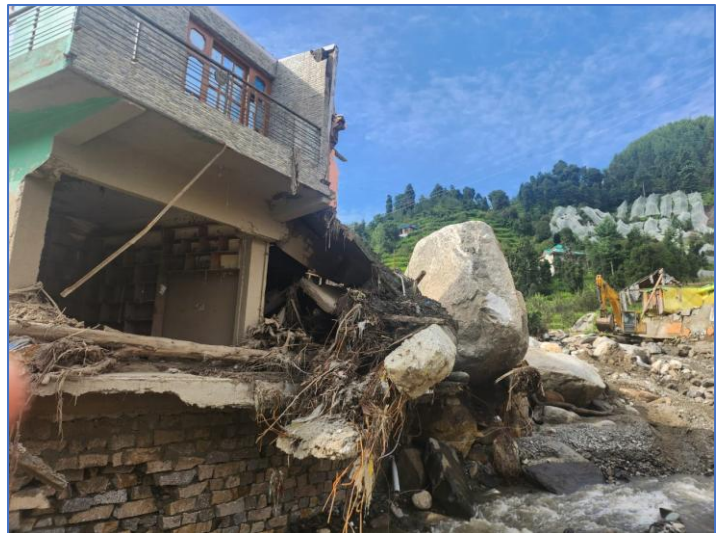
Location 4: Pandav Shila (Fig. 8)

In Pandav Shila, the failure included riverbank erosion and a strong flow-structure interaction. The mass movement here dammed the local river and destroyed nearby homes, primarily due to the impact of boulders within the debris striking built structures. This is another instance of cascading failure, where an initial slide evolved into a debris flow that altered the river course and intensified destruction. Figure 8a shows the eroded banks, and 8b presents the collapsed structure impacted by the flow.

Fig:8 Landslide in Pandav Shila a) Eroded banks b) Flow-Structure interaction caused house collapse

4. Pandav Shila	31°32'12.87"N, 77°12'40.02"E	Landslide, debris flow	River damming, flow-structure interaction	Debris flow with boulders blocked the river, redirected flow toward settlements, causing destruction of houses.

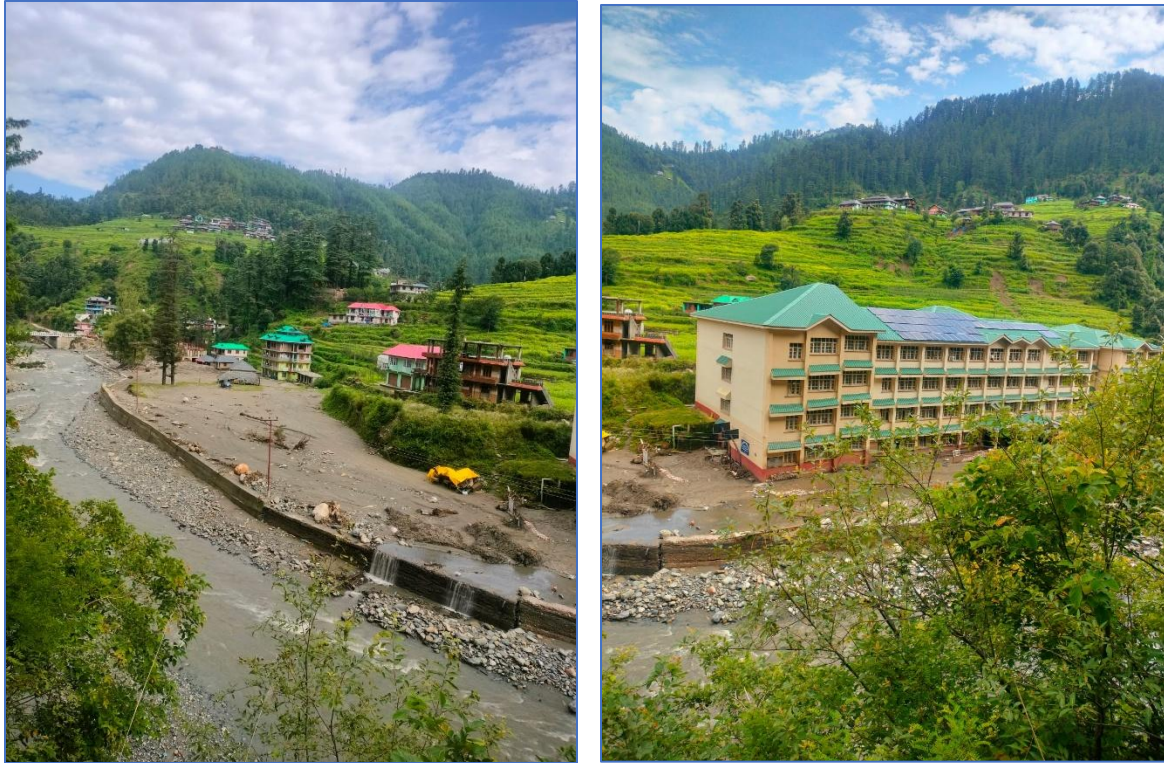
Location 5: Seraj College (Fig. 9)

This site is particularly notable for the significant human vulnerability involved. The debris flow here not only dammed the river but also led to the accumulation of 2–3 meters of debris around institutional infrastructure, submerging parts of the Seraj College building. The location of schools and colleges in high-risk zones exacerbates the hazard. Figure 9a shows the blockage of the river channel, while 9b displays the building partially buried in slurry and debris.

Fig:9 Landslide near Seraj College a) Debris flow damming river channel b) College building submerged with debris/slurry

6. Seraj College	31° 33'28.8" N, 77°11'28.32" E	Debris flow and river damming	River channel blockage; structural impact	Presence of buildings in vulnerable floodplain; 2–3 m deposition due to debris damming and spillover.

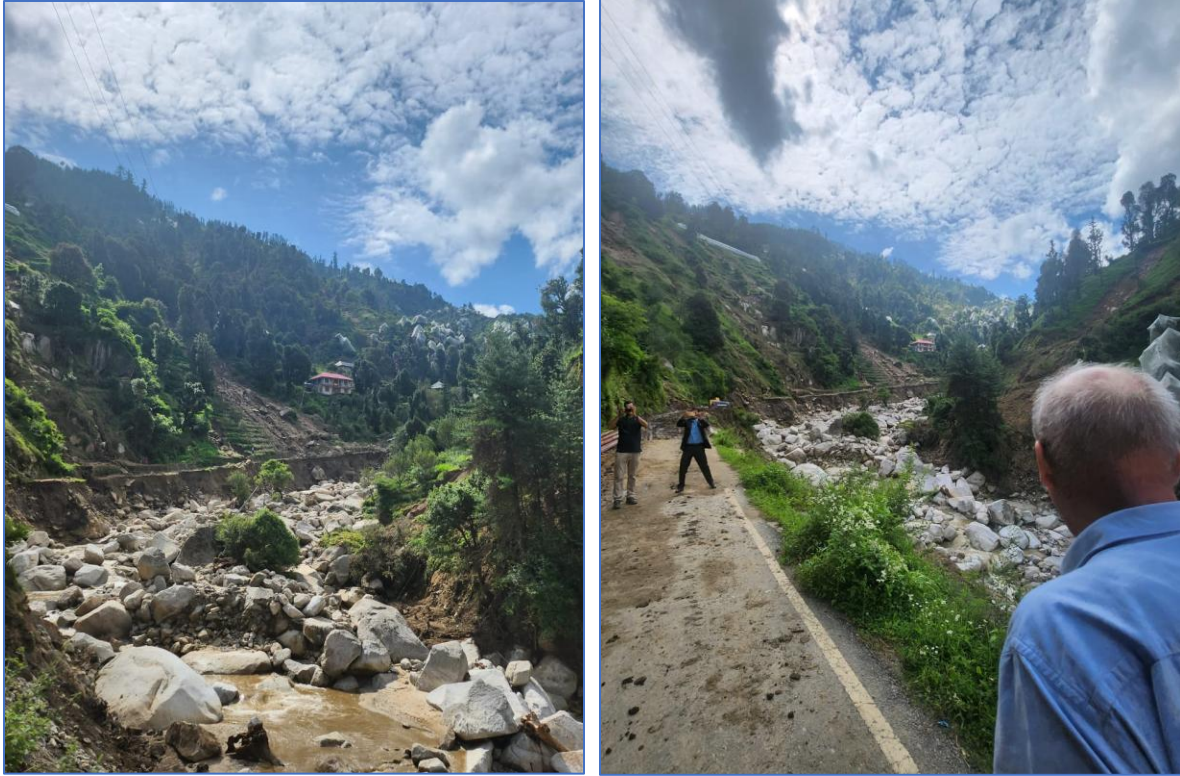
Location 6: Near Bharad (Fig. 10)

Here, the dominant feature was the presence of large boulders within drainage channels and granular flow deposition in engineered gullies. The debris blocked channels and suggests a process involving dry granular flow with minimal fluid content. The event involved a sudden release of material into man-made gullies, which likely failed due to poor design or inadequate drainage capacity. Figures 10a and 10b highlight the massive boulders and the clogged engineered gully.

Fig:10 Landslide near location 6 a) Big size boulders present in drainage channels b) Drainage gully is dammed with granular flow

5. Near Bharad	31°32'46.06"N, 77°12'40.43"E	Debris slide with granular flow	Boulder movement in engineered gulley	Oversized debris overwhelmed engineered structures; dry flow with poor water escape led to blockage.

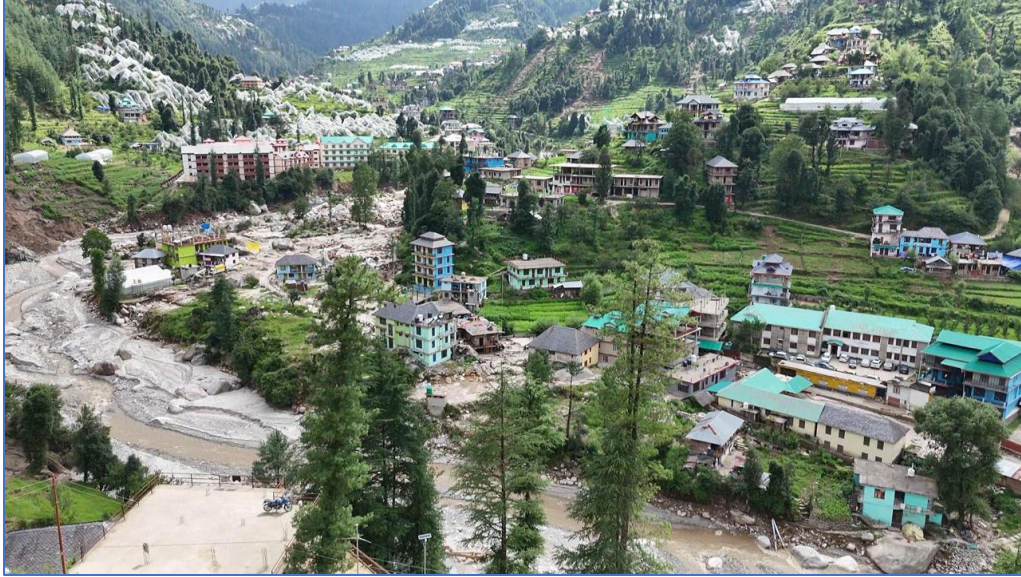
Location 7: Thunag Valley (Figs. 11 & 12)

Thunag represented the most complex and severely affected site, characterized by multiple overlapping processes like landslides, debris flows, bank erosion, and river damming which is occurring in close sequence and spatial proximity. This is a textbook case of a cascading geomorphic event, where each process fuelled the next, resulting in extensive landscape transformation and infrastructure damage. Figures 11 and 12 capture the progressive failure sequence, with river blockage, redirected flow paths, and significant debris deposition along both natural and built environments.

Fig:11 Landslide near Thunag Valley, multiple cascading events led to erosion and deposition of debris along the bank and built-up area nearby

7. Thunag Valley	31°33'30.06"N, 77°9'56.53"E	Multiple cascading landslides	Landslide, debris flow, erosion, damming	Chain reaction of failures due to intense rainfall: initial landslide triggered debris flow and river damming; high impact on nearby infrastructure.
-------------------------	--------------------------------	-------------------------------	--	--

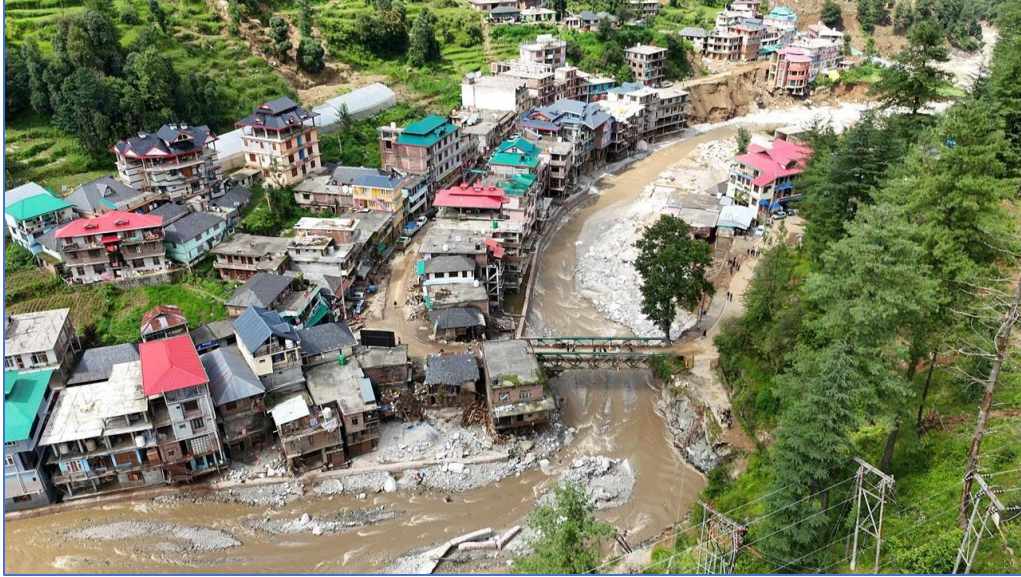
Fig:12 Landslide near Thunag Valley caused river damming and bank erosion
