Failure paths for levees

February 2022

PREPARED BY
Technical Committee on
Geotechnical Aspects of Dikes and Levees
(TC201)

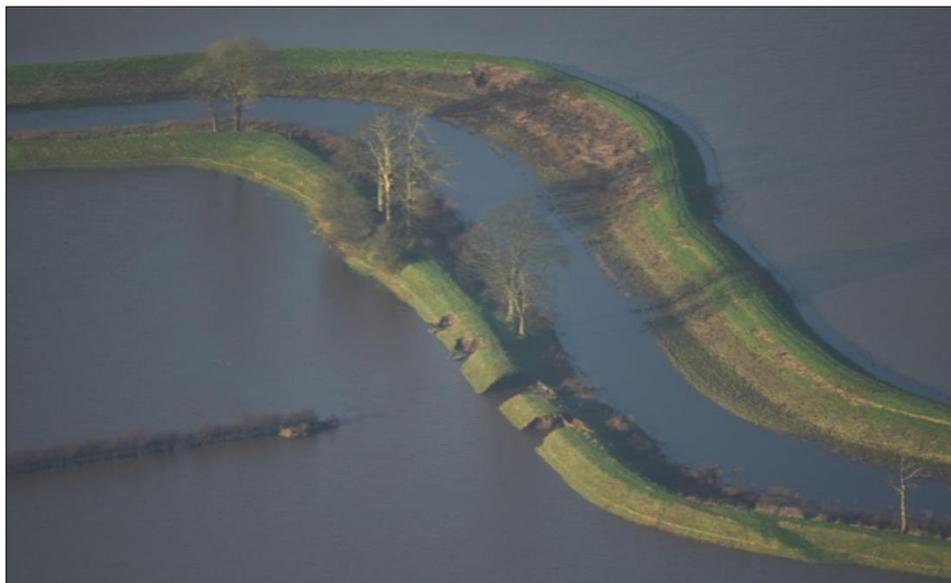
Figure 3.2 Photograph of the situation.

The flooding resulting from the breach, affected approximately sixteen properties and a large area of agricultural land. A scour hole of up to 10 m depth was caused by the flow through the breach.

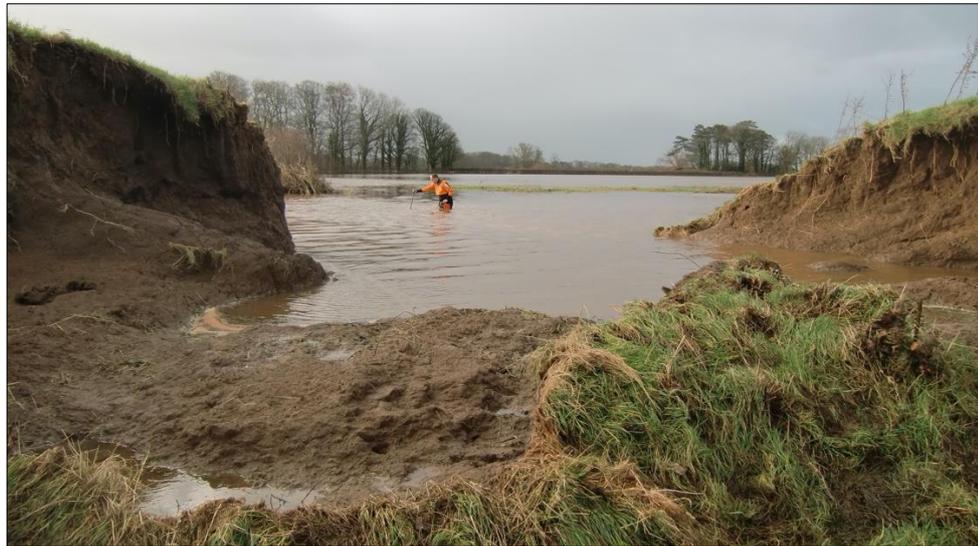
Figure 3.3 Photograph of the breach.

A forensic review of recent LiDAR images showed that the original crest level at the location of the breach was up to 100 mm lower than at surrounding areas. Furthermore, the location of the breach was underlain by both an in-filled historical meander and an old field drain. It is likely that the localized settlement of the crest in the vicinity of the breach was originally caused by consolidation of the in-fill material in the old meander. This meant that the crest level at this location was lower than at surrounding areas; overflow at this location caused rapid external erosion of the levee because of the steepness of the landward slope, about 30 degrees, the quality of the levee fill material (erodibility) and the lack of a landward berm.

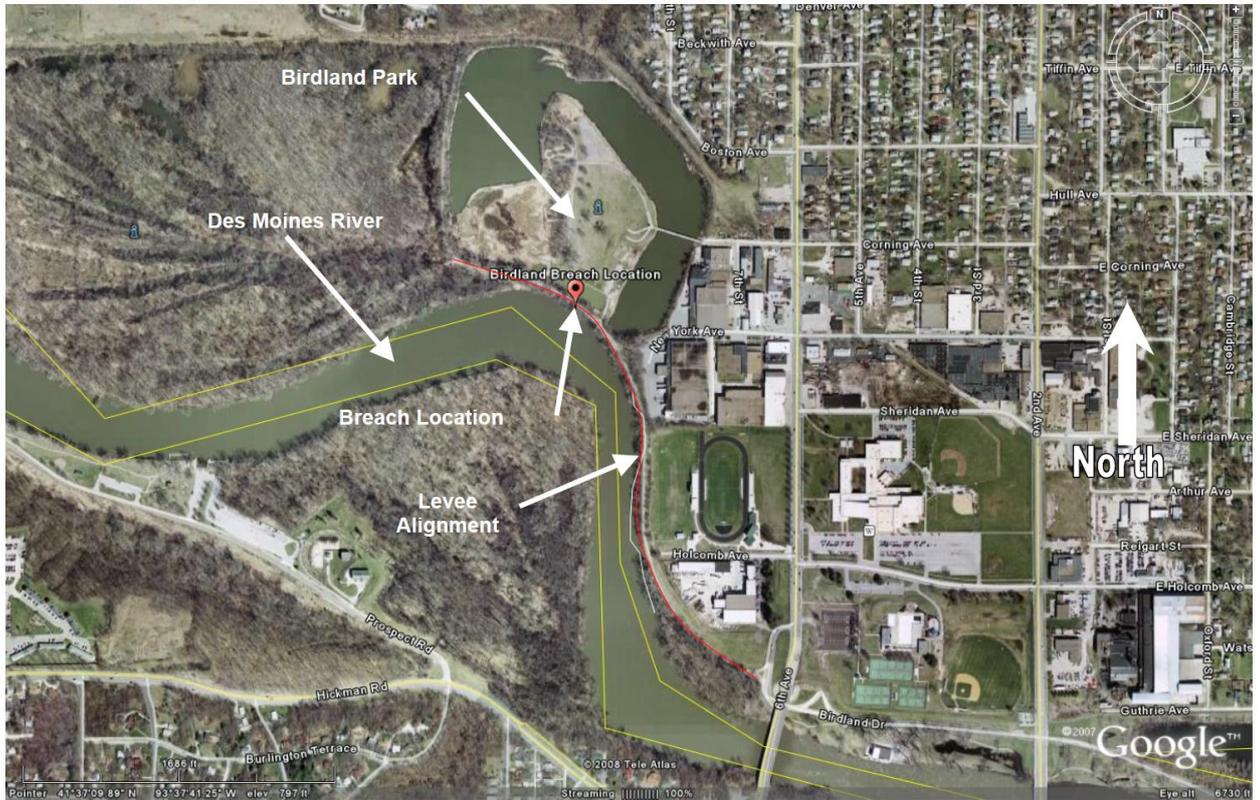
The report predicted that, in the levee's current state of disrepair, there was a 50% chance of failure for a 50-year flood event. By 2008, only a few minor improvements had been funded.

Figure 3.17 Location of the Birdland Levee breach (taken 2007).

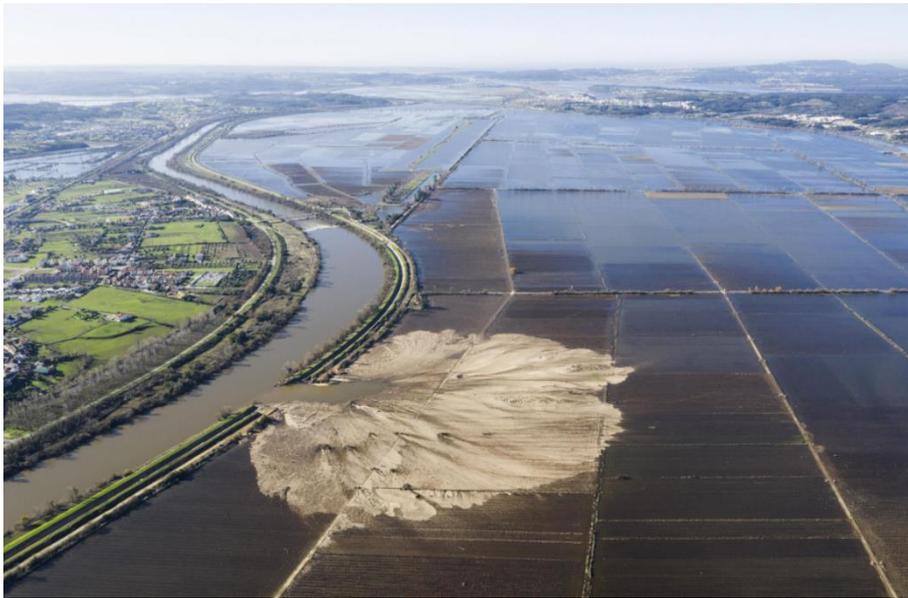
The collapse led to the flooding of the fields in the Central Valley of the Lower Mondego and the cutting of communication routes. Infrastructure was severely damaged, not only the embankment but also the road and the conducting channel at the right bank, for the water supply of agriculture and industries.

Figure 3.20 View of Santo Varão shortly after collapse of the embankment ⁴.

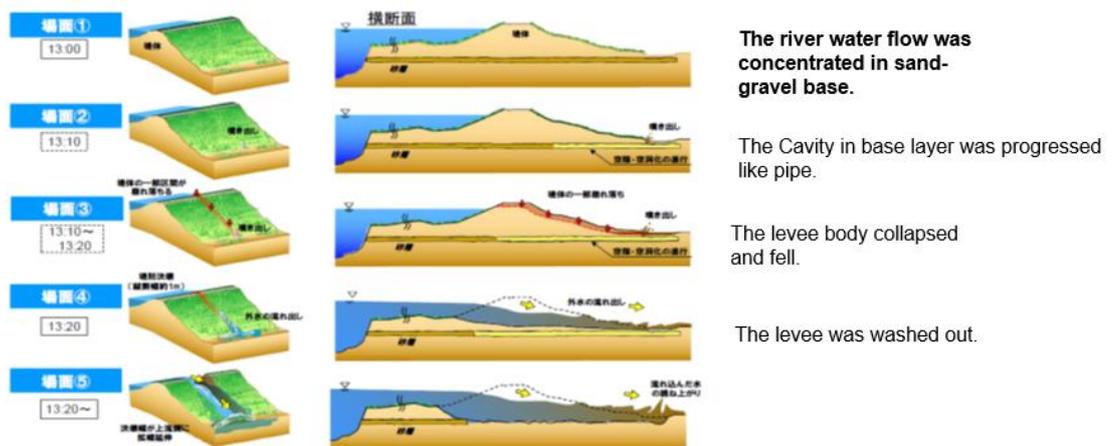
Figure 3.27 Example of piping erosion from the presentation ‘Picture-Card Show Project’ in JGS-JCES’, contribution by K. Maeda, M. Ishihara and H. Mori, using materials from the Ministry of Land, Infrastructure, Transport and Tourism in Japan.

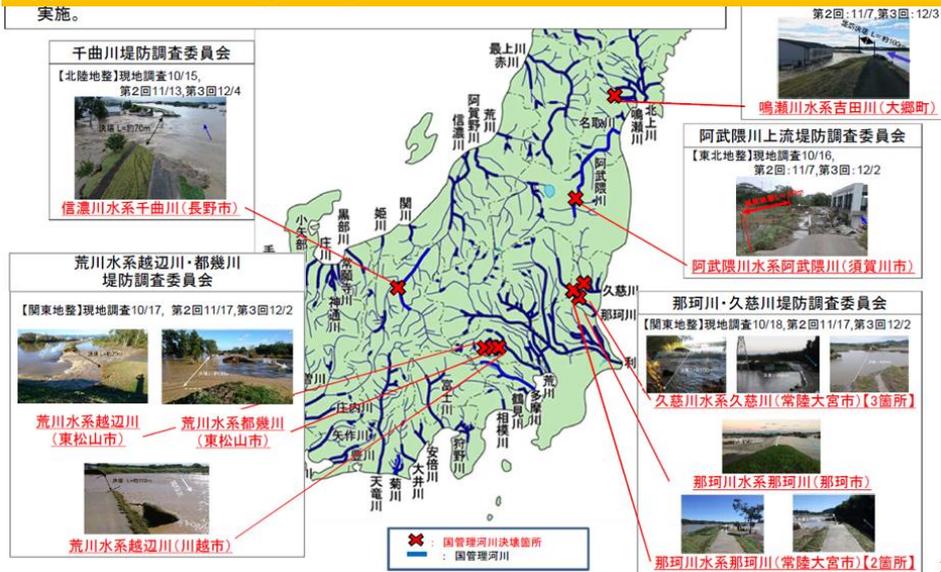
Figure 3.30 Location of overtopping from the presentation 'Picture-Card Show Project' in JGS-JCES, contribution by K. Maeda, M. Ishihara and H. Mori, using materials from the Ministry of Land, Infrastructure, Transport and Tourism in Japan.

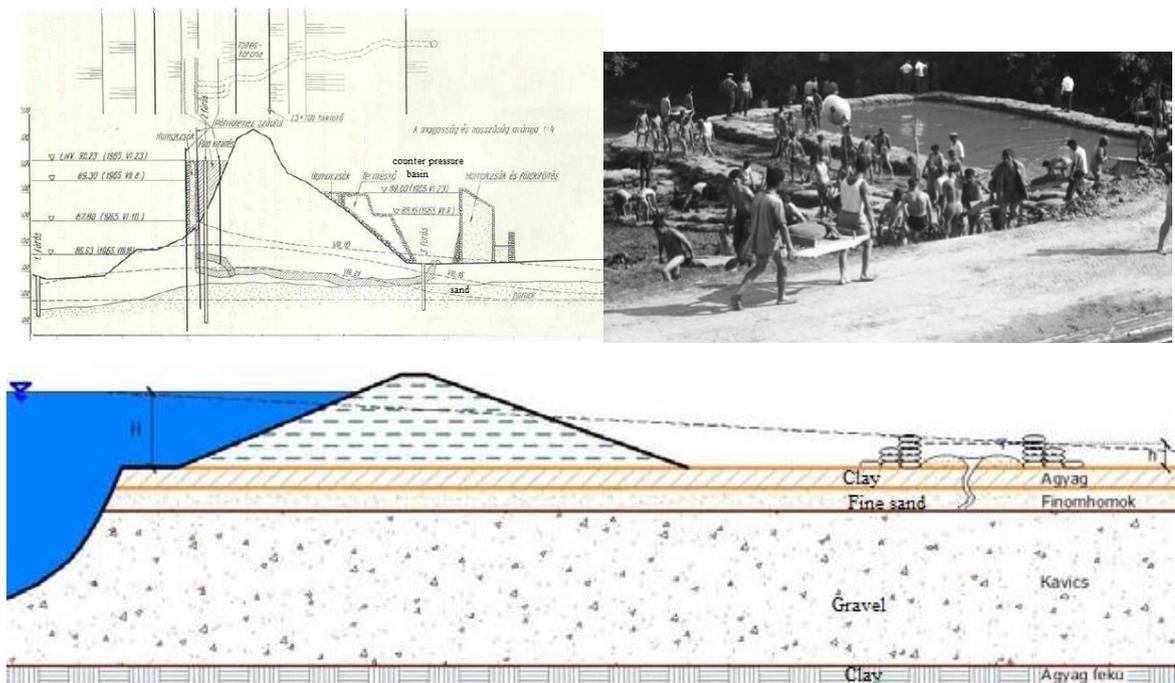
Figure 3.36 Danube, Margitta Island sand boil counter-pressure (top right) and diaphragm walls at the waterside (top left), the cause was the vicinity of an old meander (Garai, 2016). Water level of the counter-pressure basin (bottom).

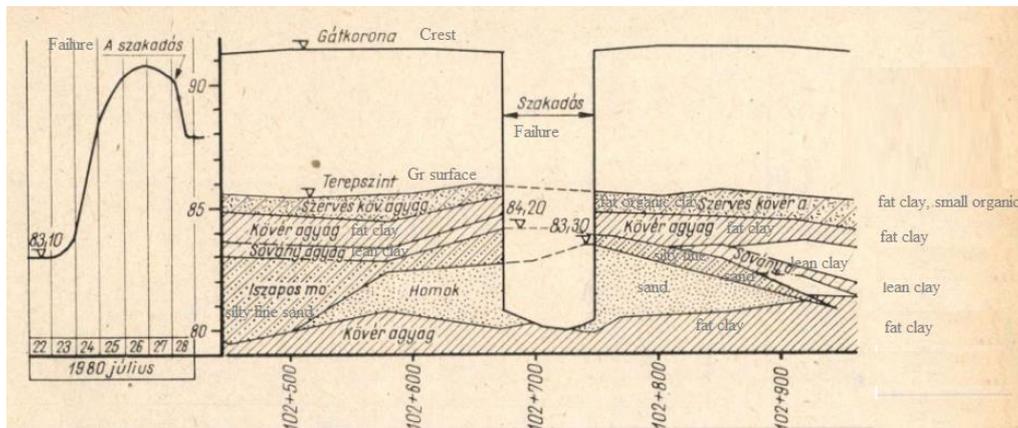
Figure 3.43 Kettős Körös, Hosszúfok in 1980, fast piping failure, failure location at top from (Szepessy, J.(1983)), with time history of flood. Bottom: grading curves, indicating the very loose sand inclusion with $3 < Cu$ and $e \sim 0.8$.

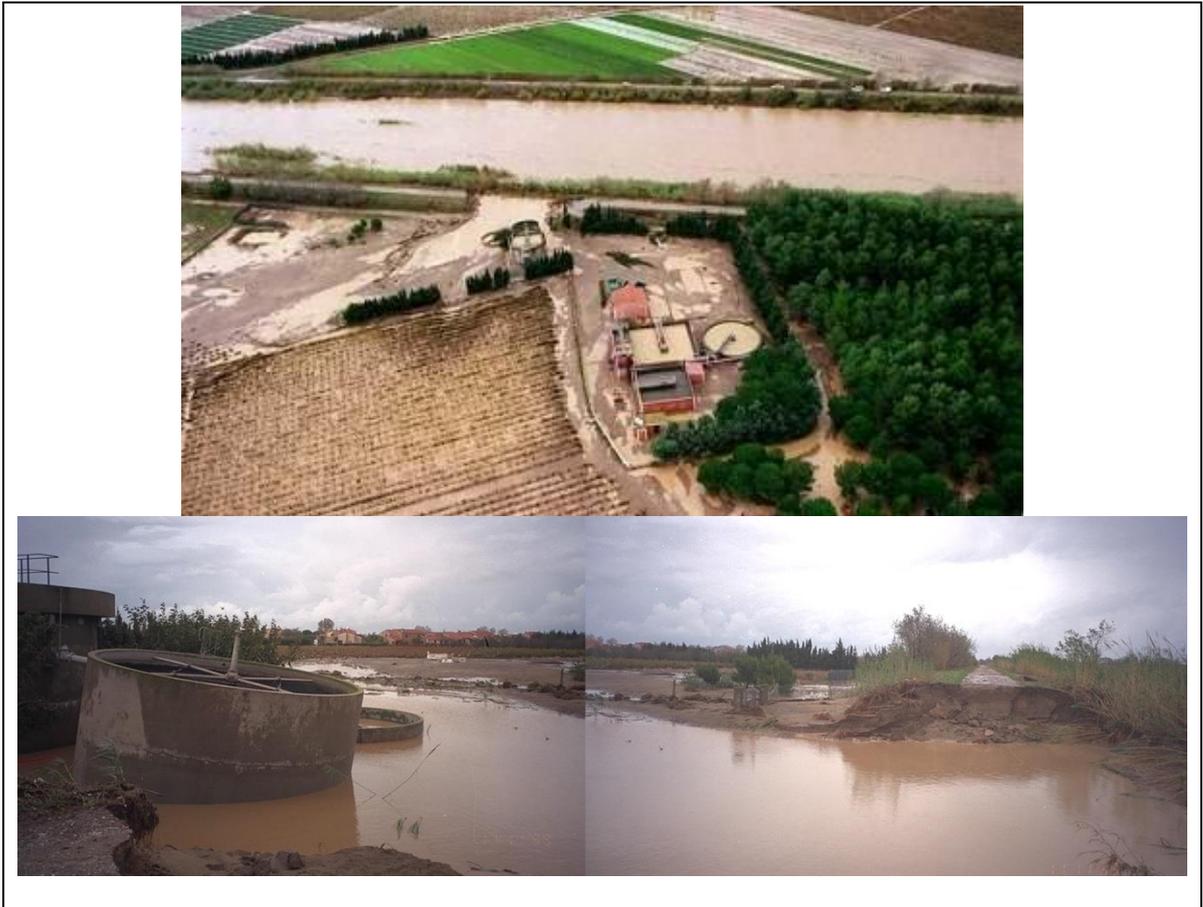
Figure 3.49 Breach in 1999 at St-Laurent-de-la-Salanque.

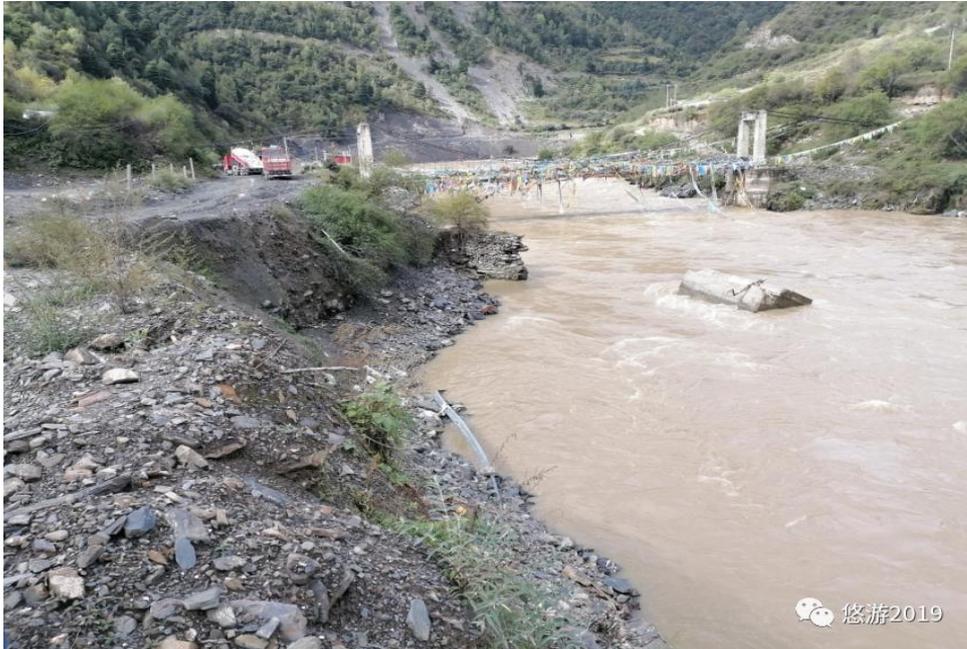
Figure 3.60 Riverbank morphology in the damaged section of retaining wall.

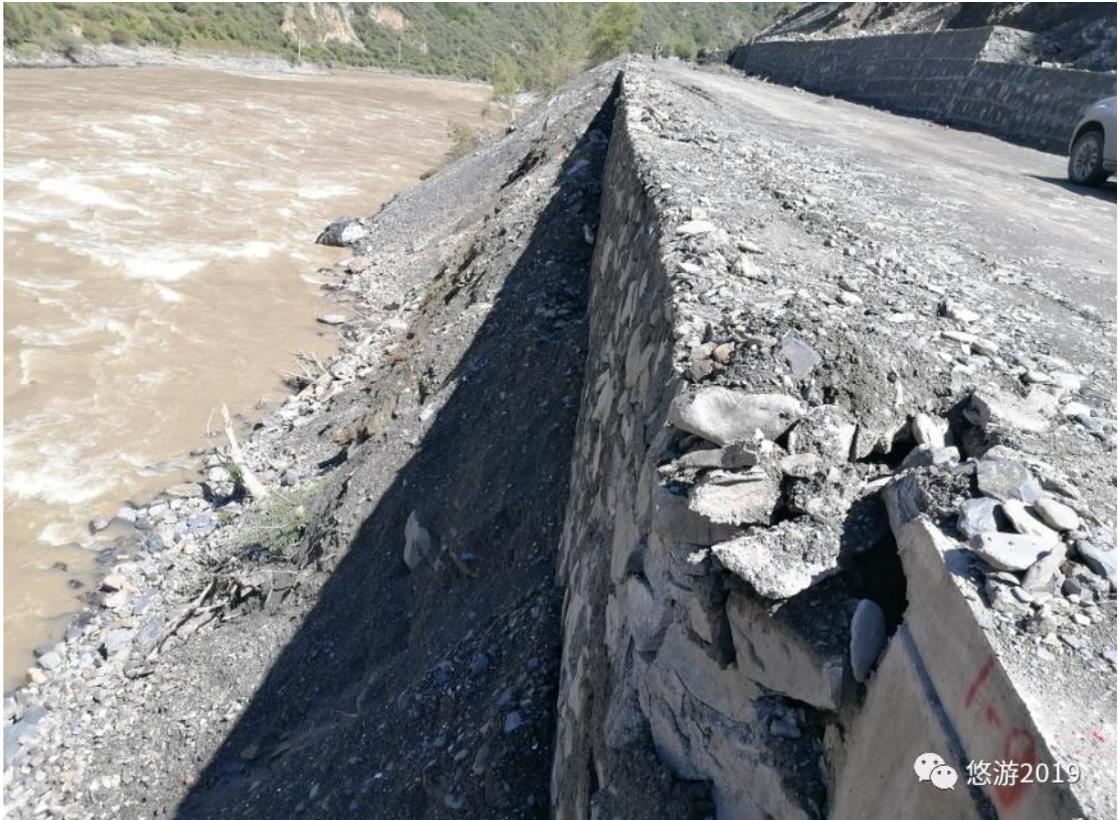
Figure 3.61 Outwards displacement of the bank slope and retaining wall.

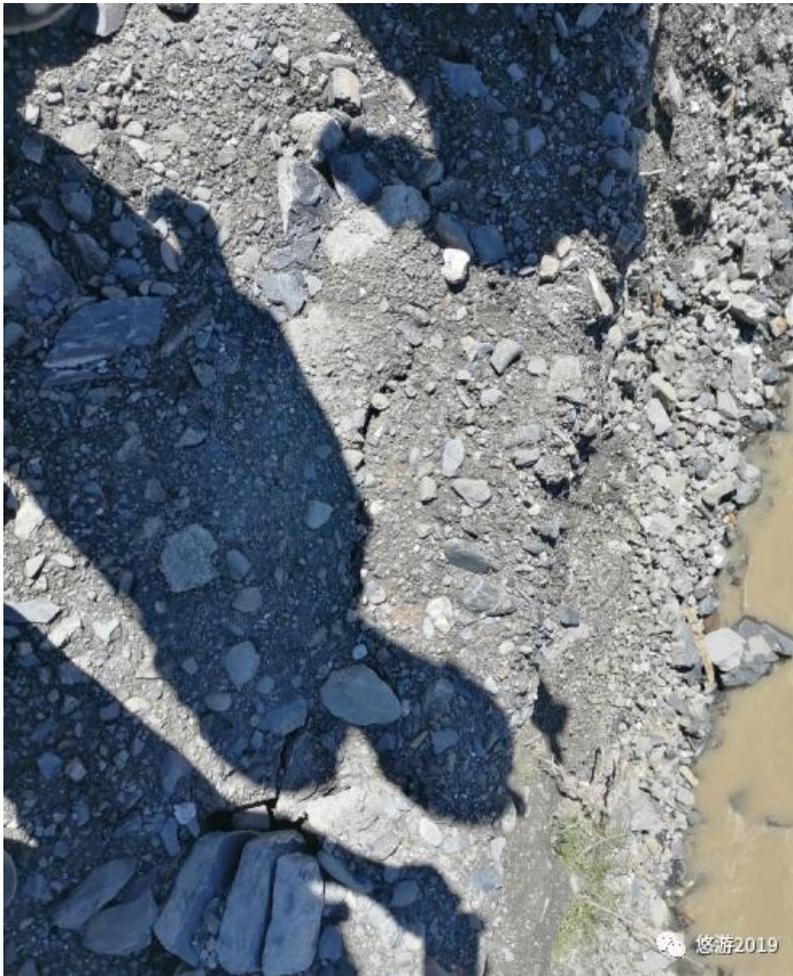
Figure 3.62 Cracking morphology of retaining wall body.
