The paper was published in the proceedings of the 20th International Conference on Soil Mechanics and Geotechnical Engineering and was edited by Mizanur Rahman and Mark Jaksa. The conference was held from May 1st to May 5th 2022 in Sydney, Australia.

Large scale levee failures at the Rixin section during the 2016 Meinong earthquake

Chin-Chin Tsai, Min-Hua Chung, & Zi-Xian Yang

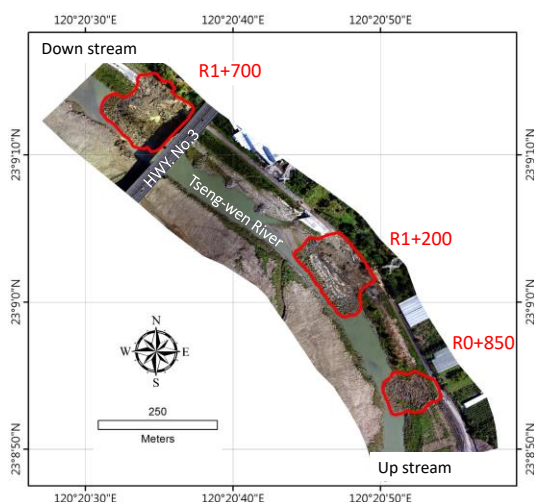
Three flow-type failures in the Rixin embankment were located near the intersection of Highway No. 3 and the Tseng-wen River as displayed in Figure 1. The height of embankment at the Rixin Section was approximately 15 m, which was constructed by a 1:2 slope with a 2 m setback at the middle. The slope was protected by a 30-cm unreinforced concrete slab.

As reported by Tsai et al. (2017), two large scale failures, R0+850 and R1+200, occurred at the upstream of Highway No. 3, as shown in Figure 1. The dimension of R1+200 was approximately 150 m by 75 m, whereas the dimension of R0+850 was approximately 75 m by 75 m. Another failure, R1+700, was located at the downstream adjacent to the Highway No. 3 Tseng-wen River Bridge. The dimension of the R1+700 area was approximately 100 m by 125 m. As shown in Figure 2, the access road on the crest and the entire section of embankment at R1+200 and R1+700 were gone after the earthquake. However, the landside ground of the levee did not exhibit significant deformation at these two locations. By contrast, the failure occurred mostly on the floodplain adjacent and ceased at the toe of the embankment at R0+850. The debris of sliding mass almost blocked the Tseng-wen River at three failure locations.

Figure 1. Orthophoto of the failure area at the Rixin section (Tsai et al. 2017).

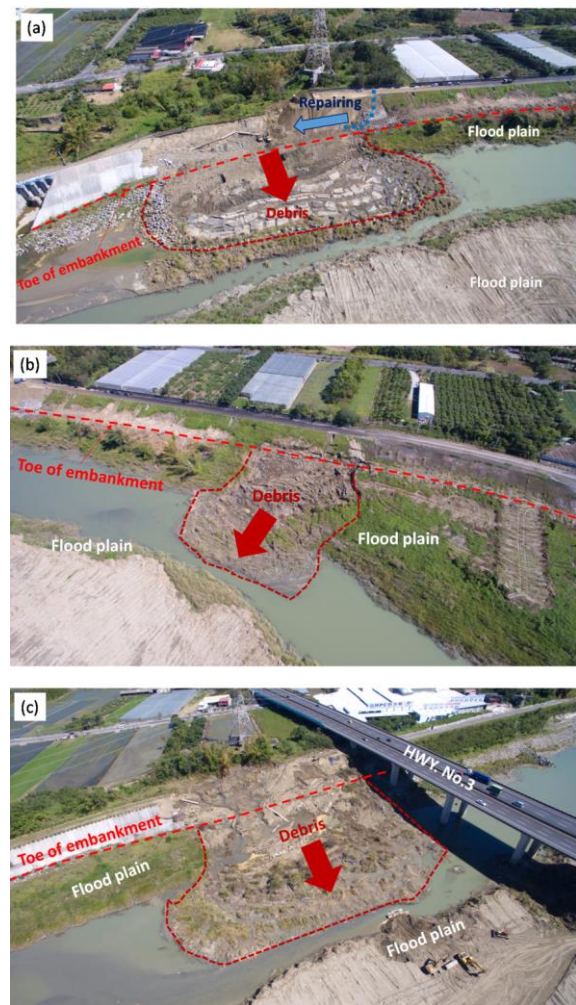
The mode of slope failure here differed from the typical slope failure that exhibits a limited sliding distance. By contrast, the embankment slumped over a wide area because of the significant loss of strength from earthquake loading but the landside ground remained intact, indicating no liquefaction associated failures occurred there. The visible run out distances were more than twice the height of the embankment. However, whether the failure was due to liquefaction or not is not clear only with the observed feature of lateral spreading. During the reconnaissance by Tsai et al. (2017), no manifestation of liquefaction (e.g., soil boil) was observed. Nevertheless, at R1+200 and R1+700, the groundwater could be high in the embankment because of the unpaved irrigation channel and the rice farm (similar to a pond) behind the R1+200 and R1+700 sections, respectively, as shown in Figure 2. Because of the seepage, several ponds filled with mud and sand mixture were developed on the debris (Figure 2a), which supported the hypothesis of seepage problem to induce the failure.

At R0+850, the embankment could be dry because no irrigation channel or rice farm existed behind. As a result, the failure here only extended on the flood plain, which was different from the other two locations where the entire embankment failed due to the seepage problem. The flood plain at R0+850 was gentle with a slope of less than 7.5° . Therefore, sudden loss of strength was required to trigger this flow-type failure.

Figure 2. Aerial photos of the levee failure at the Rixin sections (a) R1+200, (b) R0+850, (c) R1+700 (Tsai et al. 2017).

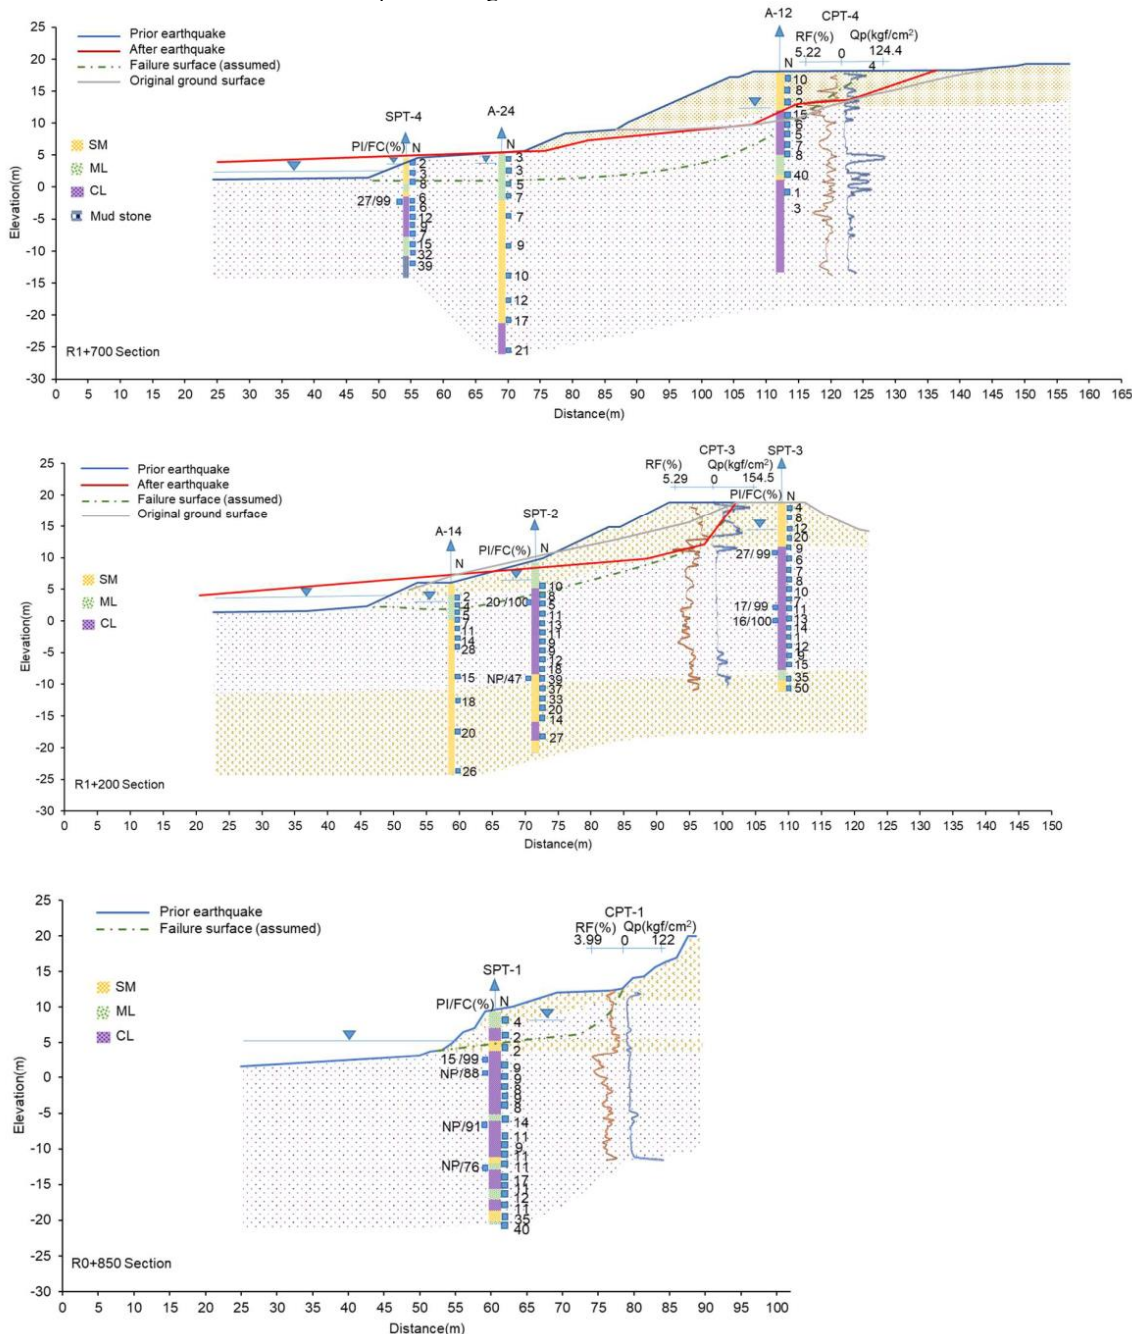
At R1+200, additional sand fill was placed on the original ground to form the current embankment mainly composed of loose sand.

The foundation soil is thick low to medium plastic clay with PI ranging from 16~27 and extends to the floodplain. The measured groundwater table was high at this section due to an unpaved irrigation channel behind the embankment, indicating a potentially seepage problem.

At R1+700, a larger amount sand fill was placed to form the current embankment. Similarly, the embankment mainly composited of loose sand and lay on medium plastic clay. The thick foundation clay layer is judged to extend to the flood plain although the top layer of SPT-4 exhibits a sand layer. This sand layer could be moved from the embankment since this boring was drilled on the debris after the earthquake. The groundwater

At R0+850 section, the failure here that only extended on the flood plain was different from the other two locations, where the entire embankment failed. Therefore, one boring and one CPT was drilled on the flood plain. The flood plain at R0+850 was gentle with a slope of less than 7.5° and mainly composited of soft clay. The foundation soil that extended to flood plain is also medium plastic clay, similar to the other two sections. While the embankment is mostly dry, the flood plain is submerged (saturated).

Figure 3. Subsurface characterization of R0+850, R1+200, and R1+700 section

The cross section prior to and after earthquake and the determined failure plane are shown Figure 3. At section R1+200 and R1+700 where significant failure occurred, the fill of the embankment was gone and piled up in the river. At section R0+850 where only tension cracks formed at the toe of embankment, the ground surface didn't have considerable change. Based on the ground surface prior to and after the earthquake, the failure surface of section R1+200 and R1+700 was assumed rationally. The sliding plane, determined based on the residual slope after the earthquake, starting from the crest of embankment, passing through the shallow part of the clay foundation, and extending to the toe of the flood plain. It was found that failure plane mostly went through the foundation clay layer. Therefore, this layer dominates the stability of this sections.

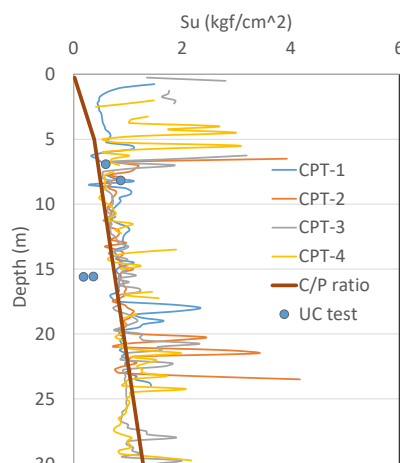
The strength properties of three main layers are listed in Table 2. The friction angle of sand layer is based on the SPT-N while the friction angle of clay layer is based the triaxial tests. The undrained shear strength of clay layer (S_u/σ_v') determined as 0.40 is based the CPT and lab test results as shown in Figure 4.

Figure 4. Undrained shear strength of clay layer

S_u/σ_v' of 0.40 is used based on the CPT, laboratory test as shown in Figure 4. Therefore, OCR is approximated as 1.8 per (Ladd 1991).

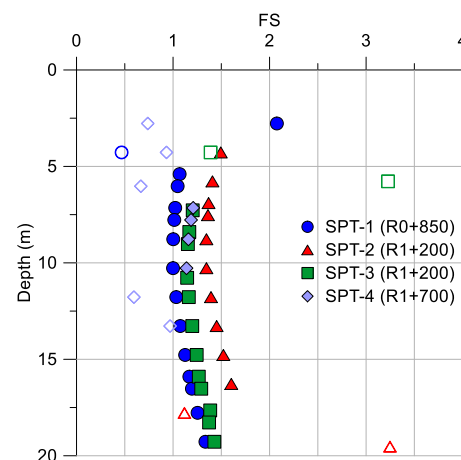
The liquefaction analysis result is shown in Figure 5. FS of all borings is close to 1 near the top of clay layer (5-10 m). Note that the result is based on the assumption of $K_{\alpha}=1$ (i.e. initial stress ratio is 0). However, for levees or slopes, initial stress ratio is not a unit and a correction factor less than 1 is required to reduce liquefaction resistance. Therefore, this result indicates those sections are marginally stable and was potentially onset of large strains. Moreover, those layers are corresponding the failure plane.

Figure 5. FS of liquefaction triggering analysis. Solid symbols indicate clayey soil and hollow symbols indicates sandy soil.

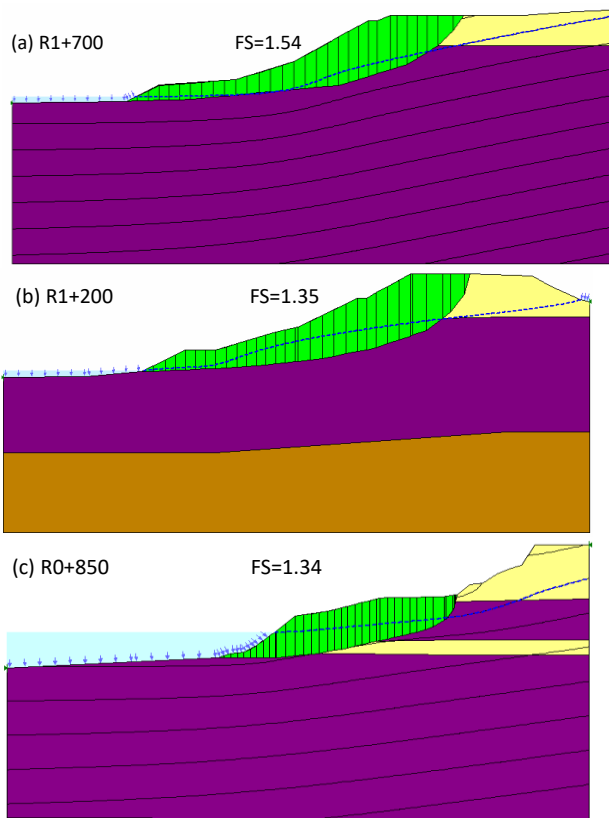
Seepage and slope stability analysis are performed with the computer program SLOPE/W (GEO-SLOPE International Ltd., 2012) for the static condition using the drained strength prior to the earthquake condition. The seepage analysis were first performed to obtain the phreatic line as shown in Figure 6 and then the slope stability analysis is performed to obtain the static FS of three sections. The result (Table 3) shows that FS is greater than 1, confirming the stability of these sections prior to the earthquake. However, the FS are close to one of R1+200 section, indicating marginally stable.

Figure 6. Seepage and static slope stability analysis result.

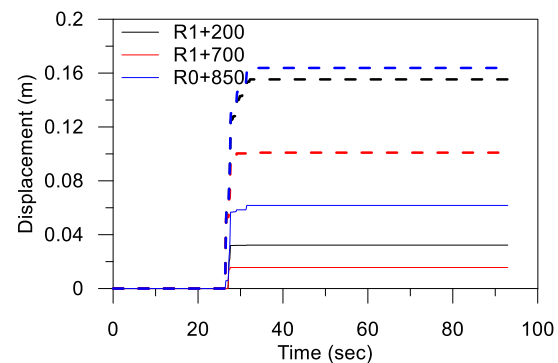
The time history of Newmark displacement is shown in Figure 7 and the total displacement is summarized in Table 5. It should be noted that the calculated Newmark displacement is an index and may not reflect the real displacement, especially not representing those (consequences) induced by the flow-type of failure. Typically, 5 cm is a threshold to trigger the failure of a slope. The estimated Newmark displacement is less than 5 cm expect for R1+200 without considering strength softening, indicating no failure occurred in these section. However, once the cyclic softening was considered, the estimated displacement is greater than 5 cm, consistent with the field observation of failure.

Figure 7. Time history of Newmark displacement with soften (dash line) and without softening (solid line).
