## Structural mitigation of a deep-seated slow moving landslide along a major national road in Sri Lanka

**Asiri Karunawardena**

**ABSTRACT:** The government has implemented large-scale landslide mitigation works along the National roads in highland areas to avoid the frequent disturbance of the transport system due to the occurrence of landslides. The stabilization of Kahagolla landslide is one of the largest mitigation works carried out under the “Landslide Disaster Protection Project”. This landslide was first identified in 1957 and creep movements have followed thereafter at different times affecting the road structure. Detailed field and laboratory investigations, instrumentation and monitoring were performed to investigate the characteristics and the possible causes of the landslide. Stability analysis were carried out on the established landslide profile based on the above information and results indicate that some parts of the landslide are in a highly active stage. Also, analysis indicates that the main reason for landslide activation is the increase of ground water level and subsequent loss of slip surface strength. Based on the results of investigations and stability a

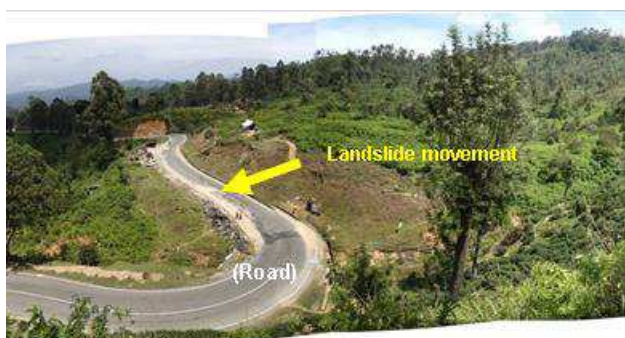
Kahagolla landslide is a well-known massive landslide in the lower central hills of Sri Lanka, which is located at the 10 km post of A016 road in Badulla district. The site area experiences an annual average rainfall of around 2000 mm, which mostly falls during the north-east monsoon from October to January, triggering its movement. The main landslide body extends over 4.5 hectares in an abandoned tea estate with an approximate length and width of 600m and 150m respectively. The road runs across the toe of the landslide, towards the North-Eastern direction. The landslide was first identified in 1957 and gradual movements have occurred thereafter, during periods of heavy rain. The continuing movement of this soil mass pushed the road section as shown in Figure 1 and as a result of that, the road connecting Haputale and Bandarawela towns was sporadically damaged while threatening many lives and community properties located just below the landslide area.

Figure 1. Kahagolla Landslide.

The landslide mass of this site is composed of a colluvium of sand, silt, and boulders. The topographic condition of the site showed features of multiple landslides, gentle but disturbed slopes with a couple of steps formed by smaller scarps, ponds and wet lands scattered in the landslide area. Further, a significant number of open cracks were observed throughout the landslide. According to the topography of the landslide area, the rainfall to the surrounding area flowed into the site in the form of both surface and ground water and was accumulated within the landslide mass and they act as the main triggering factors of landslide. Upsurge of ground water level soon after intense or prolonged rain period destabilized the slope, along with severe erosion by surface water runoff, thus creating instability in

landslide mass and gradual movement of the landslide, damaging the main road located at the toe of the landslide.

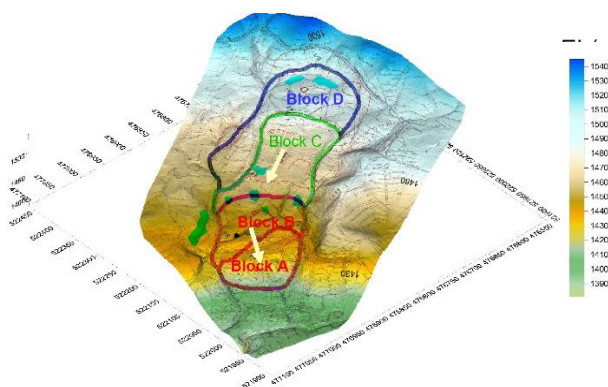
shown in Figure 5. Block A is located at the toe of the landslide across the road and appeared to be highly active. In block B, height of the scarp was about 3m, however the extension of the scarp towards the side of the landslide was not clear. The main part of the block was gentle but had disturbed the slope. Block C had a 5m high scarp and bare ground was observed around the scarp. Extension of scarp was clearly observed as a form of minor scarp. The main part of the block had a disturbed slope. In the area identified as Block D, the steep slope was located along the estate road and identified as the head scarp. Heavy water seepage and surface water flow were observed in this block during the rainy period. Monitoring results indicated that some parts of the landslide moved actively in rainy seasons. The landslide itself moved repeatedly every year and caused frequent damages to the road. Based on the results of monitoring, it was understood that the landslide area of this site moved intermittently during rainy seasons by various degrees; Block A was the most active but Block B, C and D were still active more or less. This means the countermeasures for the site needed to cope with all blocks. As for the relation of the blocks, it was likely that Block A became activated first then other blocks followed in order of Block B, C and D. It was a rational observation that the blocks moved mutually dependently, and that activity of one block affected the other block consequently.

Figure 5. Identified Landslide blocks and movement direction

The direction of the landslide movement was assumed to head straight to block D and the main traverse line of this landslide was presumed at the center of landslide body delineated by the mountain stream on both sides. The direction of the landslide movement was, however, controlled by the stable ridge located at either side of the landslide body at the middle to lower slope. At the middle of the body, the landslide changed its movement counterclockwise and Block B, and subsequently Block A, moves straight to the main road.

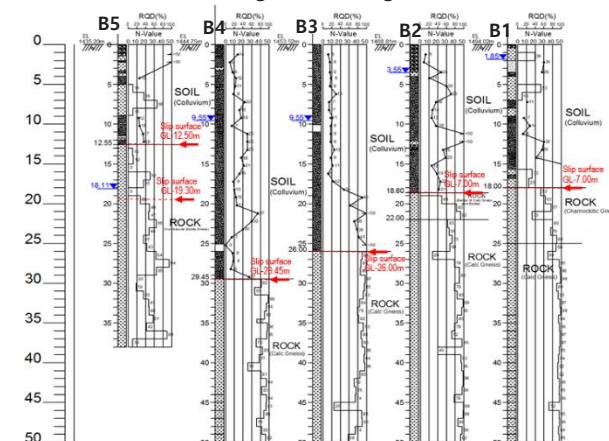
The estimation of the slip surface was mainly done using the core samples collected through the drilling investigation. Typical characteristics of the slip surface such as a thin layer of clay with high water content which is deposit at boundary of stratum were investigated. An effort was made to identify the slip surface on the drilling core sample, based on the above features. In addition, results of the monitoring of inclinometer and pipe strain gauge were considered in the identification of slip surface. However, due to limitations in the quality of core sampling available for the site, the slip surface of the site was assumed mainly based on the boundary between bed rock and overlying colluvium and assumed depth of the slip surface in boreholes is shown in Figure 6. For some sections, the slip surfaces were considered as running through the weathered rock strata. The landslide map and the landslide profile with assumed slip surfaces based on the above data is shown in Figure 7 and Figure 8.

Figure 6. Identified slip surface using output of borehole investigation

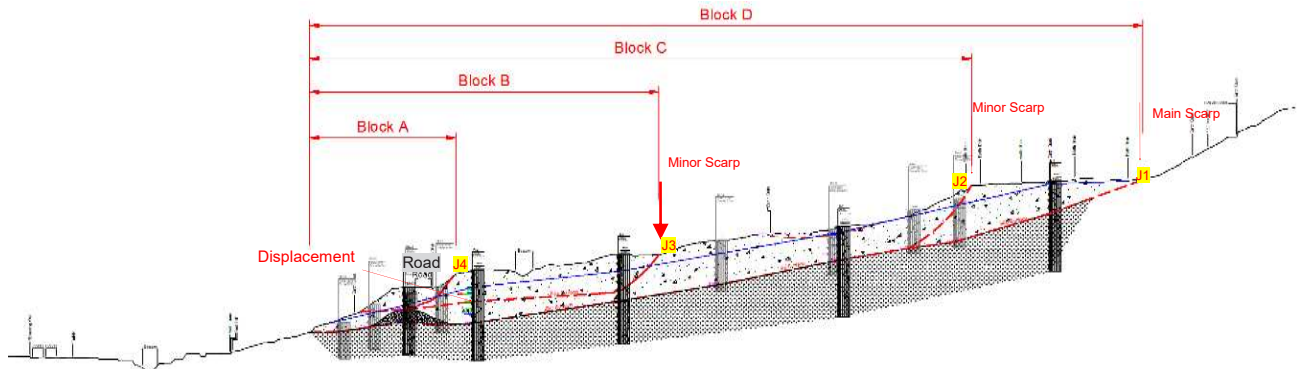
Figure 8. Landslide profile with assumed slip surfaces (J1, J2, J3, J4)

Counterweight embankment plays a huge role in stabilizing the slip surface J1 and J2 while other most critical slip surfaces are stabilizing with groundwater control works. However, in order to achieve desirable safety margin in slip surface J4, ground anchors are also included in the design.

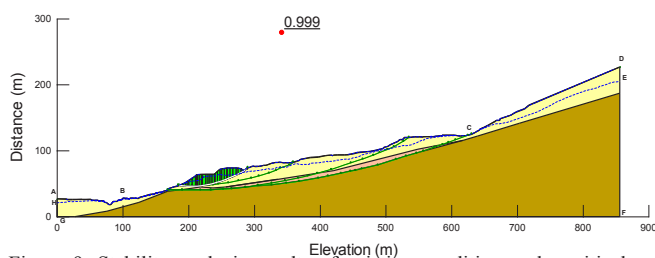
Stability analysis was carried out for the assumed landslide profile and slip surfaces. The analysis was carried out using GeoStudio 2016 from Geo Slope. The Morgenstern Price method was utilized in the analysis as the assumed slip surface geometry of the failure was irregular in shape. The unit weight ( $\gamma$ ), cohesion ( $c'$ ), and the friction angle ( $\phi'$ ) of 18 kN/m<sup>3</sup>, 10 kN/m<sup>2</sup> and 32° respectively was used in the analysis. These parameters were obtained from the laboratory tests conducted from the shear undisturbed samples collected from shear surface of the soil. The ground water level required for the analysis was estimated from the field monitoring results. The performance was verified at critical water level, i.e ground water level when landslide starts to slide. This situation is considered a critical state and the factor of safety at the time of landslide is considered as the critical safety factor and its value was taken as 1.0. However, the factor of safety obtained was considerably higher than 1 and indicated that the shear strength parameters obtained from the laboratory test results were not representative of the properties of the slip surface. This may be due to the heterogeneity of soil characteristics, the disturbance to the soil samples in the process of extraction and testing, sample location not representing the whole area etc. Therefore, selection of appropriate shear strength parameters for the analysis were done by simulating the critical state (FOS=1) of the landslide. Shear strength parameters obtained from the laboratory were used as reference for the trial simulation. Trial analysis were done for different shear strength parameters. Previous studies done for Watawala landslide in Sri Lanka shows that cohesion value of the slip surface was relatively small (Rajaratnam and Bandari 1994). Analysis indicated that when  $c' = 5.25$  kN/m<sup>2</sup> and  $\phi' = 17^\circ$ , stability model reasonably simulates the observed field deformation condition. Stability analysis results of existing condition of Block A under critical water level is presented in Figure 9.

Figure 9. Stability analysis results of existing condition under critical water level - Block A

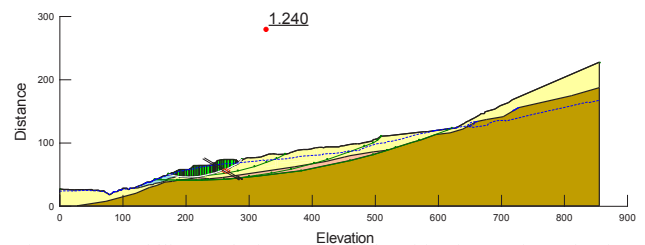
Figure 10. Stability analysis results with mitigation option of using ground anchors for Block A

Stability analysis had been conducted to determine the scale and quantity of landslide countermeasure works required to maintain the stability of the landslide and so ensure the target safety factor. The design safety factor of 1.2 was targeted by considering infrastructure such as main transport road, some houses, tea cultivation and stream that could be affected in the event of a landslide occurrence. In the selection of design safety factor, both technical and financial aspects were considered. The effectiveness of application of countermeasures were analyzed by GeoStudio 2016 using the Morgenstern Price which is widely used for simple landslide stability analysis. In the selection of countermeasures both control type and preventive type works were examined. Control works were designed to mitigate the landslide by changing natural conditions such as topographic and ground water conditions. Preventive works were designed to stop part or all landslide activity using restrain forces by artificial structures such as retaining wall, soil anchors, piles etc. Stability analysis results with mitigation option of using ground anchors for Block A is presented in Figure 10.

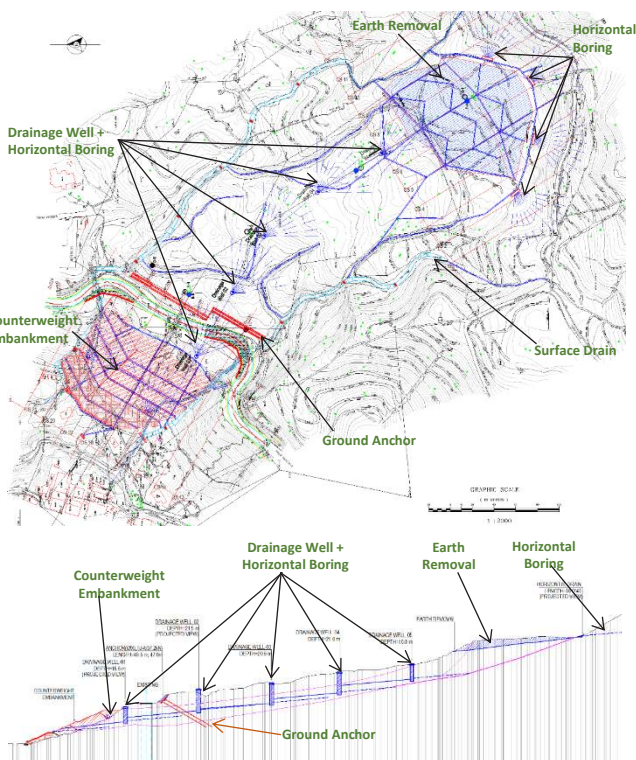
Figure 12. Plan view and cross section of proposed countermeasures

Based on the results of investigation and stability analysis, several suitable combinations of countermeasures were considered, and examined to decide a couple or more appropriate combinations of countermeasures in terms of both economic efficiency and design requirements. From the more appropriate combinations of countermeasures, an optimum combination of countermeasures was selected by careful examinations and comparison among them. The improvement of safety factor with application of each counter measures are given in Figure 11. The plan and cross section of proposed countermeasures for the landslide mitigation are given in Figure 12.

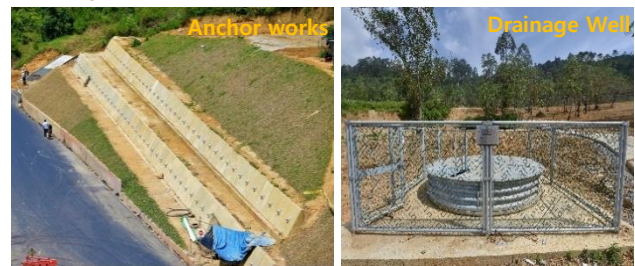
Figure 13. Photographs of implemented countermeasures

The designed countermeasures were constructed at the site using the Japanese technology and in accordance with Japanese Standards in order to stabilize the landslide. Work was carried out under the full supervision of a Japanese expert and transfer of the technology to the local construction industry was expected. Stabilization involved the construction of surface and subsurface drains and drainage wells to lower the ground water levels. Surface drains were constructed to intercept and divert the surface runoff reducing infiltration and divert the surface water away from the landslide. The drainage wells with horizontal drains were constructed at identified locations to control the ground water level below the design level. Earth removal at the head of the landslide and counter embankment construction at the toe area of the landslide was done with the aim of balancing the force and improving the overall stability of the landslide. Ground anchors were installed just above the road which was

located at the toe region of the landslide to prevent the shallow landslide which caused the frequent damages to the road.
