## Remedial design of failed embankment founded on clay shale in east kalimantan, Indonesia

**ABSTRACT:** During construction of a 15-meter high embankment in Balikpapan - East Kalimantan, a section of the embankment at STA 2+905 failed following a prolonged rainfall. The failed embankment was subsequently repaired by re-excavating and re-compacting it to its original geometry. One year later, however, extensive cracks re-appeared at this section, leading to the failure of the adjacent box culvert. The second remedial work was carried out by installing mini piles to reinforce the foundation at the failed section. Yet, the cracks and slips still occurred at this section.

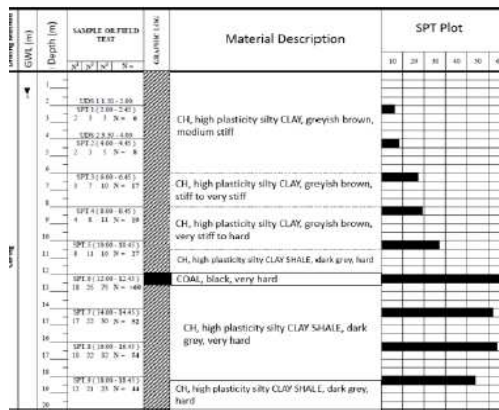
Balikpapan is located at Balikpapan Formation consisting of interlayered quartz sandstone, siltstone and shale with limestone and coal layer insert. Limestone contains fossils of the upper middle miocene age. Deposition environment in shallow littoral regions with a thickness of 800 meters. The soil investigation carried out at site confirms the existence of a stiff shale layer underlain by a thin hard black coal layer. Typical subsurface geotechnical condition at the location of the failed embankment section consist of medium to stiff CLAY of high plasticity, underlain by dark grey stiff to hard silty CLAY SHALE above black hard coal layer and underlain by hard dark-grey silty CLAY SHALE. As shown in Figure 1, the SPT N values for the grey very stiff clay SHALE above the coal layer was ranging from 19 to 27. This was the layer that likely experienced strength reduction which lead to embankment failure.

Figure 1. Typical subsurface geotechnical condition beneath the failed embankment section

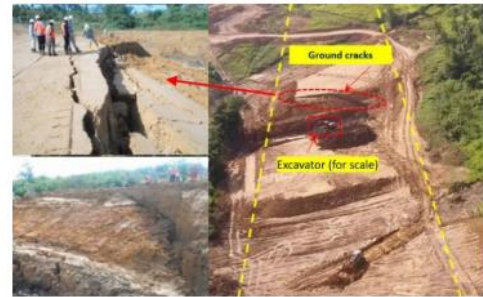
Figure 2. 1<sup>st</sup> ground cracks observed during culvert excavation (24 Feb 2017). Yellow dashed lines indicate the design road alignment.

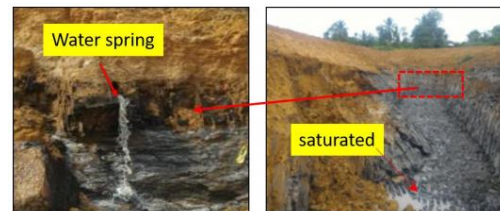
Figure 3. Hard dark grey silty clay shale at the culvert foundation exposed during the excavation. Note the seepage coming from the upstream side of the culvert.

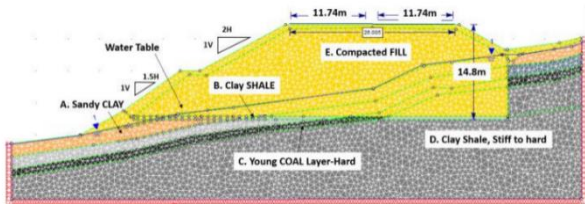
The geotechnical model, the embankment geometry before 1<sup>st</sup> failure and the finite element mesh at STA 2+905 are shown in Figure 5. Soil layers and the location of water table were developed based on the results of borehole and data before and after slope failure. The soil parameters for the compacted fill, clay shale, sandy clay, and coal layer were obtained from the results of laboratory data and available correlations applicable for the soil at the site. The soil parameters used in the analysis are presents in table 2.

Figure 5. Embankment geotechnical model and FE mesh for case 1 (before 1<sup>st</sup> failure)

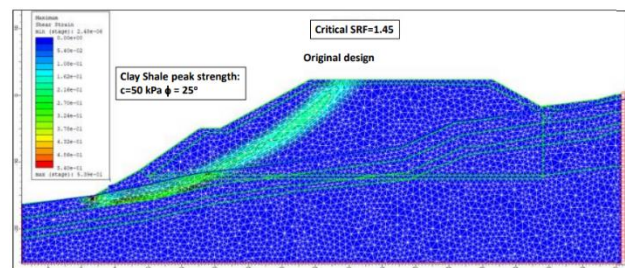
The result of safety against failure of the original embankment at STA 2+905 was analyzed using Strength Reduction Method (SRM) using RS2 software (Rocscience, 2019). The analysis were conducted using the peak strength of all materials comprising the dam, with clay shale layer strength of  $c' = 50$ kPa and  $\phi = 25^\circ$ . The calculated factor of safety of the embankment section for the original condition was around 1.45, with potential failure surface as shown in Figure 6.

Figure 6. Computed potential failure surface for Case 1. (Clay shale peak strength of  $c=50$ kPa;  $\phi = 25^\circ$ ; FOS=1.45)

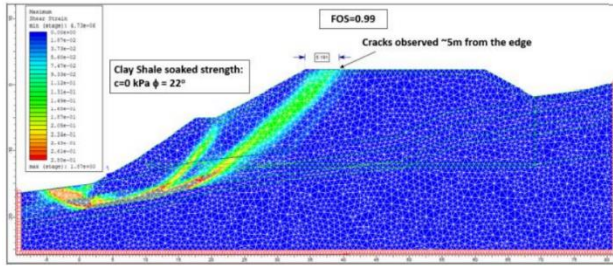
The clay shale strength was then reduced to soaked strength parameters to simulate the actual slope failure where cracks were observed at the top of embankment. The results are presented in Figure 7. As shown in the figure, the slope failure zones developed from the top of the embankment and extends down to the toe of embankment, which agree quite well with the field observations. Results of back analysis indicate that the shear strength parameters of the soaked clay shale layer at failure (FOS~1) were  $c'=0$  kPa and  $\phi = 22^\circ$ .

Figure 7. Computed potential failure surface for Case 2. (Clay shale soaked strength of  $c=0\text{ kPa}$ ;  $\phi = 22^\circ$ ; FOS=0.99)

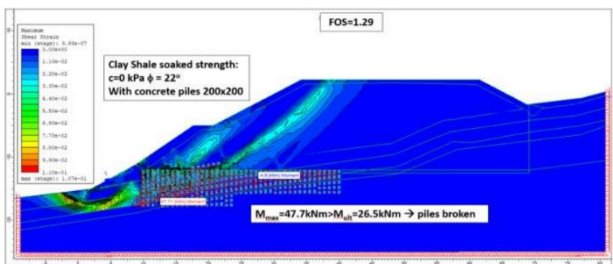
When the soaked strength of  $c' = 0\text{ kPa}$  and  $\phi = 22^\circ$  was assumed for the clay shale strength, the computed slope factor of safety was 1.29, which was theoretically stable (Figure 8). However, the computed maximum bending moment in the piles was 47.7 kNm, which was much higher than the ultimate moment capacity of the piles of 26.7 kNm, suggesting that the piles were already broken when the fill was re-constructed to its original design level. Hence the piles were not able to withstand the embankment weight and started to deform.

Figure 8. Computed potential failure zones for Case 3a, PC piles 200x200 reinforcement. (Clay shale soaked strength of  $c=0\text{ kPa}$ ;  $\phi = 22^\circ$ ; FOS=1.29)

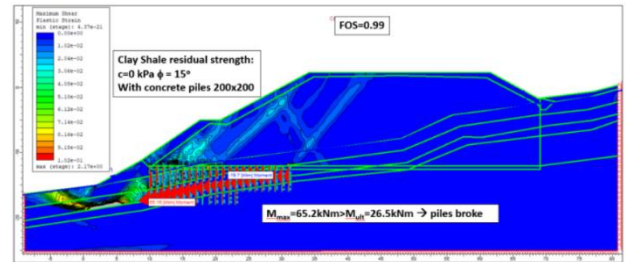
When the shear strength was further reduced to its remolded strength with  $c'=0\text{ kPa}$  and  $\phi = 15^\circ$ , the computed factor of safety was dropped to 0.99 (Figure 9). As shown in the figure, the zones of slope failure developed all the way from the top of the embankment to the area up to 10 meters away from the embankment toe. The greater affected slip area appears to be caused by the pile reinforcement in the pile reinforcement was able to mobilize larger area to provide more resisting forces, the PC piles were not strong enough to withstand the forces exerted by the embankment when the clay shale deforms due significant loss of its original strength and stiffness.

Figure 9. Computed potential failure zones for Case 3b, PC piles 200x200 reinforcement. (Clay shale soaked strength of  $c=0\text{ kPa}$ ;  $\phi = 15^\circ$ ; FOS=0.99)

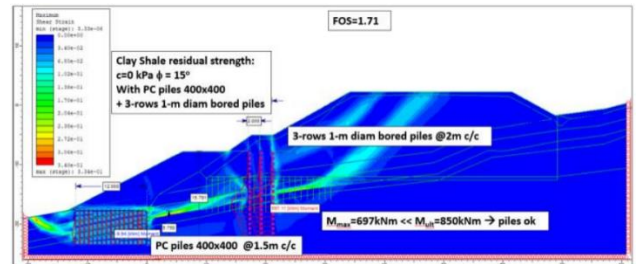
Figure 10. Computed potential failure surface after bored piles installation. (FOS=0.99)

The results of finite element analysis in Figure 10 shows that the bored piles configuration has improved the global safety factor to 1.71, even using clay shale residual strength parameter. The computed moments in the bored piles and the PC piles were less than the moment capacity of the piles. The figure also suggests that the potential failure surface developing along the previous failure surface.

A series of bored piles was selected as the most suitable solution to improve the safety factor of the embankment system mainly due to its minimum disturbance to the clay shale layer during construction. In addition to the bored piles, a stabilizing berm was needed to prevent local failure of the toe. PC piles would consists of 3 rows of 16m-deep bored piles, installed @2m center to center perpendicular to the failure plane, 17 rows of 6-m deep 400x400 PC piles @1.5 center to center and stabilizing berm. The broken piles on the culvert foundation were not taken into account in the analysis.

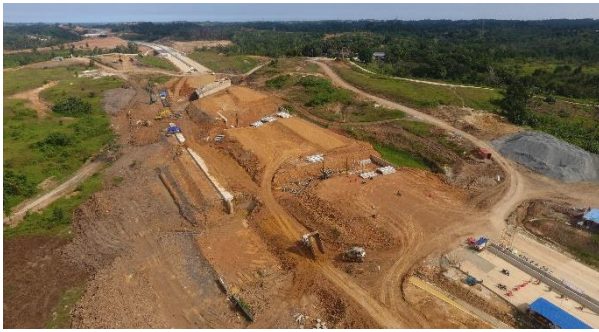
Figure 11. Progress of soil reinforcing using bored pile, PC piles and berm

- A group of bored piles was selected as the most suitable solution to increase the global safety factor of the road embankment. The proposed design consists of 3 rows of 16-m deep 1000mm diameter bored piles @2m center to center, with stabilizing berm reinforced with 6m deep 400x400 PC piles. Due to further technical judgement of consultant, it modified into 1-row bored piles. Care must be exercised during the installation of the piles to prevent disturbance or wetting on the clay shale. The result of analysis using RS2 software (Rocscience, 2019) using remolded strength of the clay shale layer indicate that the new remedial work would be stable with computed factor of safety of 1.7.
