## Large slope stability problems in projects with complex geology

**Camilo Marulanda**

##### 3.1 Porce III Hydroelectric Project

### 3.2 Mataro Hydroelectric Project- Slide No. 5

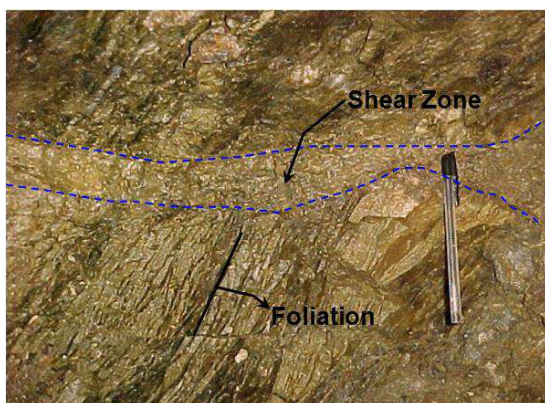
During the geotechnical investigations completed for this project, several shear and shear gouge zones were identified, with variable thickness ranging from 0.05 to 2 m parallel and across foliation planes in the area of the dam and in the tunnels. The material in the shear zone was pulverized rock with plastic soft fine-grained material accompanied by highly folded and fractured quartz veins. The shear zones that follow the foliation planes consisted of thin layers of weathered micaceous material (See Figure 1).

Figure 1. Shear zone intersecting a foliation

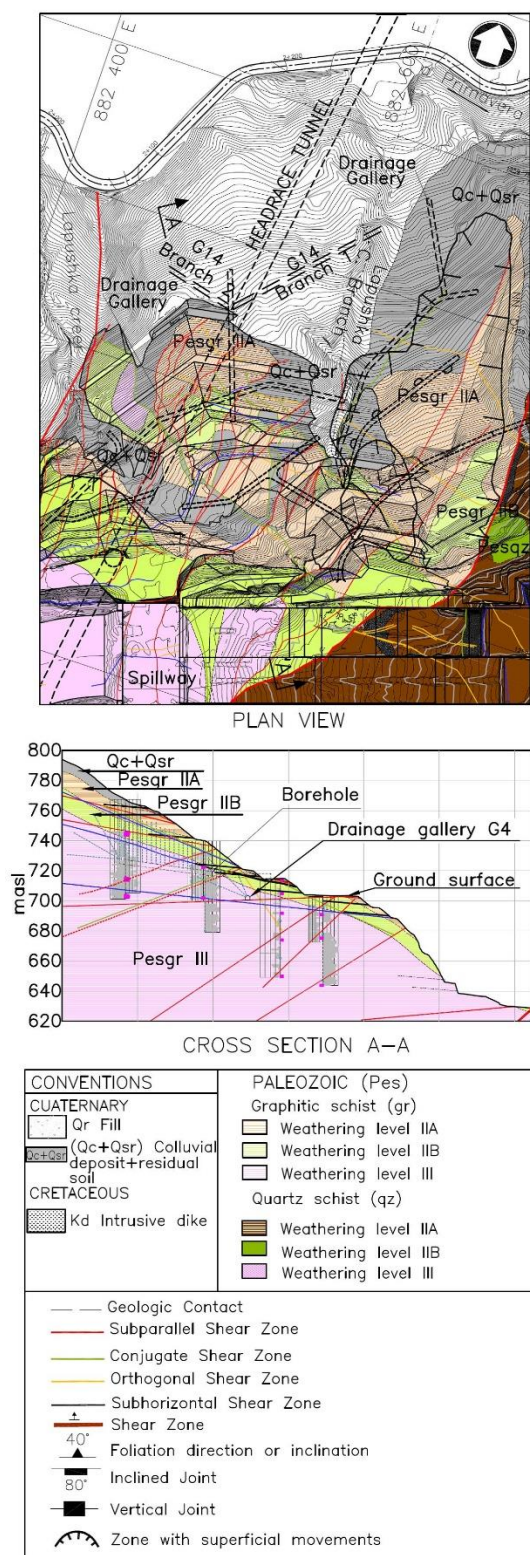
Other example of the problems related with shear zones included the excavations over the diversion tunnel performed for the upper side of the spillway. In this zone, instability resulted from a shear gouge plane inside the schist bedrock. The shear plane had dip angle of 26° SW towards the slope. In addition, the unstable block was delimited by the foliation planes and a lateral shear gouge zone associated with the foliation (See Figure 2 and 3). The mechanism analyzed had a three-dimensional geometry and was affected by the presence of underground water accumulated behind and over the failure surface.

Figure 2. Geologic plan view and cross section at the spillway (Porce III).

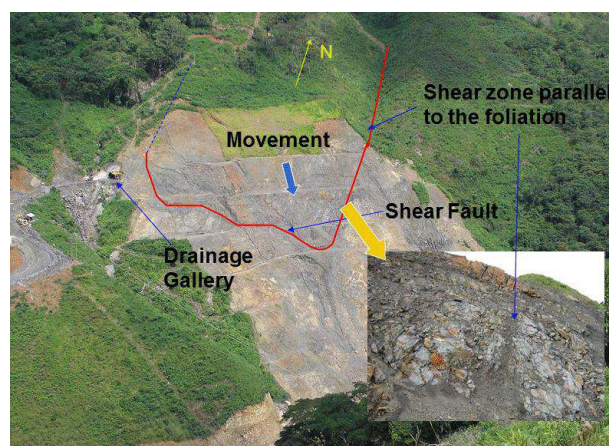
For the analysis and interpretation of the model, several exploratory boreholes were required. The sensibility analysis and back-analysis indicated that the residual shear strength was given by friction angle in the order of 25 to 28°. Laboratory tests of shear strength of undisturbed samples registered friction values of between 22° and 34°, with a cohesion that ranged from 0 to 80 kPa.

Figure 3. Failure surface at the spillway left slope (Porce III)

The studies and the exploration demonstrated the presence of a high water table, affecting the stability conditions of this unstable zone. From the stability analysis, it was established the need to build drainage galleries and a superficial drainage system in order to lower the water pressures that were generating the instability problem. The model of analysis found feasible to increase the level of static safety using the drainage from around 1 to up to around 1.35. Additional measures including the installation of tendons of 72 tons were defined. Once the drainage measures were implemented, a drastic decrease in the movements was registered, therefore improving the stability conditions (Figure 4).

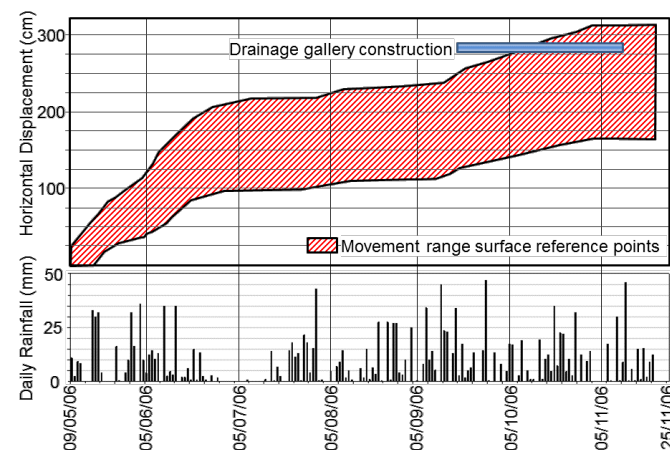
Figure 4. Displacement rate reduction due to the excavation of the drainage galleries (Porce III).

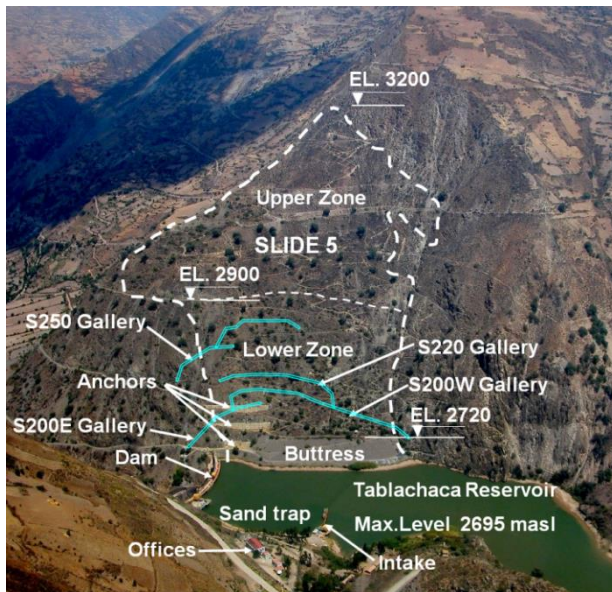
After the construction of the Tablachaca Dam, and shortly before the filling of the reservoir (September 1972), an important ancient slide, named Slide No.5, was identified in the right abutment, upstream of the dam (see Figure 6). Initial investigations indicated that the slide mass could be divided into an upper zone (initially inferred inactive) and a lower

active zone. The active zone extends from elevation 2660 masl to elevation 2920 masl above the dam and reaches a maximum depth of 70 m measured from the surface. The active zone area is approximately 7.50 ha and its volume is estimated at 3 Hm<sup>3</sup>. The upper portion of the slide is comprised by an “inactive” zone that extends up to elev. 3200 masl, covering an area of 14 ha approximately and an active zone representing an additional 5 Hm<sup>3</sup>.

In September of 1972, upon completion of the dam, filling of the reservoir was initiated from river level up to elevation 2695 masl. During this period, slope movements were observed as well as the formation of cracks on the surface. Movements reached several meters and generated a slide of about 65,000 m<sup>3</sup> of material into the reservoir. As a consequence of this phenomenon, the reservoir had to be lowered and movements monitored although not systematically until 1980 when intense rainfall occurred, and the slide was again visibly active. In February 1982, movements increased to daily rates of up to 5 cm/day. Consequently, the project was declared in a state of emergency and the owner decided to undertake the necessary studies to carry out the stabilization works (Marulanda et al. 2010).

Figure 5. General view of Slide No. 5 (Mataro).

In June 1982, the emergency works required to control the movements of Slide No. 5 were undertaken. The main contingency measures consisted of (1) construction of a free draining buttress at the foot of the slide, (2) installation of prestressed anchor up to 110 m long near the dam and at locations where the buttress could not be placed, (3) construction of two drainage galleries with radial drains within the rock mass and (4) drilling of horizontal drainage holes from the surface. Construction of the buttress fill included

Construction of the buttress started in September of 1982 with the treatment of the sediments in the reservoir and was completed in September 1983. The works comprised compaction of 1,583 gravel columns in an area of 7,600 m<sup>2</sup> and placement of 467,000 m<sup>3</sup> of fill material to build the buttress. Subsequently, 419 anchors were installed in three different walls exerting a combined force of 486,000 kN (48,600 ton). The sub-surface drainage system consisted of the construction of two galleries excavated into the rock mass behind the slide with a combined length of 1,527 m. A total 190 radial drainage holes were drilled along the galleries with a total length of 3,290 m. Twenty-one horizontal drainage holes were drilled from the surface with a total length of 1,282 m. The superficial drainage system consisted in the construction of 5,963 m of drainage ditches at different levels across the slide. Figure 5 shows the dam site and main stabilization works at Slide No 5.

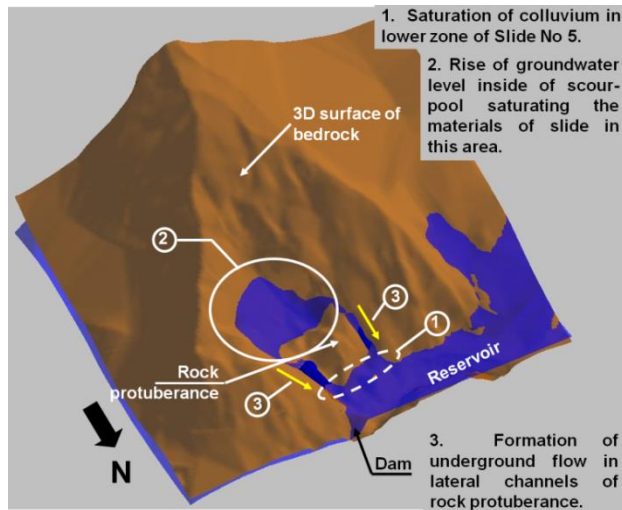
Figure 6 presents the presence of a scour-pool or cavity formed in the bedrock which is covered by the ancient landslide and the more recent colluvium deposits. In the area immediately upstream of the dam, a gorge exists (see points 3 in Figure 6) that descends from an elevation of approximately 2800 masl down to the riverbed. The gorge is oriented towards the reservoir and coincides with the movements that have occurred in this area. In the intermediate zone, the scour-pool does not reach the bottom of the river, but rather is bound by a rock protrusion composed of highly fractured and gouged slate. In the west sector of the slide, another type of gorge, of less depth and width than the one previously described is located (descends to an approximate elevation of 2800 masl).

Figure 6 also presents the phreatic surface prior to construction of the drainage galleries. This figure illustrates that prior to construction of the galleries; a buildup of water level developed in the scour-pool that forms the bedrock, thus saturating the slide material. At the same time, such a rise in water level, connected the scour-pool to the reservoir by means of two underground flow paths (gorges) located in each side of the landslide, developing seepage forces in the lower portion of the sliding masses and reducing the stability. Upon completion of the drainage galleries and under the current conditions, the water build up in the scour-pool continued to take place, but its level decreased, and the underground water flow disappeared. Based on piezometric data, it could be determined that the construction of the drainage galleries lowered the water table in around 30 m on the lower zone of the slide and up to 70 m in the area of the scour-pool formed by the bedrock, indicating the effectiveness of drainage works.

Figure 6. Behavior of groundwater levels before construction of drainage works Superficial and Deep Movements (Mataro).

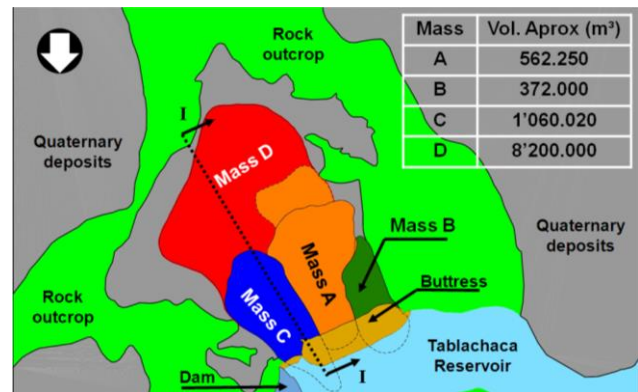
In the lower area of the slide, three potential masses were identified and are referred as A, B and C (see Figure 7). In the upper area of the slide, Mass D was identified by means of the deep shear points registered on the inclinometers above elevation 2750 masl and below elevation 3115 masl. Based on these shear points the deeper slip surface was identified behind the slip surfaces A, B and C, which have less depth than Mass D (see Figure 7).

Figure 7. Plan view of potential slide masses in Slide No. 5 (Mataro).

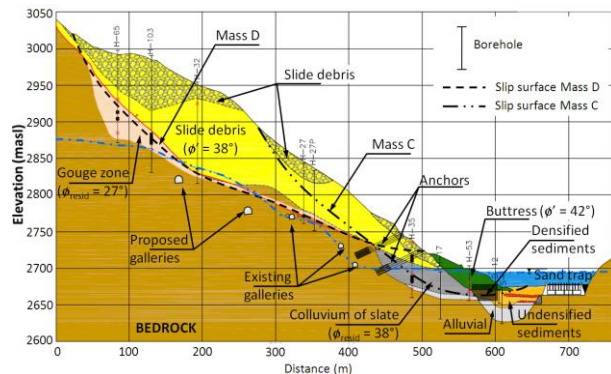
The strength parameters for the different materials that compose Slide No. 5, shown in Figure 8, were determined based on the different investigation programs performed since the early stages of the project. Special care was given in adequately characterizing the gouge zone, where the slip surfaces were developing. The most recent sampling program performed in 2005 included undisturbed samples obtained from the walls of galleries, samples taken with triple-tube core barrel taken from the 722 m of boreholes performed in 2005.

Figure 8. Cross Section I-I through Slide No. 5 (plan view presented in Figure 7) (Mataro).

Based on the results of the stability analyses, it was determined that masses A to C have acceptable stability conditions. Therefore, only a rehabilitation of the buttress was recommended to secure the long-term effectiveness of that structure and assure the stability of these masses, especially B and C. In the case of mass D, it was determined that under a severe rainfall event (return period of 100 years) the mass would exhibit a precarious stability condition. This, due to the fact that the existing drainage galleries do not have the range to control the groundwater level at the base of mass D, and therefore a build-up of water level could occur under a severe event. Based on this assessment, two additional drainage galleries were recommended as shown in Figure 8.
