## Case study of remediation of a landslide south of Sydney, NSW, Australia

**Reas Beeston & Scott Morrison**

**ABSTRACT:** This paper presents a case study of the remediation of a historical landslide beneath a portion of coastal road south of Sydney, NSW. The site is located about 50 kilometres south of Sydney CBD, Australia. The landslide has been known since the 1950s and has been monitored in various forms since then. A maintenance approach was adopted whereby the road area over the landslide was regularly reinstated. Recently, reinstatement was necessary every 3 years, and it was decided in late 2017 that a more sustainable, long term solution to the remediation was required. The background and design approach for the remediation is presented, including the options for remediation that were explored, and the results of three-dimensional numerical seepage modelling that was used to assess and optimise the trench drain spacing. Field performance after several years of monitoring post remediation is also generally discussed. Thus far it has been found that the remedial measures have controlled movement as predicted, and the client is no longer having to regularly repair the ro

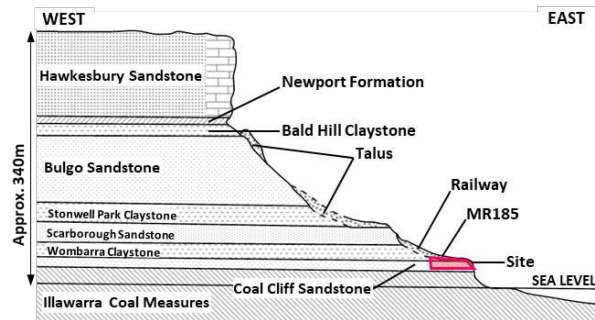
A schematic geological section of the Illawarra Escarpment geology through The Slide is shown in Figure 1, (Walker 1985). The upper parts of the site along Lawrence Hargrave Drive are about 78m AHD (above sea level) with the lower parts being about 60m AHD (above sea level).

Figure 1. Schematic Geological Section for the Scarborough-Clifton area with position of Lawrence Hargrave Drive and Site (after Walker 1985).

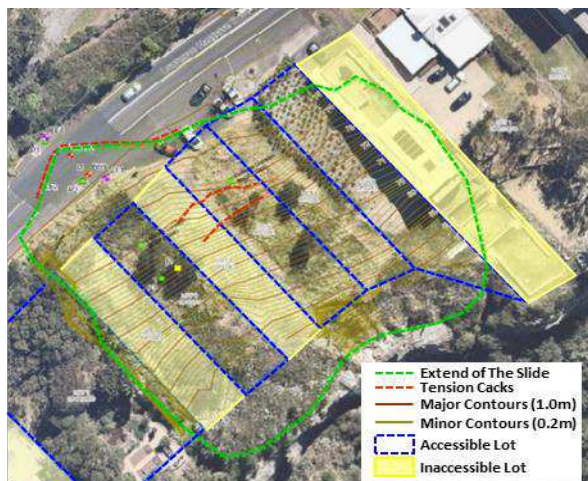
To update the desktop review, site mapping was carried out in early 2018 to update the relevant site features to The Slide. During mapping work, the extent of the main headscarp tension crack was marked along with a number of tension cracks, water seepages and other features downslope. Following markup of site features on aerial photography a drone was used to capture and better view site conditions at the base of the slope (inaccessible on foot) and give perspective to the site and The Slide, particularly in the near cliff and cliff areas downslope.

Figure 2. Site Features, with assessed extent of The Slide shown.

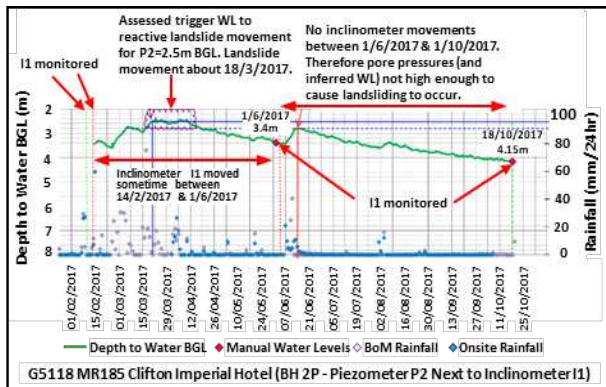
It was noted that within the first two weeks of March 2017 the site experienced a significant rainfall event and the total monthly rainfall in March 2017 of 369mm was the highest ever recorded monthly rainfall for Bellambi AWS. Upon review of the available data, trends indicated that The Slide reactivates when peak groundwater levels reached in BH1i and BH2i, which are listed below.

- 0.6m bgl in borehole 1P (P1),
- 2.50m bgl in borehole 2P (P2), and
- 1.60m bgl in borehole 3P (P3).

The inclinometer data indicated significant movements at The Slide around mid-March 2017, which was likely due to the higher groundwater levels in this period.

Figure 3. Groundwater monitoring and inferred groundwater trigger level at Piezometer P2 to reactivate The Slide movement.

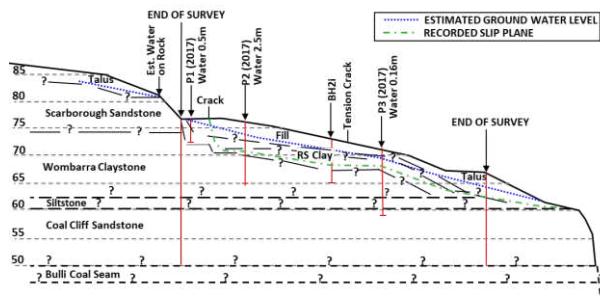
Figure 4. Interpreted subsurface Conditions at Section 2 (through the Head of The Slide) showing an inferred slide plane and interpreted groundwater levels at time of reactivation of The Slide in mid-March 2017.

The Slide is a relatively shallow landslide varying in thickness from 3m to 6m. The base of The Slide is generally sliding close to the residual clay/weathered rock interface over most of the landslide. Towards the toe, the slide plane also passed through remnant colluvium materials.

Contributing to activation of The Slide is the presence of fill in the vicinity of the backscarp and midpoint. The fill is assessed from review to be placed during construction of the road and the platform for the former house downhill. The presence of several metres of additional fill loading of about 50kPa to 60kPa coupled with high PWP's from rainfall events likely cause The Slide to regularly reactivate and creep downhill.

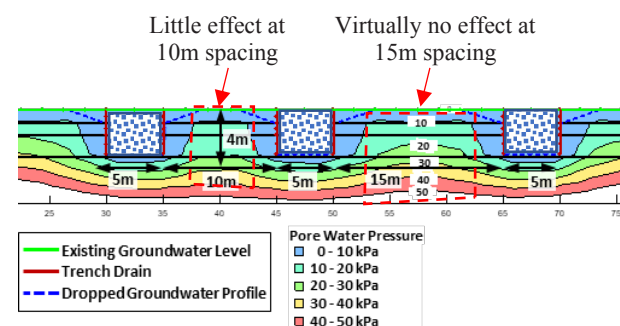
Figure 5: Impact of trench drain spacing on dewatering (output from SEEP/W 2D).

Analysis in SEEP/W indicated that in slope cross-section 3m deep trench drains with spacing of approximately 5m laterally 'wall to wall' can dewater the soils between the trench drains to levels close to the toe/floor of the drain. For trench drains spaced at 10m to 15m intervals horizontally, the dewatering effect would only partially dewater the slope. The results of this 2D analysis indicated that potentially the drains would not dewater across the private lots and their effectiveness will reduce significantly. Stopping the drainage analysis here would have resulted in the clients selected option not being adopted due to lack of dewatering The Slide.

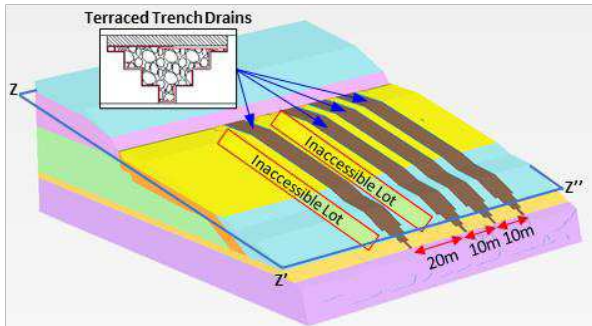
Figure 6: Arrangement of proposed terraced trench drain in PLAXIS 3D.

Based on the outcomes of the seepage analysis, the trench drain layout in Figure 6 was proposed for installation at The Slide for subsurface drainage measures comprising:

- Install a network of spaced trench drains in available lots up through the headscarp of the slope under the road to intercept water before entering and saturating The Slide.
- Excavate the trench drains to depth of 3.0m whilst terracing the excavation to allow placement of geofabric, aggregate

- Trench drains to be terraced, geofabric lined, and filled with clean free draining durable angular aggregate. Three 100mm diameter subsoil pipes to be installed towards the base of the trench for redundancy/maintenance purposes. Trench drains to have a minimum fall of 2% to 3%.
- As a guide deepen the trench drains to a minimum 2.5m depth or top of weathered rock where possible.
- Cap trench drains with at least 1m of low permeability clayey material (compacted to 95% std), dressed with 0.3m of topsoil (compacted to 90% std) seeded to encourage vegetation to regenerate.
- A minimum 0.5m to 1m thick drainage rock should be kept in the toe outlet area of the drains.
- Inspection pits which include flushing points should be installed at the head of the trench drains to allow maintenance of the pipes by the client.

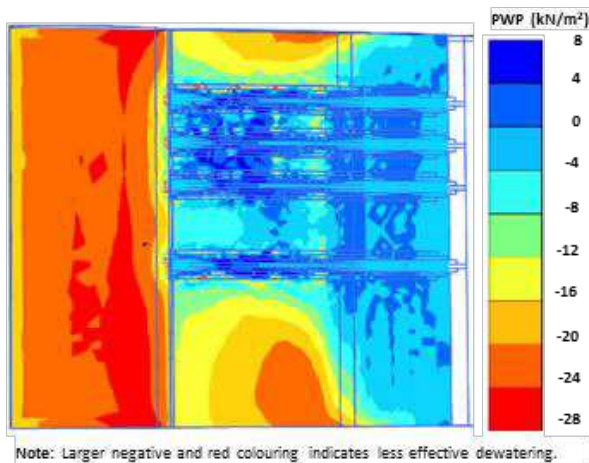
In addition to the 2D analysis, the results of the PLAXIS 3D model indicate that as the trench drains continue down slope, the effect of dewatering between the 10m and up to 20m spaced trench drains gradually draws the groundwater level to the toe of the drains. The effect of the dewatering occurs progressively

further downslope for a wider drain spacing, and that a spacing of ~10m is assessed to have relatively rapid dewatering capacity.

Figure 7: Impact of terraced trench drain spacing on PWP in PLAXIS 3D, in a Z-Z'-Z'' inclined plane. The darker shades of blue indicate lower to zero pressure indicating dewatering, where the orange to reds indicate excess PWP.
