## Settlements of an erection bay of the Mavčiče Dam founded on a backfill

**Pavel Žvanut**

*Slovenian National Building and Civil Engineering Institute, Ljubljana, Slovenia, pavel.zvanut@zag.si*

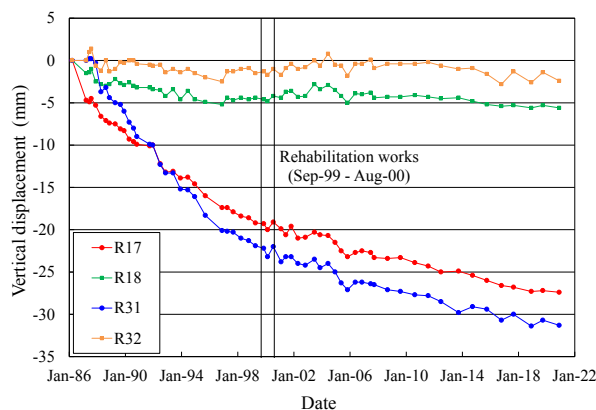
erection bay located at the top of the backfilled right part of the dam, where the results of geodetic measurements of vertical displacements showed a significant increase in settlements. As a result of these settlements, differential settlements with respect to the adjacent machine hall occurred. By 1999, i.e. over a period of 12 years, these differential settlements had increased to 22 mm (see Figure 5). These results were confirmed by measuring the relative displacements of expansion joint (marked by D6), located between the machine hall and the erection bay (see Figure 6) (Žvanut & Brinšek 2018).

Figure 5. Measured settlements next to the expansion joint between the machine hall and the erection bay.

Geodetic measurements of vertical displacements carried out since then have shown that the settlement rate of the erection bay has slowed down slightly (by November 2020, i.e. over the last 20 years, the settlements had increased by up to 9 mm, see Figure 5); however, from the point of view of the operation of the two crane rails the settlement process must be stopped.

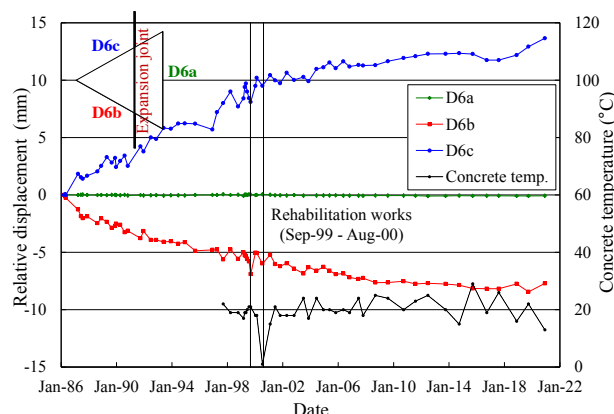
Figure 6. Relative displacement of the discussed expansion joint D6.

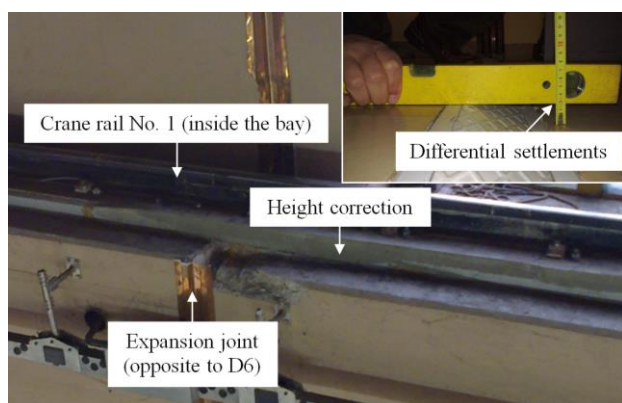
Due to the resulting differential settlements, the crane rail which is located along the crest of the dam, as well as the crane rail which connects the machine hall to the erection bay, became non-functional, and needed height corrections (see Figure 7). The results of geotechnical investigations, by drilling three investigation boreholes (one in the upper courtyard area and two in the erection bay area) in 1993, and additional six such boreholes (four drilled in the upper courtyard area and another two drilled in the lower courtyard area) in 1996, showed that the settlements were the consequence of the secondary consolidation of the backfill, and probably also of the scouring of fine material from the backfill.

Figure 7. Performed height corrections of the crane line No. 1, located inside the erection bay.

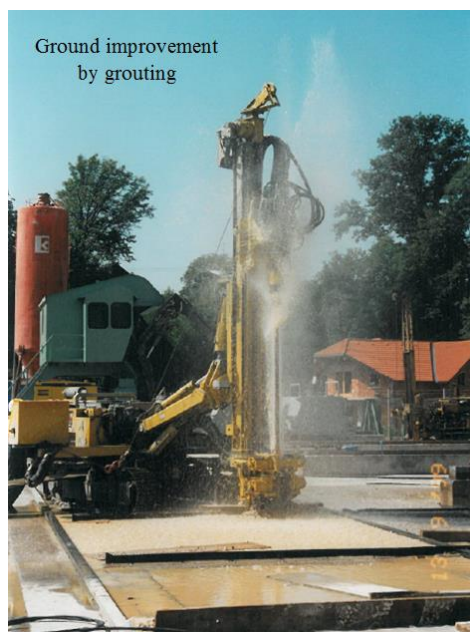
Figure 8. Performed rehabilitation works at the right part of the dam.

For this reason, between September 1999 and August 2000, rehabilitation works of the backfill and the substratum of the erection bay at the right part of the dam were carried out (see Figures 8 and 9) using grouted boreholes, which extended into a depth of 50 m below the ground surface or from 1 to 2 m into the impermeable base. The distance between the individual boreholes amounted to 1.25 m. The permeation grouting was carried out using a combination of water reactive polyurethane and a mixture of cement and bentonite (Isakovič et al. 2002).

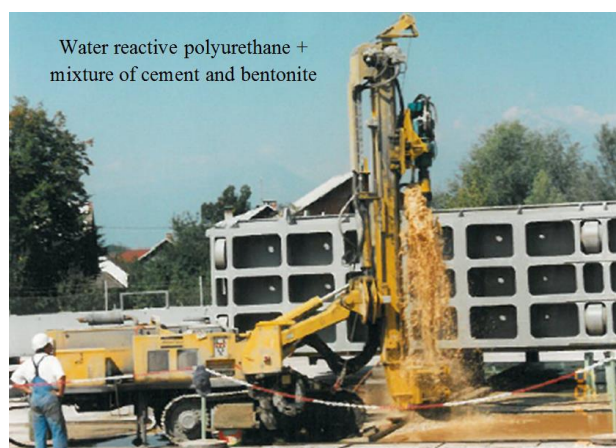
Figure 9. Performed rehabilitation works at the Mavčiče Dam.
