Case studies on the restoration and retrofitting of heritage churches and buildings in the Philippines

R. A. C. Luna, E. B. Abiad, J. C. E. L. Santos, E. P. Kasilag, R. C. C. Perez, M. G. L. Casuncad, M. P. V. Folloso, R. M. Garcia, F. J. T. Bernales, & J. V. D. Razon
AMH Philippines, Inc, Philippines, rodora.perez@amhphil.com

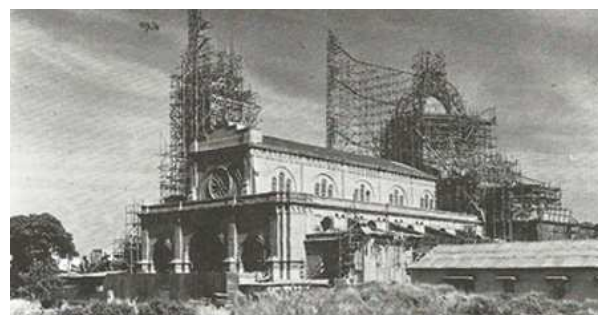
Figure 1. The ruins of Manila Cathedral after the WWII destruction in 1945. (Source: <http://manilacathedral.com.ph/>)

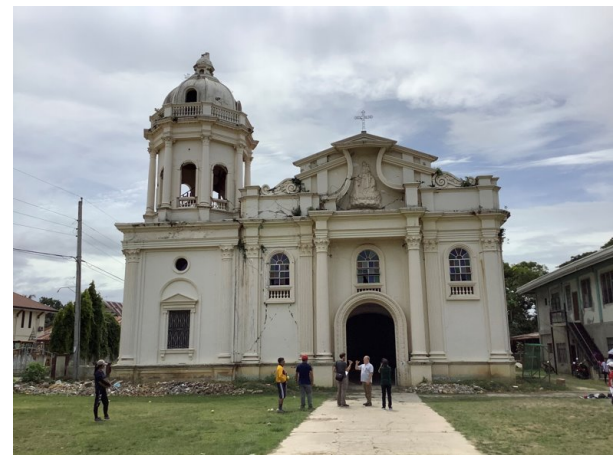
Unfortunately, a major earthquake occurred in Bohol in October 15, 2013 and critically damaged the church structure. Structural cracks, permanent displacement and localized collapse were observed all throughout the structure.

Figure 2. The façade of the Antequera Church showing structural damage after the major Bohol 2013 earthquake.
