## Desiccation control under a historical building founded over clayey soils: a case study

**Cesar S. Ramírez,** Luis Parra-Gómez, Carlos R. Reina-Leal & Julio E. Colmenares

**ABSTRACT:** A case study involving desiccation control for the stabilization of a structurally affected, 80-year-old historical building in Bogota is presented and discussed. The building houses the school of arts of the Universidad Nacional de Colombia. Due to its historical and architectural components, it was declared a heritage asset for the country. The two-storey structure is founded with square footings over an organic clay deposit. In 2016 the building suffered severe and sudden crackings after an extremely dry period caused by the 2015-2016 ENSO. Forensic engineering studies found that the damages were caused by the volumetric contraction of the foundation soil due to changes in the water content. The presence of trees near the building aggravated the effects of the desiccation process. Different engineering solutions to control further changes in the water content were considered. The transient flow problem was modelled and used to assess solutions by considering risks to neighbouring buildings an

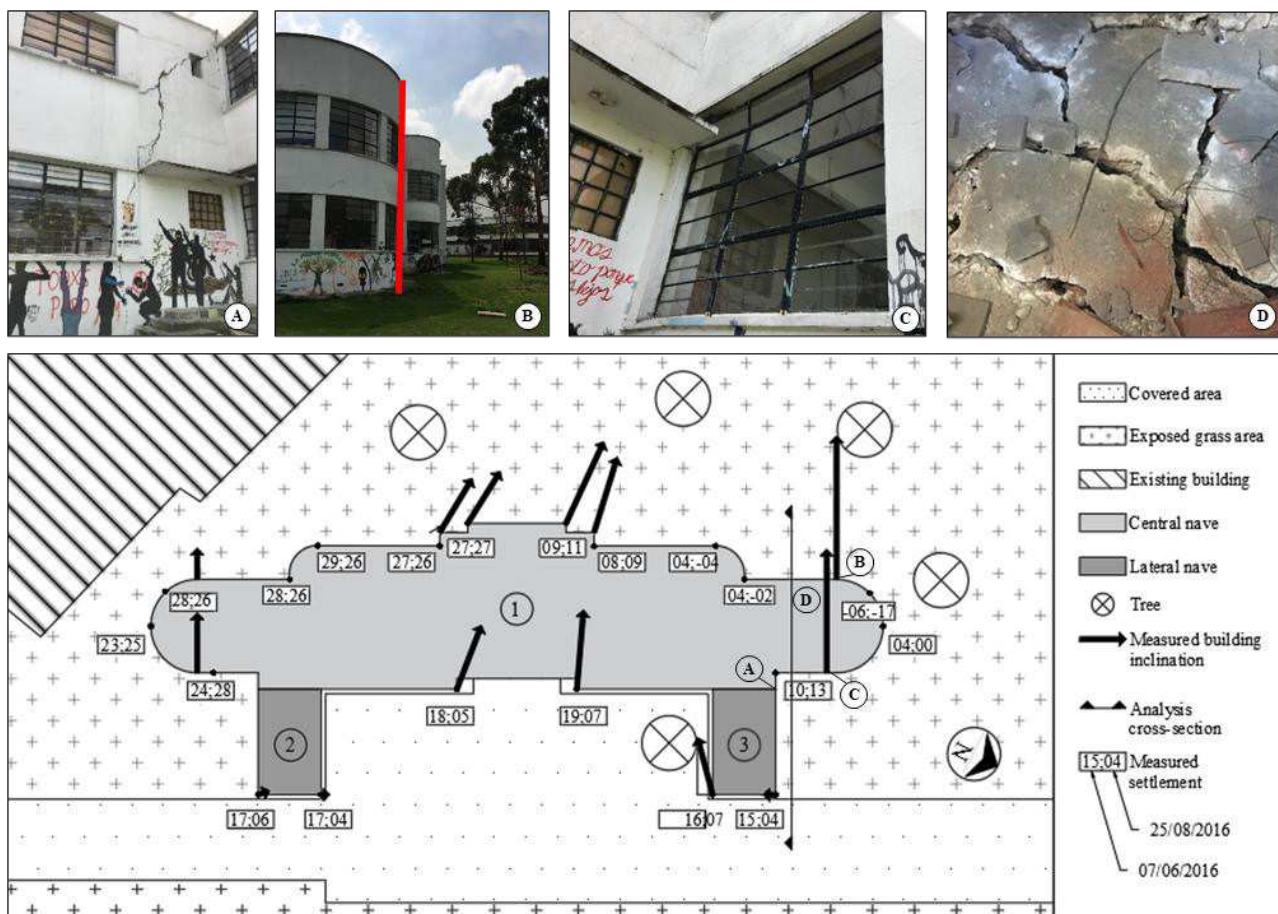
Figure 1. Schematic of the "Bellas Artes" building with topographic measurements, structural damages, and surrounding areas.

West. Fissures widened, and window frames began to bulge inwards and became visibly affected. Damages reached a critical point when a sudden and wide crack appeared in the architectural joint between the central and northern structures. The crack extended across both storeys and posed a severe risk of wall collapse to the building inhabitants (see Figure 1a).

With the appearance of the crack, the building moved considerably, and its inclination towards the north became evident (Figure 1b). Window frames on the ground floor were crushed (Figure 1c), and the activities inside the building had to be shut down until further notice. The closure of the building brought severe inconvenience to the university's art school, and the damages to the historical building caught the attention of the national press.

A plan to reinforce and recover the building was put into motion, and its activities began in early 2016. The building was evaluated from structural and geotechnical perspectives, while topographical surveys were carried out from February 2016 to August 2017. Building movements were tracked with respect to baseline levels measured in the first month. Inclinations measured showed that the building was moving as three individual structures, each of which followed different directions. The central and south ones had visible leanings towards the W, and the northernmost one moved towards the east. In all cases, movements occurred towards the neighbouring eucalyptus trees located in these directions. Successive surveys showed that movements continued, and the building responded to changes in its surroundings.

The trial pits showed that the soil under the floorboards of the building was severely desiccated. Tension cracks in the material were measured and found to be deeper towards the NW side of the building, in the area with higher movements (Figure 1d). Thus, the hypothesis that settlements had been caused by volumetric contraction of the soil under the footings was proposed. In August of 2016, a topographic survey indicated that the building had recovered part of its inclination after the advent of the rainy season and cutting eucalyptus trees. This evidence strengthened the volumetric change hypothesis.

Therefore, the clay volume change of the shallow soil profile caused by a loss in water content gave a coherent explanation to the observed structural damages and movements of the building. The sudden and severe cracking of the exterior walls could be explained as being caused by the desiccation event that followed the 2015-2016 ENSO period. The intensity of the desiccation process was different for each face of the building. The existing structures and pedestrian road protected the soil to the E and S, while the W and N fronts were exposed to high rates of water evaporation. With the low hydraulic conductivity of the material, pore pressures could not homogenize rapidly, and the effect resulted in a significant stress differential within the soil. Given that the clay is highly compressible, this gave rise to differential settlements.

The effects of suction were aggravated by three factors: (i) the presence of non-native arboreal species close to the building foundation causing a lowering of the water table levels, (ii) the existence of leakage from the hydraulic systems of the building that allowed to maintain a higher water table level around point (C) in Figure 1 and (iii) the lack of irrigation in surrounding areas. Considering those effects, the spatial occurrence of desiccation-induced suction matched the building movements and provided a logical explanation for the damages.

The building reinforcement proceeded with a plan to mitigate further movements by addressing future desiccation events and the identified aggravating factors. The eucalyptus trees around the building were removed, and the hydraulic systems were scheduled for reconstruction during the structural reinforcement.

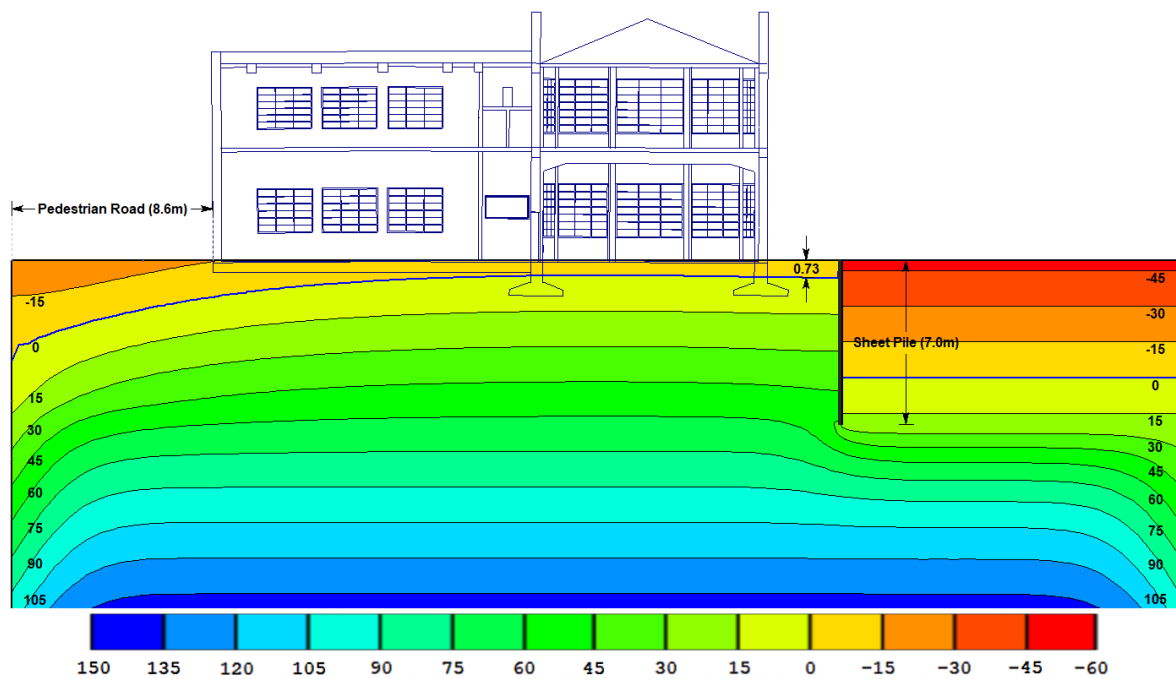
The compressibility properties of the soil profile were used to relate suction levels to settlement values. The water table descent had to be contained to less than 0.40 m after twelve months to keep future movements of the building under 2 cm. Solutions complying with these criteria included using a 7.0 m length sheet pile or covering an area distanced 15.0 m around the building. The selection of a final solution came down to the costs and installation requirements of both alternatives. The sheet pile solution offered the advantage of requiring intervention along a smaller area; however, the driving needed for the installation could cause vibrations and potentially affect the building and other surrounding structures. The surface impermeabilization did not require specialized machinery or processes but impacted a large area around the building and required the movement of a considerable volume of soil.

Figure 2. Pore pressure values obtained in the model for a 7.0 m sheet pile after 12 months of desiccation (values in kPa).

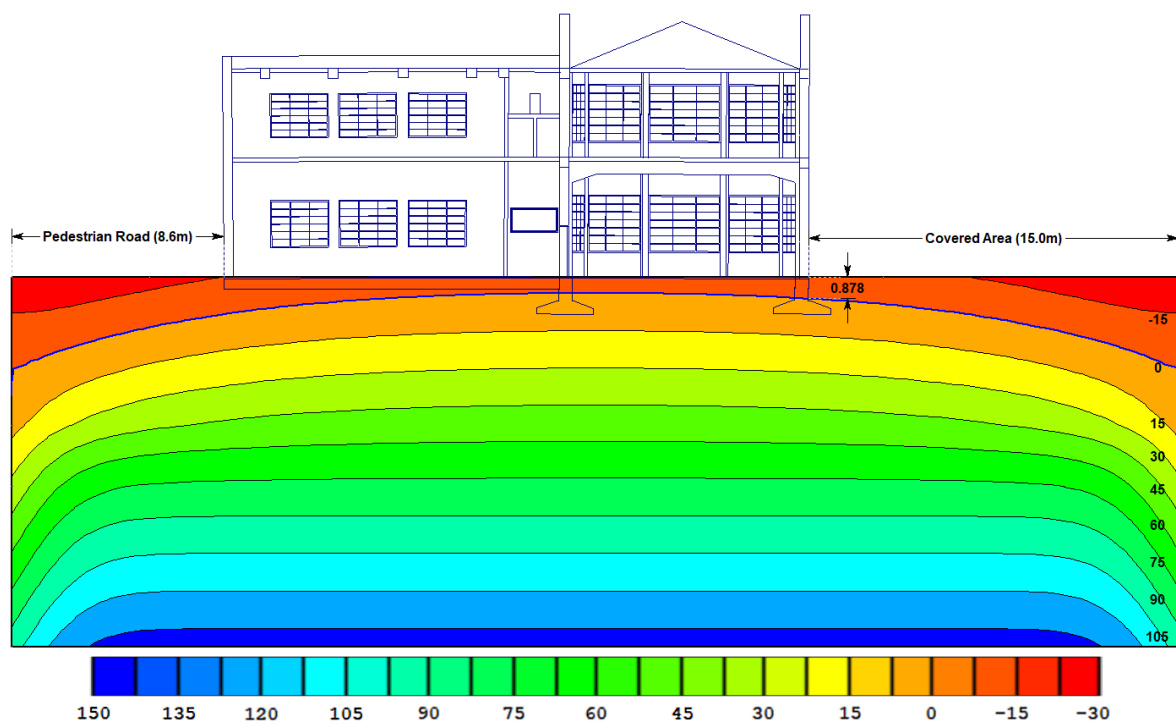
Figure 3. Pore pressure values obtained in the model for a covered area of 15.0 m after 12 months of desiccation (values in kPa).

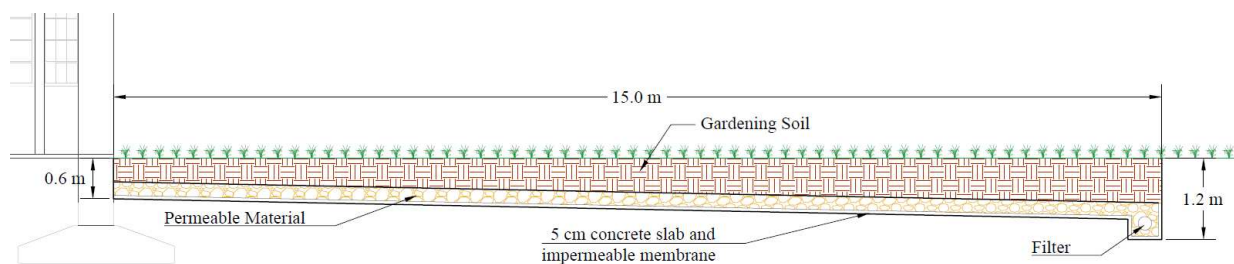
Figure 4. Schematic view of the impermeabilization adopted as the final solution.

The architecture team in charge of the renovation project proposed the development of areas for students on the NW side of the structure. Such construction meant that the impermeabilization alternative could be easily implemented under the new zones proposed, which amounted to significant economic and technical advantages. These advantages led to the selection of the 15 m impermeabilization as the optimal solution for the building. The administration of the university insisted on the conservation of green areas that are characteristic of the campus, and thus, the protection proposed had to allow for gardening arrangements. Figure 4 shows a scheme of the final solution adopted.

Evapotranspiration within the soil will be controlled using a 5 cm concrete slab placed over a 1.5 mm thick geomembrane. The system will be built underground to allow for the placement of low height vegetation. By doing so, water storage within the gardening soil is permitted, preventing rapid evacuation towards the sewerage. The concrete slab was designed with a 2 % inclination to allow for water drainage to go away from the building. The final solution is in line with soft engineering principles where the water is allowed to follow a cycle more similar to the naturally occurring infiltration.

The impermeabilization was accompanied by the construction of concrete beams connecting the footings of the foundation. Connecting beams were designed to be capable of managing moderate differential settlements without adverse effects for the architectural components. This ensured that the building would have adequate geotechnical behaviour in the years to come
