The paper was published in the proceedings of the 20th International Conference on Soil Mechanics and Geotechnical Engineering and was edited by Mizanur Rahman and Mark Jaksa. The conference was held from May 1st to May 5th 2022 in Sydney, Australia.

The failure of an earth retaining wall: investigation and assessment of the causes

Giuseppe Scarpelli, Paolo Ruggeri & Viviene M.E. Fruzzetti

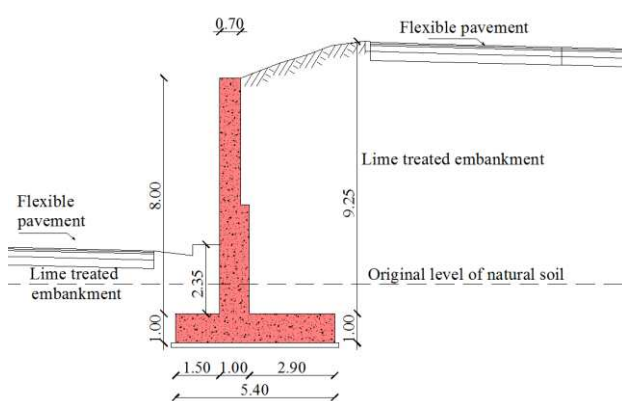
The wall retains a 9 m high embankment over the footing with the ground slightly sloping towards the top of the stem and is finished with 2 m of made ground over its base at the front.

Figure 1. Cross-section of the reinforced cantilever wall (segment of maximum height)

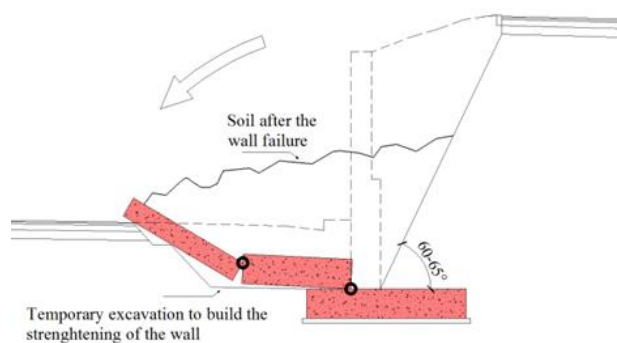
With the piles being completed, the removal of the ground above the slab initiated to allow the construction of the counterforts. It was during such excavation phase that the forward rotation of the stem accelerated ending with a full collapse by toppling; the collapse included the ground wedge which was retained by the wall as sketched in Figure 2. The impact of the stem on the ground as profiled for temporary excavation works together with the weight of the collapsed soil caused the failure of the stem at the weakest cross section, that is where thickness changes. Again fortunately, no one was injured in the event, thanks to the ductile mode of failure that occurred.

Figure 2. Scheme of the wall collapse

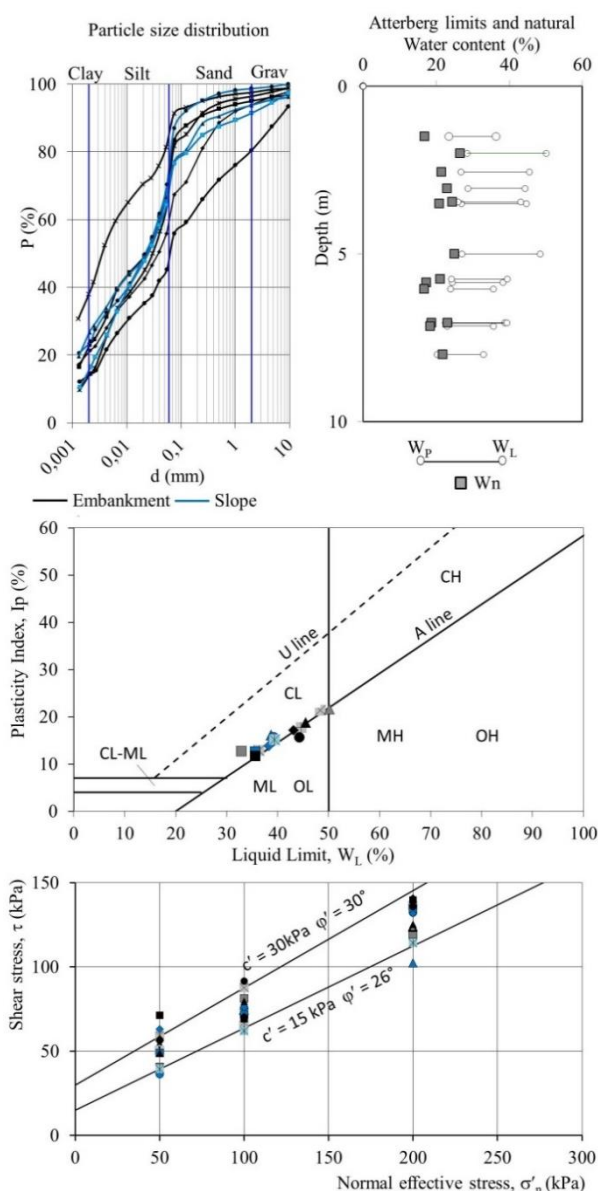
Figure 3 presents some results from laboratory testing on the backfill soil. The backfill soil resulted fine graded, made of 20% of clay, 50% of silt, 25% of sand and 5% of gravel. The grading indicates that most of the particles fall between coarse silt and fine sand, consistently with the effect of the lime treatment of the original soil. The soil resulted of low plasticity, with Atterberg limits falling along the A-line. The natural water content was almost constant with depth as typical for a layered embankment and lower than the Plasticity Limit, indicating a brittle soil state. The undrained shear strength c_u from pocket penetrometer sounding on the laboratory samples ranges between 100 and 300 kPa, in agreement with the range $c_u = 152 \pm 89$ kPa suggested by Haigh et al. (2012) for soil at plastic limit. Direct shear testing provides a range for peak effective cohesion c' and friction ϕ' by means of a lower failure envelope for which $c' = 15$ kPa and $\phi' = 26^\circ$ and an upper envelope for which $c' = 30$ kPa and $\phi' = 30^\circ$.

Figure 3. Laboratory test results on undisturbed samples of the embankment

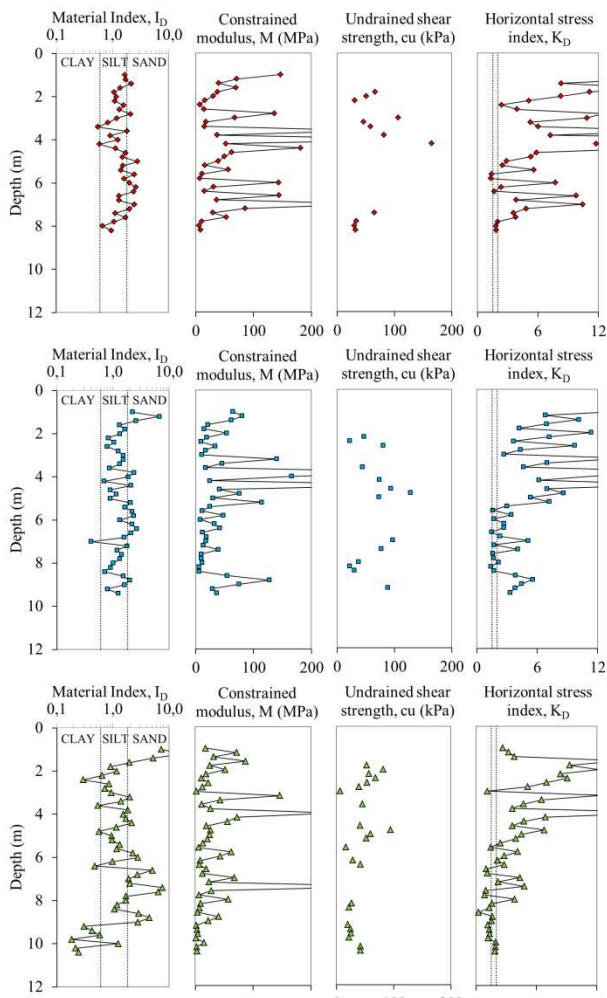
As shown in Figure 4, the first 6 m of the embankment present very high values of K_D . Having no relevant indication of cementation from laboratory samples and being the embankment manmade (i.e. no ageing), it is possible to infer that such high values of K_D are justified by heavily overconsolidation of the tested soils. Empirical correlations available in the literature allows to estimate the value of K_0 from K_D for natural soils; such correlations are not useful for lime-treated and roller compacted materials. However, former data indicate unequivocally that the horizontal stresses in the embankment are very high, well above those expected for NC deposit.

Figure 4. DMT results

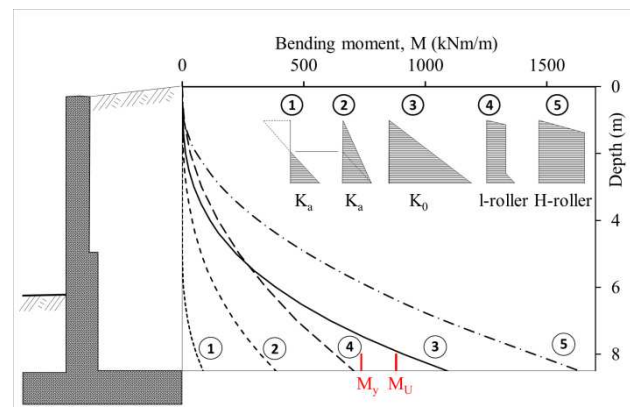
Figure 5. Assumed earth pressures and consequent bending moment distributions

The bending moment distributions shown in Figure 5 refer to a stem 1 m wide. The corresponding bending resistance of the stem at the base (M_U) is equal to 880 kNm/m and this value is also indicated in the figure. Note that this resistance was calculated by considering the measured values of the strength of materials, that is no safety factor was considered. Such value decreases to $M_y = 736$ kNm/m if the nominal and not the measured strength at yielding of the steel is considered.

The comparison between the bending moments at the stem base for the 5 earth pressure distributions and the structural resistance of the stem cross section allows to infer that the K_0 and H-roller moment distributions (diagram n.3 and n.5) cannot be sustained by the wall. In other words, actions from such lateral stress distributions would have been sufficient to determine the collapse of the wall since the construction of the backfill. On the contrary, the fact that the wall operated for several years before collapse, indicated that the initial earth pressure had to be consistent with the structural strength resources of the wall itself. Hence, earth pressure diagrams n.1, 2 and 4 fulfill this requirement. Taking into account the construction phases, the distribution 4 appears to be a good approximation for the soil pressures acting on the wall at the end of construction.

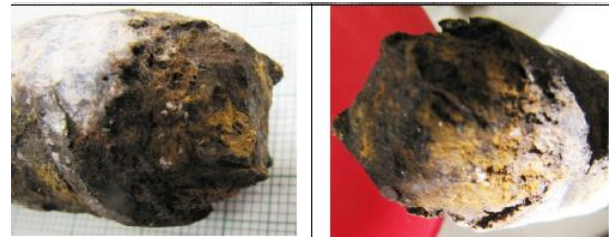
A second possible explanation resulted from the accurate analysis of the reinforcement bars in the zone of the joint between stem and foundation, exactly where they broke due to the tensile force. As shown in Figure 6, a close examination of the two sides of the broken bar, demonstrates that a severe localised corrosion occurred before failure. This phenomenon is made evident by the thick rust layer that determined a narrowing of the resistant area of the bar. Such loss in steel was relevant because it involves the entire surface of a “TempCore” reinforcement bar. This is because the “TempCore” treatment, very common for concrete rebars (see Noville, 2015), determines different properties of the

steel in the cross-section of the bar: a thin thickness of steel along the perimeter acquires very high strength, while the core of the bar remains mild. Therefore, the loss of the external area of the bar determines a more than proportional reduction of its total tensile strength.

Figure 6. Picture of the two sides of a steel bar ø20 picked up from the zone of failure between the stem base and the foundation of the collapsed wall (courtesy of Fratesi 2018)

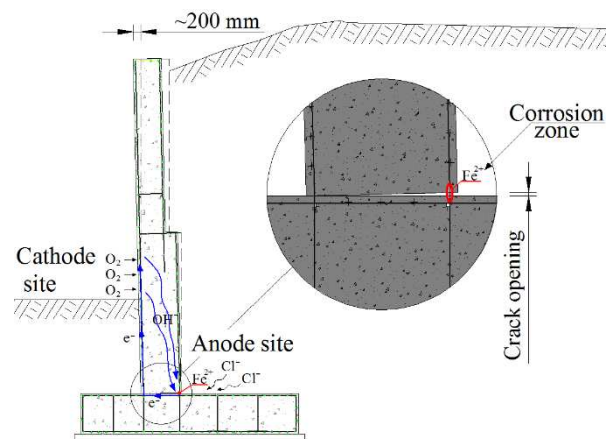
Some measurements demonstrated the existence of a “macrocell corrosion” between actively corroding areas of rebars and large passive areas of the wall. In Jaggi et al. (2001) is possible to find detail of this dangerous phenomenon. In summary, rebars in concrete structures, thanks to the high pH environment that take place in concrete, are generally protected by the spontaneous formation of a thin protective oxide film (passive film). Besides, all the bars in a concrete structure result electrically connected. If a little portion of the rebars network loses its protection it is likely that the exposed area of steel will suffer a heavy corrosion process. This happens because there is a little area where the corrosion is able to operate (local anode) and a large area of steels where oxygen is reduced to hydroxyl ion (large cathode). Anode and cathode form a short circuited corrosion cell, with the flow of electrons in the steel and of ions in the pore solution of the concrete. This process is schematically represented in Figure 7.

Measurements of the corrosion potentials of the anode and cathode supported the existence of this process in the considered case study. Therefore, the delayed failure of the wall can be explained by the time required to corrosion to proceed so much to reduce the rebars cross section enough to produce their tensile failure.

Figure 7. Simplified scheme of the “macrocell corrosion” activated on the analysed wall
