Assessment of soil cracking mechanism in the south-east area of Mexico City based on deep geotechnical exploration

Gabriel Auvinet-Guichard, Moisés Juárez-Camarena, Edgar Méndez-Sánchez, Francisco Hernández-Vizcarra, Sergio A. Martínez-Galván, Marco A. Pérez-Ángeles & Jesús Sánchez-Guzmán
Geotechnics, Instituto de Ingeniería, UNAM, Mexico, gauvinetg@iingen.unam.mx

ABSTRACT: This paper presents an interpretation of the results of a deep geotechnical exploration campaign carried out at several sites, in the south-east area of Mexico City. The purpose was to identify the mechanism of generation of the cracks in the soil that have affected this area during the last decades. The stratigraphic characteristics and the subsoil properties correspond to an abrupt transition zone between lacustrine soft clays and firm soils or volcanic rocks found in this area of Mexico City. Cracks can thus be attributed to the uneven consolidation of the lacustrine clays affected by drawdown of pore pressure due to deep pumping of water in local aquifers. Some remedial and mitigation measures that have been implemented in the area are presented.

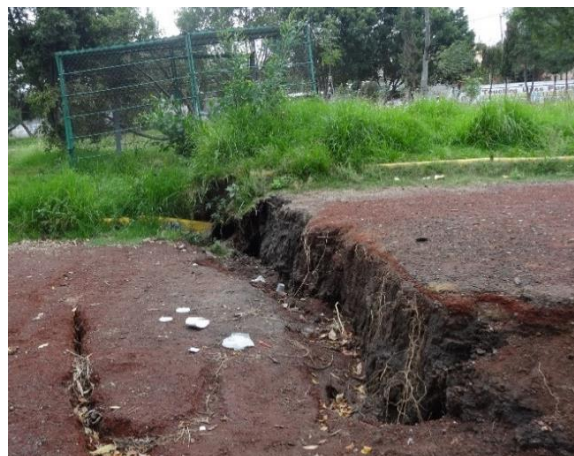
It has also been observed that earthquakes can modify the geometry of existing cracks and generate additional discontinuities. The cracking of the soil observed in the periphery of *Santa Catarina* range, attracted the attention of the media after the earthquake of September 19, 2017. It was necessary to clarify that most of the cracks existed previously to the earthquake and that they had only undergone geometric changes (opening, increase of escarpment), some of them significant (Figure 1) during this event.

Figure 1. Activation of a pre-existing crack during the earthquake of September 19, 2017 (Deportivo Cananea, Alcaldía Iztapalapa).

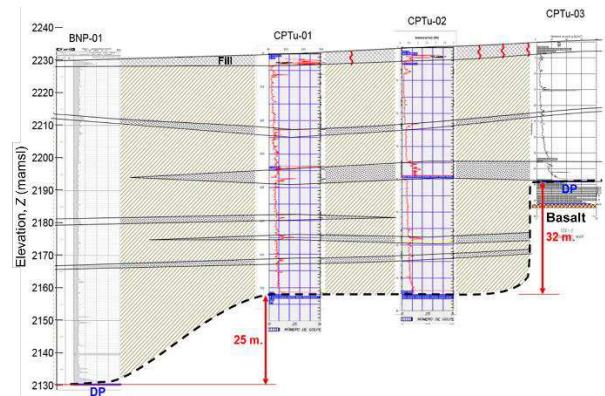
In Figure 5, a cross section of the subsoil at this site is presented. A difference of approximately 25m in clay thickness can be observed between the deep level benchmark (BNP) and boring SM-01. The thickness of clay increases towards the southwest. Likewise, the clay thickness between wells SM-01 and SM-02 is approximately constant but between borings SM-02 and SM-03 a difference of 32m is observed due to the presence of a buried basaltic flow.

Figure 5. Cross section of the subsoil, *Colonia Del Mar* site.

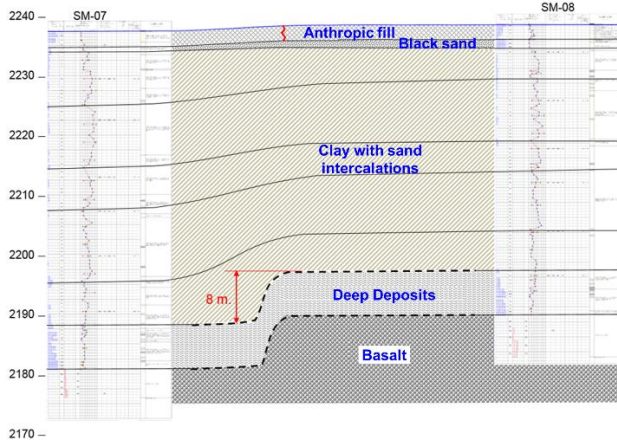
thick. The thickness of the main clay layer, with interbedded sand lenses, is 48 m for SM-07 and 40 m for SM-08. The deep deposits and basalt flows were found at a depth of 56.5 m in SM-07 and 48.7 m in SM-08, a difference of approximately 8 m.

Figure 13. Cross section of the subsoil, Colonia La Planta site.

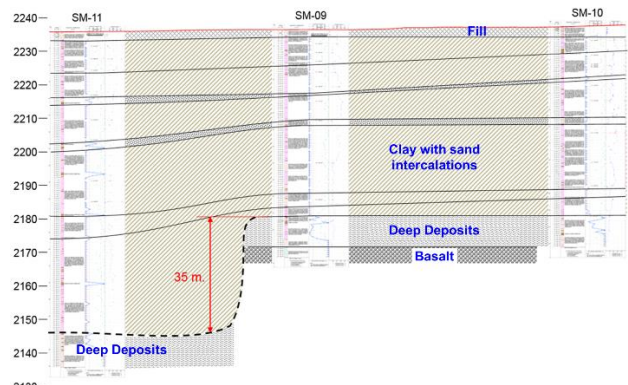
Figure 15 shows a cross-section of the subsoil. Below a predominantly silty sand-type fill of variable thickness (up to 2.5 m), a layer of fine black sand with a thickness of 1.0 to 2.0 m is found. Under this sand layer, there is a layer of clay, with interbedded sand lenses, with a thickness of approximately 56.0 m (SM-09 and SM-10) and 90 m (SM-11). The deep deposits and basalt are found at an approximate depth of 63.0m in the SM-09 and SM-10 borings, and 95.0 m in the SM.11 boring. Basalt was found only in boring SM-09 at a depth of 65.0 m. It is observed that between the SM-09 and SM-11 borings the step in the resistant materials is of the order of 35 m.

Figure 15. Cross section of the subsoil, Colonia El Molino Tezonco site.

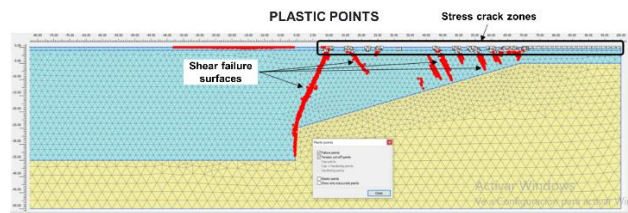
The results of the deep geotechnical exploration presented confirmed that the main cause of the soil cracking in the area is the abrupt variation of the thickness of the lacustrine clay in the transition between the lacustrine zone and firm materials such those surrounding the Santa Catarina range. The consolidation process of the clay under these geometric conditions leads to pronounced differential settlements and to the generation of tensile and shear stresses in the soil and to cracking. This mechanism can be reproduced by finite element analysis (Figure 16) and corresponds to the mechanism defined as Type II by Auvinet *et al.* (2017, p. 108 and Figure F.25).

Figure 16. Numerical modeling of the consolidation of a clayey layer of variable thickness.

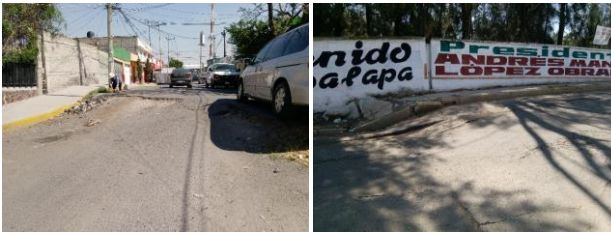
Many streets in Mexico City are affected by soil cracking. The presence of steps makes it difficult for vehicles to transit and some the streets must be closed to traffic (Figure 17).

Figure 17. Examples of crack with step on streets in Iztapalapa municipality.

A mitigation measure called "angular strain dissipative trench" (Auvinet *et al.*, 2019) has been proposed and implemented on more than 1000 cracks. This trapezoidal trench is excavated on the trace of the crack and filled with a clean sand that cannot transmit tensile stresses. In case of evolution of the crack step, the sand dissipates the angular strains induced within the superficial soil, avoiding direct damage to the pavement.

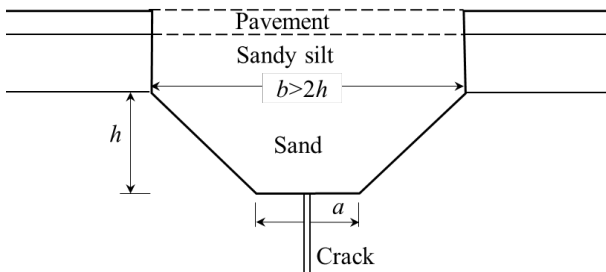
Figure 18. Geometry of dissipative trench.

The geometry of the dissipative trenches must be adapted to the different conditions found on the site (Figure 18). The depth, h , of the granular fill must be chosen to keep the slope of the surface below the maximum allowable value for an acceptable time. The design was based on parametric studies performed using a model based on the discrete element method.

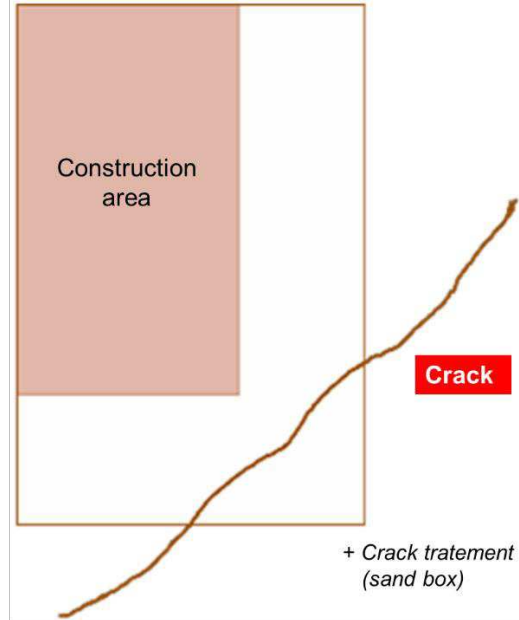
Figure 19. Adaptation of architectural design to the presence of a crack.

The construction of buildings on soil affected by cracks requires special attention. In the case of cracks with a step larger than 10cm, it should not be considered as acceptable to build over the crack. The project must then be adapted (Figure 19). If the above is not possible, it should be considered that the land is not suitable for construction.

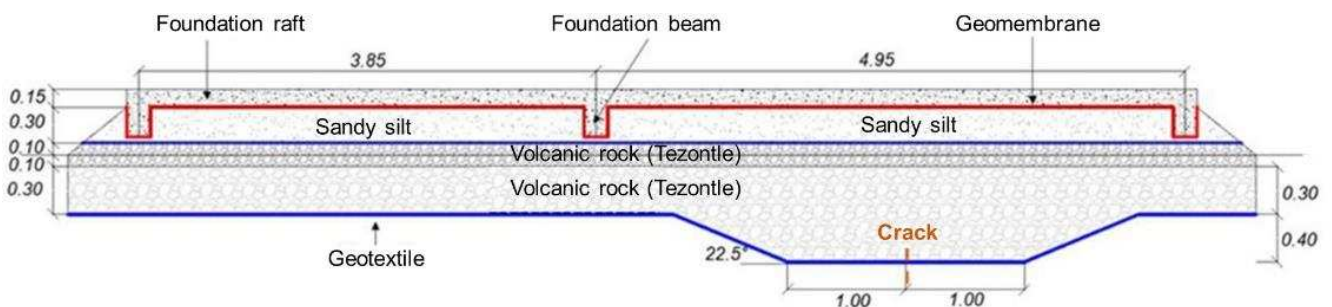
Figure 21. Foundation design for subsoil with cracking.

In the case of cracks with a step of less than 10 cm, it can still be considered acceptable to build over the crack provided that a trench of granular material is placed on the trace of the crack as shown in Figure 21.

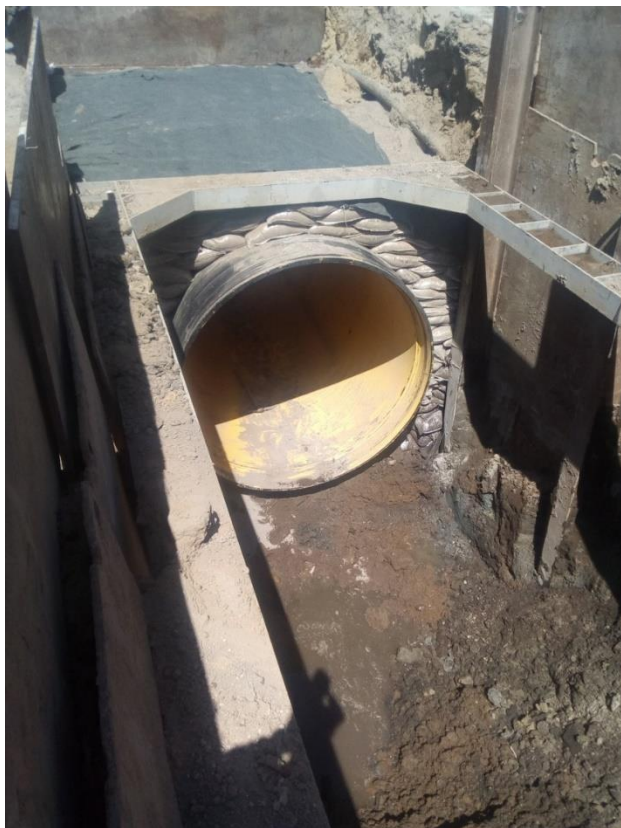
Figure 22. Protection of culvert in area affected by soil cracks.

A similar strategy has been adopted to protect public services such as potable water or drainage utilities. Pipes and culverts are protected by sand in order to avoid direct interference with the cracks (Figure 22).
