# Monitoring of slopes, rock faces and masonry walls in a 19<sup>th</sup> century public park: the example of the Buttes Chaumont Park (Paris, France).

**Marc Peruzzetto, Isabelle Halfon, Clara Levy, Florian Masson, Aurore Ramage, Gildas Noury, Ribes David**  
*BRGM, Orléans, France, [m.peruzzetto@brgm.fr](mailto:m.peruzzetto@brgm.fr)*

**ABSTRACT:** Developed on former gypsum quarries, the Buttes Chaumont Park is a 25-hectare geotechnical complex that is unique in the world. After three years of heavy work to create, in particular, an artificial cave, a lake and an island, the park opened in 1867 and has suffered gravitational hazards ever since (landslides, rockfalls and sinkholes). The BRGM has worked with the Paris City Council since 2021 to characterize the geological and geotechnical context, identify major gravitational hazards, and monitor the evolution of instabilities in slopes and rock/masonry walls. In this context, the BRGM has proposed, defined and followed a geotechnical supervision scheme including four levels of monitoring: detailed quarterly site visits since March 2023, bimonthly tacheometric surveys (operating since December 2022), monthly manual gauges measure

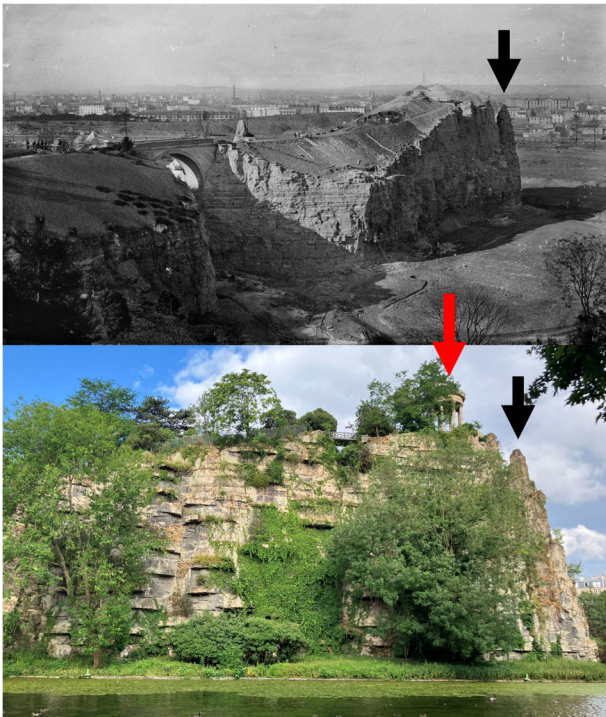
and southern sides are more complex: to create a vertical and higher rockface (up to 20 m), the gypsum is recut and overtopped by retaining walls supporting the marls and backfills. The whole face is then recovered by a millstone cladding (Figure 1). Finally, a fully artificial cavern and a waterfall are created near the southern shore of the lake in a recess of the quarry face.

Figure 1. Picture of the eastern side of the island during construction works around 1865 (top) and in 2025 (bottom). The black arrows locate an artificial peak on both images. The red arrow locates the Temple of Sybil.

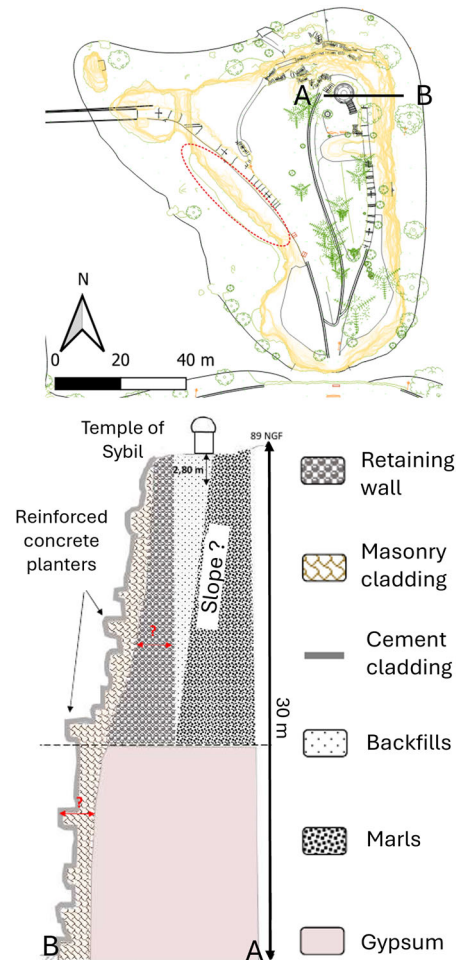
The quarry irregular topography led to designing a scenery that mimicked the Romantic vision of nature of the second half of the 19<sup>th</sup> century. The works initiated in 1864 involved significant earthworks (about 410,000 m<sup>3</sup>) and backfilling (about 520,000 m<sup>3</sup>, particularly around the island to create an artificial 2.2 ha lake (Figure 1 and Figure 2). The island has been remodeled from a mass that hadn't been quarried, with the succession (from top to bottom) of a gypsum mass (GM1), clays (GC), marls (SGM) and fills (Figure 2). The gypsum is apparent on the western and southern sides of the island. The northern

Figure 2. Top: Topographic map of the island. The red ellipse locates topographic targets from Figure 5. Bottom: Cross-section of the island eastern wall with main geological / geotechnical units (section A-B on map). The Temple of Sybil is shown in Figure 1.

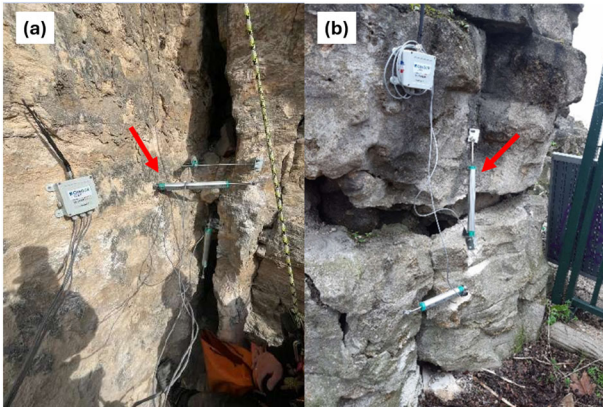
Figure 3. Example of electronic extensometers installed on a 30 cm vertical crack in the gypsum on the western side of the island (*fissure 1*, a), and on a 15 cm horizontal crack in masonry walls below the Temple of Sybil (*fissure 2*, b). The red arrow points at the extensometers analyzed in this work.

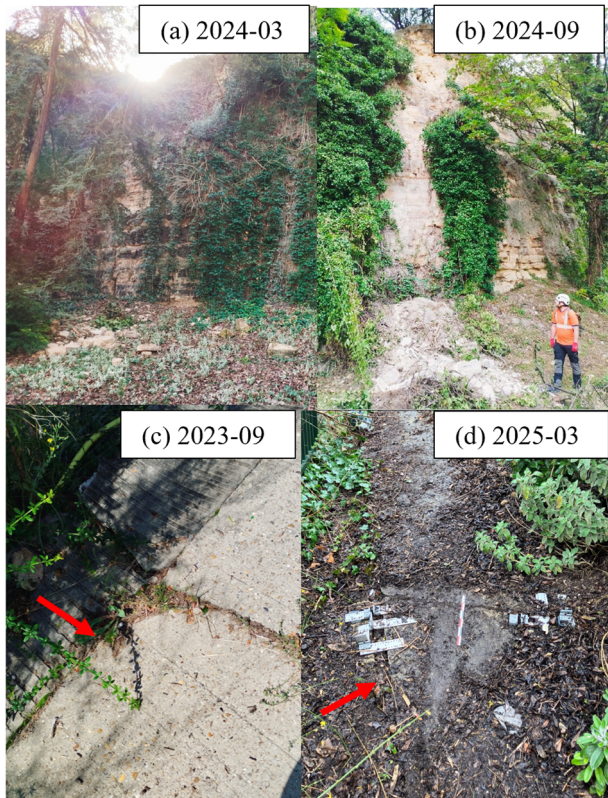
Figure 4. Observations during field visits. Top: examples of rockfalls. Bottom: Pathway photographed in September 2023 and March 2025, showing crack evolution (between pathway and gutter, red arrows) and manual gauges installed in 2024 (bottom right)

Quarterly visits include an overview of the whole park but focus on the island sector. 10 visits were carried out between March 2023 and June 2025. Regular rockfalls from the gypsum rock faces have been identified, most of them involving blocks of about 1 liter. However, at least 4 more important rockfalls (between 0.5 and 1m<sup>3</sup>) also occurred, initiated from the top of the gypsum rock faces where roots development and associated meteoric water circulations favor the development of cracks (Figure 4a and b).

The movements of a shallow landslide on the island were also monitored (Figure 4c and d). Located in marls and probably associated with the ageing of historical geotechnical structures, its initiation date is not known. However, the BRGM witnessed its reactivation starting between September and December 2023, as evidenced by growing gaps between an inclined pathway and adjacent rainwater drainage channels.

- recommended to establish a 10 m security perimeter above the gypsum rock face, following the rockfalls that occurred between December 2023 and March 2024;
- identified cracks to be instrumented with manual gauges or electronic extensometers, at the beginning of the instrumentation and later on to complement it following observed evolutions;
- noted some structural disorders in other ageing structures (e.g. retaining walls) in the park that do not require immediate repairs but that are worth characterizing by future, more detailed, geotechnical diagnostics.

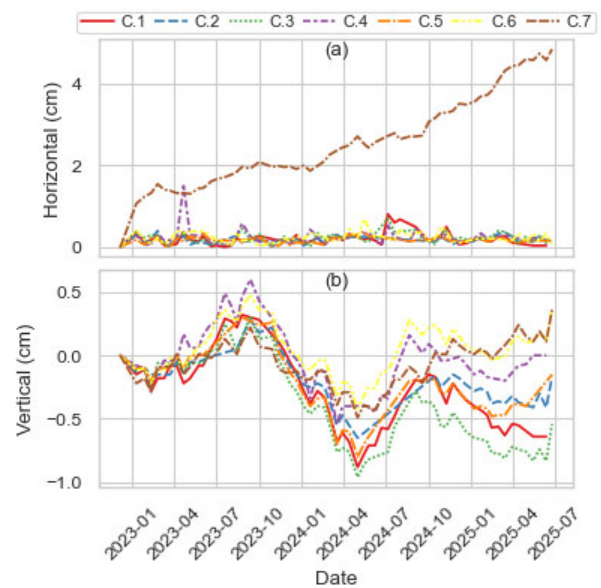
Figure 5. Horizontal (a) and vertical (b) displacements measured with tacheometric surveys since 2023 on 7 targets (C.1 to C.7) on the western side of the island (red ellipse in Figure 2).

The topographic surveys carried out since December 2022 aim at detecting (1) detachments of individual compartments already partly detached from the masonry walls and/or rock faces and (2) generalized movements at the scale of the rock faces/ masonry walls. The expected precision, as given by the surveyor, is of about 1 mm. In practice, displacements of up to 0.5 – 1 cm were observed both horizontally and vertically, without being necessarily associated to clear trends. Only one target, located on purpose on a ~1 liter gypsum block partially detached from the rock face, showed a clear and homogenous horizontal movement away from the rock face (totalizing about 2.5 cm between January 2023 and June 2025, Figure 5a). This steady displacement accelerated in October 2024, from an average ~1 to 2 mm/month. There is, however, no sign of imminent rupture. Besides, no significant vertical displacement is measured.

No clear trend is observed on other targets (individually or as a group). Homogeneous displacements on nearby targets were sometimes observed during several weeks / months but were then followed by displacements in the opposite direction. The only homogeneous behavior observed on almost all targets

was vertical displacements, with upward movement from April to October, and downwards movements from October to April (Figure 5b). The amplitude of these movements varies between the targets and the period. For instance, on the western side of the island, targets moved about 5 mm upwards in April – October 2023 and 7 mm in April – October 2024, and 1 cm downwards in October 2023 – April 2024 and only 2.5 mm in October 2024 – April 2025. In the same period, on the eastern side of the island, up to 7 mm of downward displacement was measured. Over the 60 targets and 2.5 years, a global trend of downward movement seems to emerge (on average 0.5 to 1 mm since January 2023).

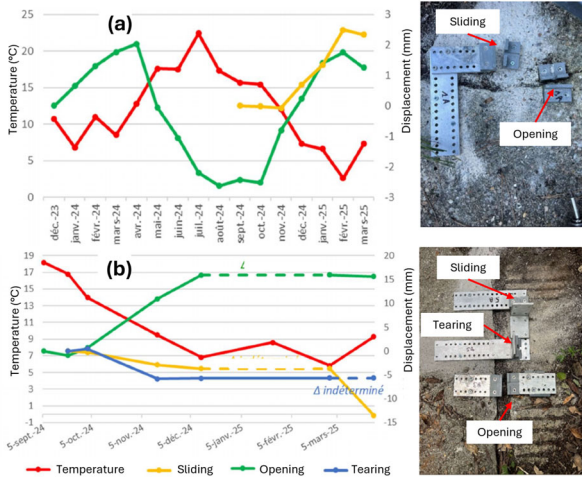
Figure 6. Manual gauges measurements on two cracks located on pathways on the island, along with ambient temperature measurements. Dashed lines on the bottom subfigure correspond to measurement gaps for which the displacements are not known. The bottom graph corresponds to the gauges in Figure 4d.

Manual measurements carried out on specific instrumented fissures provide more precise measurements of opening, sliding and tearing. Measurements are carried out on wedges fixed on both sides of the cracks with a digital fissure gauge, with an announced precision of 0.01 mm and a measurement range of 27 mm. Apart from a few seemingly aberrant measurements (i.e. significantly different of the mean of previous and following measurements), measurements are relatively stable which facilitates interpretation. The most significant displacements are measured on pathways, with opening/closing amplitudes of 3 to 4 mm (Figure 6a). Gauges installed on masonry walls display displacement of less than 1 mm. These variations are associated to clear seasonal trends, with cracks opening during autumn/winter, and closing during spring/summer. The only place where clear, non-seasonal, displacement trends are observed is on the path going through the shallow landslide mentioned in section 4.1, with crack opening of more than 1.5 cm and exceeding the gauges measurement range (Figure 6b).

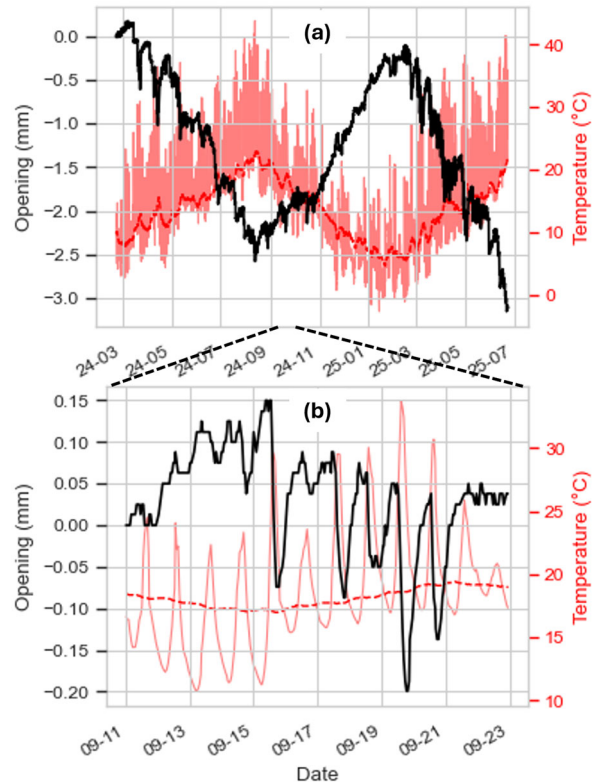
This is clearly visible in the short-term with day/night temperature variations for *fissure 1* (Figure 7b). Associated opening/closing cycles are all the more important as temperature differences are significant (Figure 8a). The correlation is less clear with temperature measured at depth (Figure 8b), suggesting these processes are related to surface mechanisms. The most important daily opening/closing amplitudes are mostly associated with sunny days (Figure 8c) with little rain (Figure 8c). Interestingly, these daily cycles are clearly visible when the cracks are closing in the medium term but are less visible when the crack is opening.

Figure 7. Automatic extensometer measurements at fissure 1 (Figure 3a). Black: opening time series. Light red curve: temperature of the extensometer digitizer. Dashed red curve: Temperature at 50 cm depth. Top: Times series between March 2024 and June 2025 (date format is year-month). Bottom: time series between 9 and 23 September 2024 (date format is month-day).

The correlation between temperature and crack opening is also clear in the medium-term with cracks closing in spring/summer and opening during autumn/winter (Figure 7a). For *fissure 1*, a simple linear relation can be derived between the opening/closing of the crack, and the temperature at 50 cm depth within the rock face (Figure 9a). The crack closing/opening rate is  $\sim 0.2$  mm/°C, but deviations around this trend lead to an irreversible behavior: the crack closed by about 0.5 mm between the summers of 2024 and 2025. As for daily cycles, significant precipitations seem to reduce the closing/opening velocity (Figure 9b), but no clear relation can be drawn.

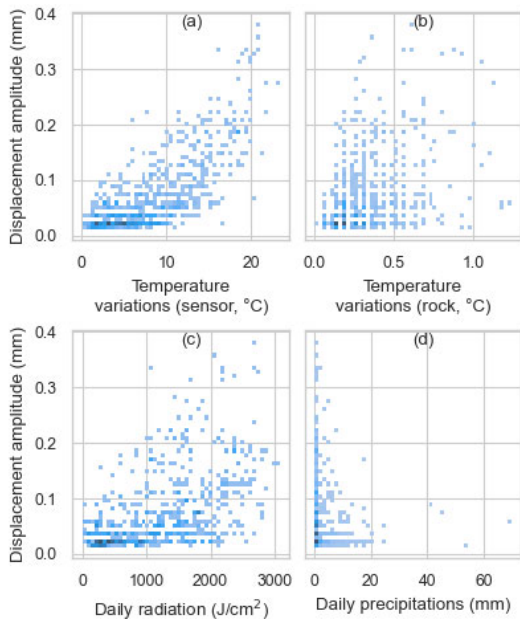
Figure 8. Normalized distribution of daily opening/closing amplitude at fissure 1 (Figure 3a) and daily temperature variations of the sensor (a), at 50 cm depth (b), daily radiation (c) and daily precipitations (d) at the Luxembourg park meteorological station (Météo-France, 2025).

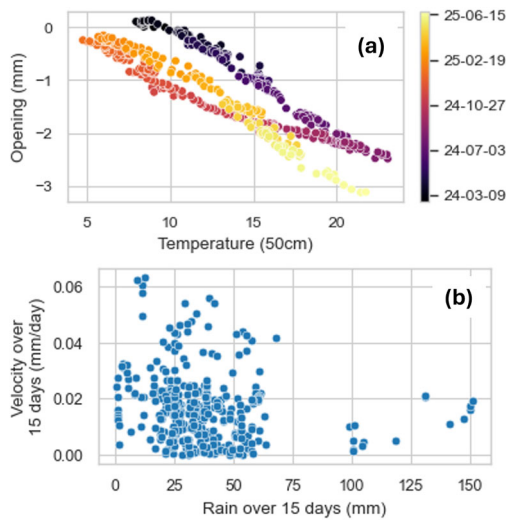
Figure 9. Analysis of displacements at fissure 1 between March 2024 and June 2025 (Figure 3a). (a) Mean daily opening (y-axis) vs mean daily temperature (y-axis) measured at 50 cm depth (date format is year-month-day in the colorbar). (b) Velocity computed over a 15 days time window (y-axis) vs precipitations over the previous 15 days at the Luxembourg park meteorological station (Météo-France, 2025).

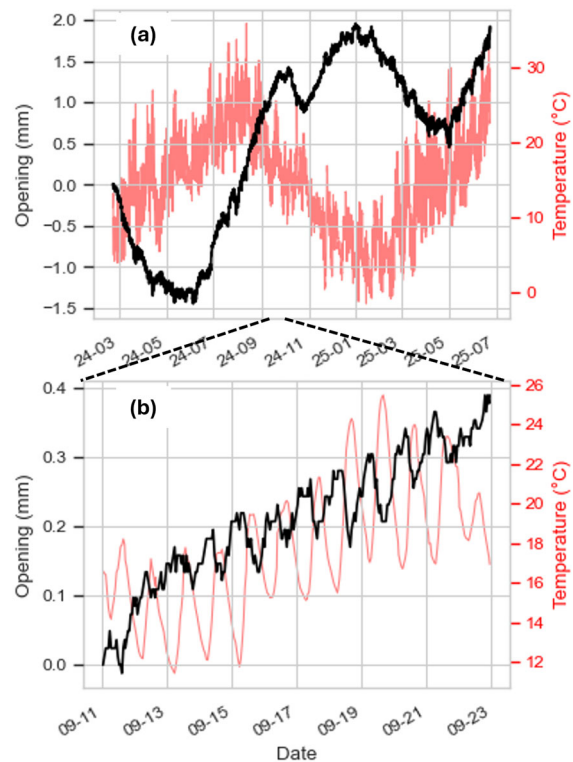
Daily opening/closing cycles are also visible at *fissure 2* and the autumn/winter period is also associated with crack opening (Figure 10). However, contrary to *fissure 1*, the opening phase started in June 2024 and May 2025 while

temperatures were still increasing. In turn, the fissure seems to follow a pluri-annual opening trend (about 2 mm between May 2024 and May 2025). Nonetheless, at least another full annual cycle is required to confirm this trend.

Figure 10. Automatic extensometer measurements at fissure 2 (Figure 3b). Displacement time series are given in black. The light red curve is the temperature recorded by the extensometer digitizer. Top: Times series between March 2024 and June 2025 (date format is year-month). Bottom: time series between 9 and 23 September 2024 (date format is month-day).
