# Post-Cyclone Jasper remediation of landslide-impacted linear transport infrastructure in Far North Queensland

**Ali Rukh, Joseph Parisi**

*Earth and Environment, WSP, Brisbane, Australia, [ali.rukh@wsp.com](mailto:ali.rukh@wsp.com)*

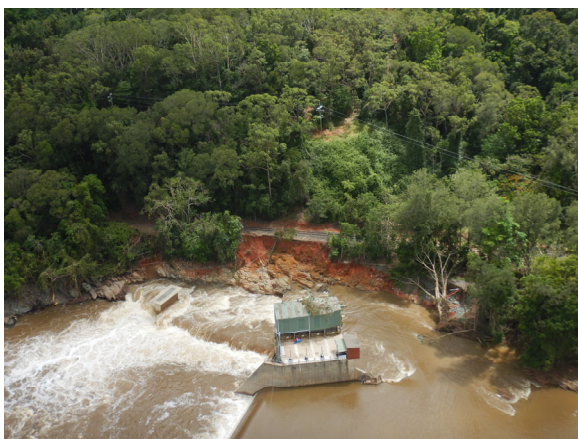
An initial geotechnical inspection of the Site was undertaken by helicopter on 20 December 2023, shortly after TC Jasper, to assess damage along the entire infrastructure alignment. Figure 2 provides an aerial overview and closeup of the affected section of the riverbank and embankment. Elevated river water levels resulted in catastrophic damage to an adjacent weir structure and extensive scouring of the riverbank and embankment resulting in the exposure of a relic concrete retaining structure understood to be constructed in the 1950s.

Figure 2. Aerial photo of the affected site (taken from a helicopter).

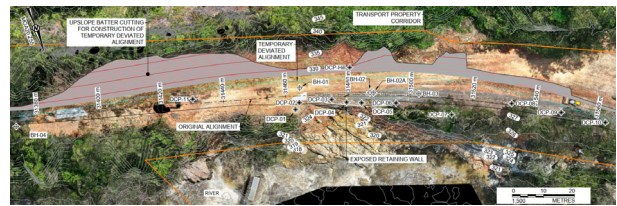
A targeted intrusive site investigation was subsequently completed to inform detailed design. The investigation consisted of three (3) geotechnical boreholes within the corridor drilled to depths between 3.0 m to 15.0 m below ground level (BGL) and twelve (12) dynamic cone penetration (DCP) tests to depths between 0.5 m to 2.9 m BGL, as illustrated in Figure 3. Standard Penetration Tests (SPT) were conducted within the soil strata to obtain *in-situ* soil strength parameters of subsoil materials. Table 1 outlines the typical material description of the major sub-surface material units encountered.

Figure 3. Intrusive site investigation plan for the Site.

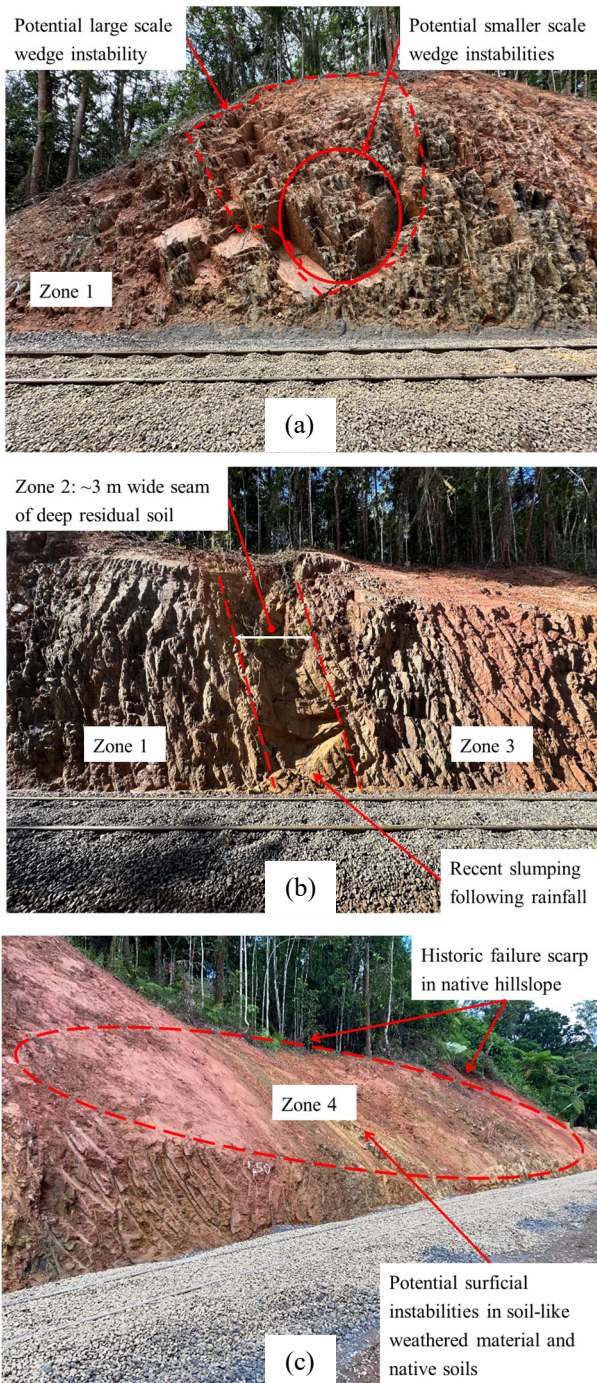
The results of the SRA for each zone are summarised in Table 2 and illustrated in Figure 6. In addition to the risk mitigation measures implemented for the downslope embankment, the following interim measures were applied to the upslope cutting; (i) scaling of loose/ partly embedded rock blocks within the cutting (ii) installation of crack monitoring gauges spanning key rock mass discontinuities; (iii) a camera to record activity on the excavated face; (iv) an automated continuous laser scanner system capturing critical zones, Zone 1 and Zone 3 with 30 minutes alert response time.

No.	Slope description	Potential failure mechanism	Risk rating
Zone 1	Up to 12 m high at 80° formed in a blocky weathered rock mass with sub-vertical joints and prominent basal plane dipping at 35° to 40°, abundant soil infilled and iron-stained defects and tree roots.	"Structurally controlled" "wedge" failure sliding along a basal plane, ~10 m W, 10 m H, 1 – 5 m D, estimated failure volume of 100 to 150 m <sup>3</sup> with individual blocks up to 1 m.	(B+) Undesirable (High) <b>Critical</b>
Zone 2	Up to ~10 m high at 70° formed in residual soil consisting of pale brown clayey sand/ sandy clay.	Localised surficial instabilities (erosion/ slumping) estimated failure volume <10 m <sup>3</sup> mainly soil with isolated blocks up to 0.4 m in size.	(B-, P1) Undesirable (High) <b>Critical</b>
Zone 3	Up to 12 m high at ~80°, locally flattening to ~50° at the upper slope, formed in variable weathered rock with closely spaced sub-vertical joints.	Localised block detachments up to 0.4 m in size and potential surficial instabilities within the overlying soil mantle.	(B-, P1) Undesirable (High) <b>Critical</b>

Zone 4	Up to 7 m high at ~45° formed mostly in soil with XW material across the lower slope.	Erosion and potential rotational slides within the range of 20 to 30 m <sup>3</sup>	(B-, P1) Undesirable (High) <b>Critical</b>

Figure 6. Key zones identified across the excavated upslope cutting: (a) Zone 1 shows potential large-scale wedge instability, (b) Zone 2 shows deep-soil seam, and Zone 3 shows potential isolated block detachment, (c) Zone 4 shows potential surficial instability.

The design was optimized along the length of the cutting to reflect site conditions. Zone 1, 3 and 4 of the upslope area consisted of 6 m long passive dowels (28 mm diameter) encased in an HDPE sheath, installed within a 150 mm drill hole at nominal staggered grid spacings between 1.5 m to 2 m and fitted with terminations consisting of a spike plate with domed locking nut, rock mesh (Proprietary Geobruigg TECCO G65/3) and erosion control matting (Proprietary Geobruigg TECMAT). The installation of rock mesh consisted of 14 mm diameter steel perimeter ropes, 4 m long perimeter rope anchors dowels, and 2 m long profiling dowels installed perpendicular to the local

Zone 2 of upslope cutting consisted of similar 6 m passive dowels (28 mm diameter) at 2 m spacing integrated with 185 mm thick reinforced shotcrete to address the presence of low strength and highly erodible subsoil material exposed in the cut face.

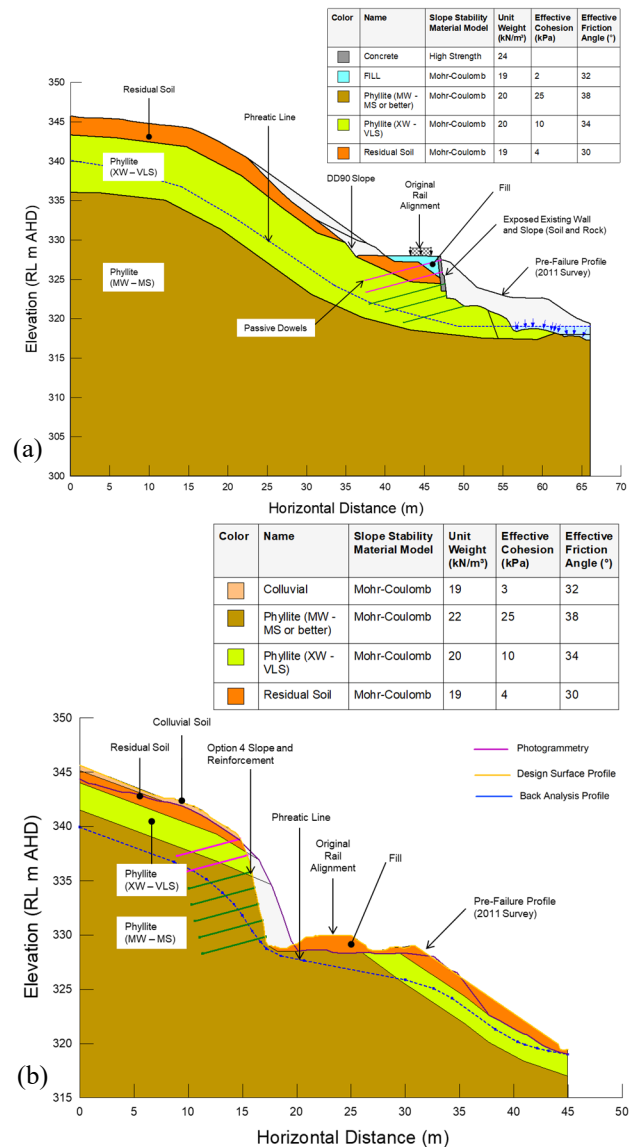
Figure 7. Geotechnical ground model adopted for remedial design of (a) downslope embankment and (b) upslope cutting.

The design included 8 m and 10 m long passive dowels (28 mm diameter) encased in an HDPE sheath, installed within a 150 mm drill hole at a nominal staggered 1.5 m grid spacings and fitted with terminations consisting of a steel bearing plate and locking nut. The hard facing design consisted of 200 mm thick shotcrete, with 40 MPa concrete, including SL81 steel mesh and 4 m long 2D500N16 reinforcing bars, orientated horizontally and vertically at each dowel head based on outcomes of the structural assessment. Enhancements to subsurface drainage were incorporated into the design to alleviate excess porewater generation behind the hard facing. Subsurface drainage included 10 m long inclined seepage drains at 3 m spacings, 170 mm wide strip drains placed diagonally at 3 m horizontal spacing and 50 mm diameter weep holes at 3 m grid spacings.

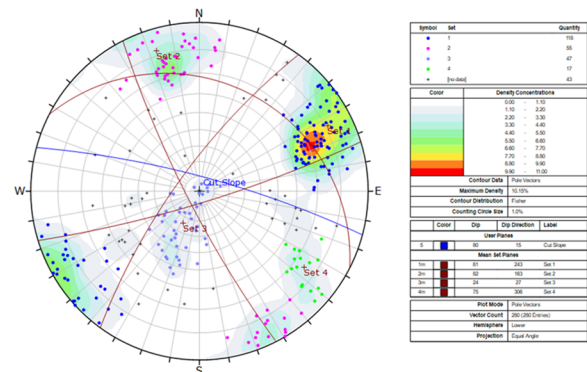
persistence of key rock mass discontinuities. The computerized discontinuity data was compared with field measurements for validation. The overall dip and dip direction of the cutting was measured to be 80/015 and was assessed to comprise four prominent intersecting joint sets (81/243, 82/163, 26/028, and 75/306), as presented graphically in Figure 8.

Figure 8. Stereograph of the cutting slope (blue line) and four prominent joint sets (dark red lines).
