Unexpected geology as part of the Hosingen bypass project: examples of the importance of geotechnical investigations

ABSTRACT: Two civil engineering structures are to be built as part of the Hosingen bypass project. Based on the topography and geological map, the rock was assumed to be shallow and only 2 exploration boreholes were planned for each structure by the project owner for the initial geotechnical study. These boreholes revealed the presence of unconsolidated material and the roof of the rock at a much greater depth than anticipated. It was therefore decided to carry out supplementary geotechnical campaigns comprising a larger grid of boreholes and geophysical surveys. The boreholes revealed a sedimentary fill up to 20m thick. This sedimentary fill was found in 12 of the 20 exploration boreholes drilled, covering a total area of almost 10,000m², in two different locations, indicating that this layer is not linked to an isolated event. It is mainly a conglomerate containing rounded pebbles of sandstone, quartzite and shale, ranging in size from a few centimeters to more than ten centimeters, with reddish clay cement. All the pebbles are aligned parallel to the horizontal,

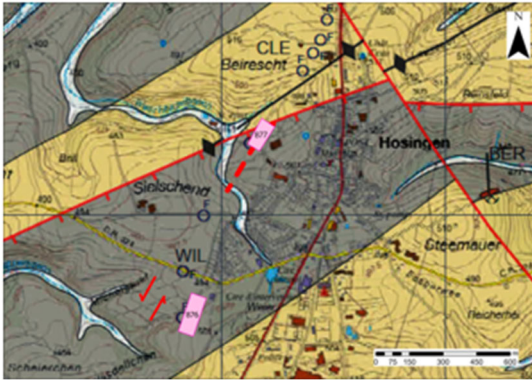
While OA876 should only be found on rocks from the Wiltz Formation, the OA877 zone straddles the Clervaux

Formation and the Wiltz Formation, close to an anticlinal fold axis and a WSW-ENE-trending fault.

Figure 2. Geology next to the futures OA876 (south) and OA877 (north) (in purple: bridges, in red: faults, in black: fold axis)

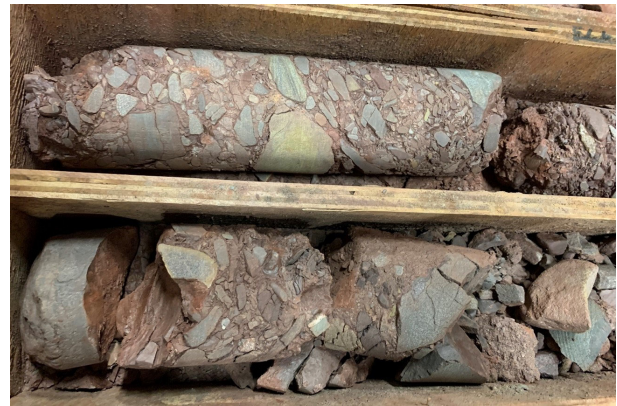
As these non-compliant situations represented a risk to the stability of the future structure, it was decided to carry out 5 urgent boreholes with pressurimeter tests spread over the entire abutment in order to find the sound rock. Loose materials such as those found at OA877 were also found in thicknesses ranging from 6.0m to 17m. These would appear to be the remains of heavily weathered ancient conglomerates with intercalations of weathered reddish clayey sandstone.

Figure 3. Weathered conglomerates

For OA876, 4 additional piles of 24m length (deeper than the 11m length piles initially planned and already in place) had to be re-drilled, in order to reach the sound Devonian bedrock throughout and ensure a uniform level of support for the foundations.

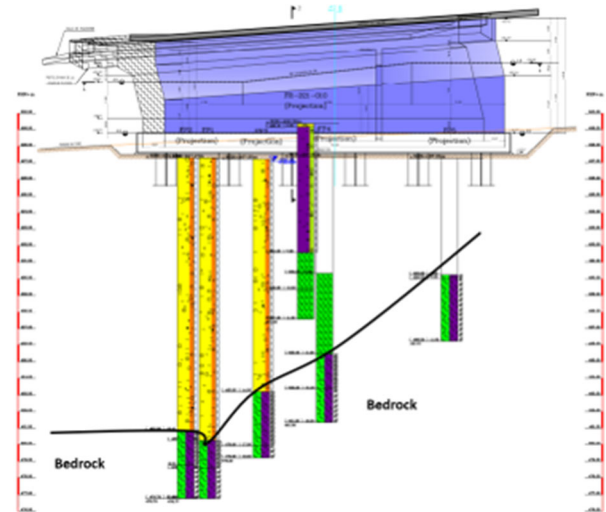
The rock appears deeper to the west than to the east of the abutment, as shown in Figure 4.

Figure 4. Level of the rock roof

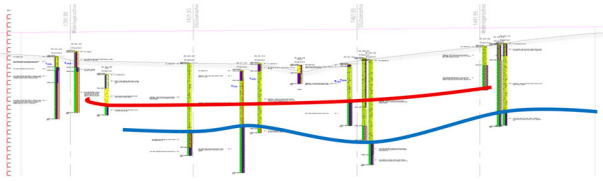
Unlike what was observed at abutment C1 of OA876, the rock roof is higher on the west side than on the east side of the axis (see Figure 5). There is therefore a risk of differential settlement between the two abutments of the structure, but also within the same abutment.

Figure 5. Difference in the level of the rock roof between the west (red) and the east (blue) side of the axis

As a result, the north abutment had to be moved further north in order to be positioned in Devonian rock, away from the loose sediments resulting from the erosion of the Tiras layers. The viaduct will therefore be twice as long as planned, requiring two intermediate piers. A solution with three spans of 30m, 40m and 30m was therefore proposed. The use of a single intermediate pier would not be possible, as it would be located directly at the bottom of the small valley, creating additional geotechnical and hydrogeological complexity related to the diversion of the watercourse, at least during the construction phase. The foundations will be constructed using piles over 25m long, whereas shallow foundations were initially planned.

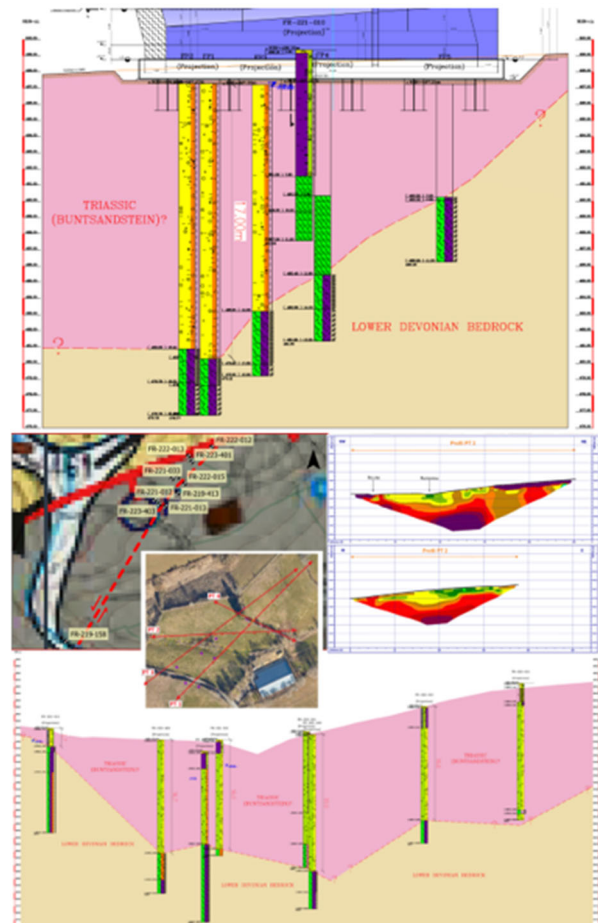
Geophysical surveys and monitoring of earthworks in the rock trench immediately to the north of OA877 have revealed the presence of 3 different fault directions: the 2 directions shown on the 2020 geological map, but also a 3rd fault direction that was previously unknown and unrecorded. The extension of this 3rd fault, present in the rocky trench, intersects both OA877 and OA876.

These faults appear to have formed a tectonic sedimentary basin, creating favourable conditions for a fluvial fill, and also preserving part of it from erosion. This sedimentary fill covering a total surface area of more than 10,000m², in 2 different locations more than a kilometer apart, indicating that this layer could be found in several locations and would not be linked to an isolated event. It is a conglomerate containing rounded pebbles of sandstone, quartzite and shale, varying in size from a few centimeters to more than ten centimeters, with a reddish clayey cement interspersed with beds of more or less clayey sandstone. All the pebbles are aligned parallel to the horizontal, indicating that the fill post-dates the deformation of the underlying Devonian shale and sandstone.

This would be the first time that layers of this age have been found in the Oesling region, much further north than the outcrops already known in Luxembourg and Belgium. Figure 6 shows the suspected ancient sedimentary basin for the 2 structures.

Figure 6. Interpretation of the 2 triassic basins, OA876 above and OA877 under, with the results of the ERT confirming the basin structure and the presence of faults
