Lessons learnt from a highway embankment failure on column-stabilized soft ground

ABSTRACT: The highway BAB A 20 crosses the marshland of the river Trebel about 40 km east of the city of Rostock. In October 2017 and in January/February 2018 a ground failure of the embankment occurred on a total length of about 80 m. In the years 2001/2002 during the construction of the new BAB A 20 in this area about 80,000 CSV columns (combined soil stabilization with vertical columns) with a total length of about 641,000 m has been installed to stabilize the soft soils consisting of peat and organic soils. In 2005 the new four-lane highway was opened to traffic in the same area. As part of a research project initiated by the Federal Highway Research Institute (BASt), the TU Berlin carried out a scientific assessment of the case of damage. In addition to the review of the literature and the documents relating to the planning and execution of the construction project, experimental investigations were carried out both in the field and in the laboratory. Model tests provided insights into the hydration behaviour of the stabilizing columns. Analytical and numerical calculations, the latter using soph

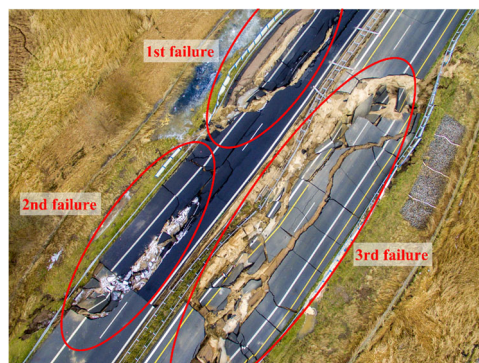
Due to detected and measured vertical subsidence of the road surface west of the Trebel bridge, the left lane in the direction of Lübeck was closed. On October 9, 2017, the embankment structure failed over a length of approx. 40 m (1st failure in Figure 2) and the highway was completely closed. Another fracture appeared in the left lane during the night of January 31 to February 1, 2018 (2nd failure in Figure 2). A third failure occurred in the opposite right lane in the direction of Szczecin during the night of February 11 to 12, 2018 (Figure 2). The German Federal Highway Institute (BASt) commissioned the Technische Universität Berlin (TU Berlin) to conduct a scientific investigation and assessment of the damage. However, this research project started after the western embankment structure, including

Figure 2. Damaged areas west of the Trebel bridge (Image source: OSTSEE-Zeitung / Alexander Müller)

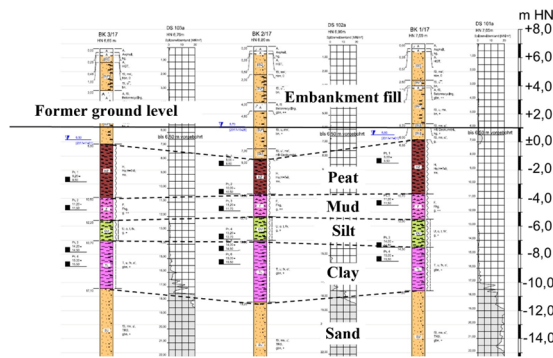
Figure 3 shows a longitudinal section of the subsoil in the area of the damaged section after the first fracture occurred. Underneath the existing embankment structure lies a Holocene lowland peat deposit consisting mainly of moderately to heavily decomposed peat with thicknesses of up to 4 m. Below this are mostly sedimented muds with a thickness of approx. 2 m in the damaged area, consisting mainly of detrital muds and limestone muds, with occasional silt muds. In the damaged area, the peat and mud are underlain by up to 2 m of organogenic silt, followed by up to 5 m of clay. Below these soft soils lie Pleistocene sands with interlayers of boulder clay.

Figure 3. Longitudinal section of the subsoil in the damaged area, lane heading towards Szczecin (after Rackwitz et al. 2021).

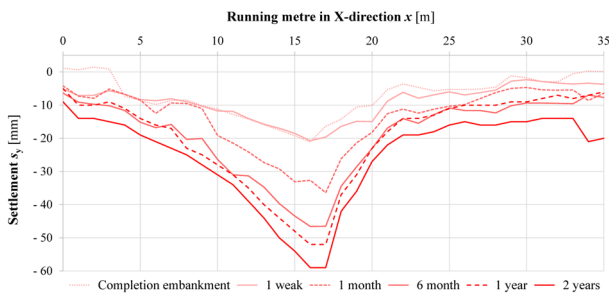
Figure 6 shows the embankment settlement measured by the HIC at km 144+926 in the area of subsequent failure, up to two years after the embankment completion. At this cross-section, the measuring tube was installed at an approx. height of +2.2 m HN. The greatest vertical deformations occurred after two years of service, reaching 59 mm at the centre of the embankment. These deformations decreased towards the edges, with lower settlements measured in the southern (right) part of the embankment cross-section than in the northern (left) part. According to the installation protocols for the CSV columns in this embankment section, additional 494 columns were installed between those already constructed as part of a remediation concept. Most of these additional columns were installed under the right-hand lane in the southern part, which explains the lower deformations, as the column spacing is denser there.

Figure 6. HIC measurements of km 144+926 in the failure area at a height of +2.2 m HN

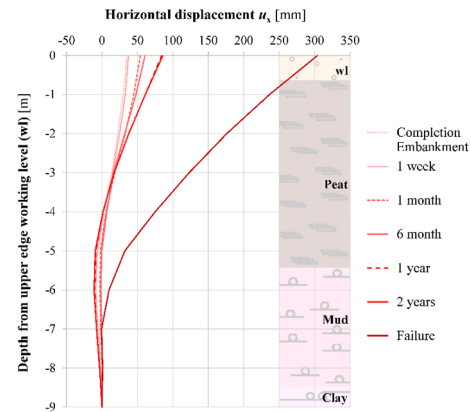
ated VIC head deformations and the geodetic measurements of the inclinometer tube heads from 2017 indicated unwanted displacement at the foot of the tubes. Figure 7 shows the corrected VIC measurements at km 144+926, with the estimated deviation from the head to the toe of the VIC and throughout the measurement times deducted. From the time the embankment was completed until shortly before it failed, maximum deformation always occurred at the VIC head. Between 2004 and 2017, the horizontal displacement at the upper edge of the working level increased from 86 mm to 304 mm (Figure 7), shortly before the first fracture occurred (Figure 2).

Figure 7. Corrected VIC measurements of km 144+926(A) in the failure area, starting at the upper edge of the working level

Unplanned additional loads arose due to the groundwater level dropping by up to 1 m in 2016 and the working level being thicker than planned. The underlying peat compensated for the resulting horizontal loads, leading to additional deformation, especially at the embankment toe. Another unplanned situation occurred in 2017 when a trench was excavated in the area of subsequent failure. This resulted in the vertical unloading of the edge columns, reducing their compensating bending moment. From October 4 to 7, 2017, a total of 88 mm of precipitation was recorded. Since the backfilled trench was uncovered, water flowed freely and saturated the backfill material. This caused water pressure to build up in the embankment.

The VIC measurements (Figure 7) showed that the CSV columns close to the embankment toe are subject to high bending stresses. The deformation patterns resemble the bending curve of an elastically supported beam. Due to the vertical load on the columns, uniaxial bending with longitudinal force can be assumed. The flexural stresses can be calculated by considering the axial force acting on the column relative to its cross-section and the bending moment relative to the column's moment of resistance. At the point of maximum moment, the flexural stresses must not exceed the strength of the unreinforced column material. For the columns at the embankment toe, the axial force is

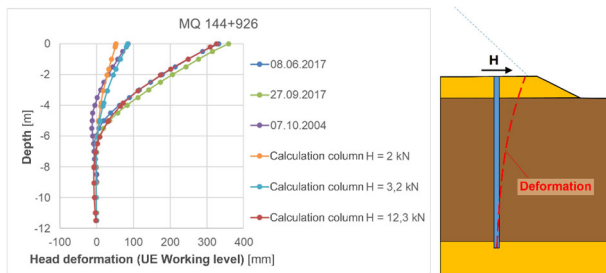
Figure 8. Measured and calculated horizontal deformations (left) and modelling (right)

Applying a horizontal point load of 2 kN to the column head results in a horizontal displacement of 53 mm. The corresponding maximum bending moment was determined as 5.4 kNm. Comparing the calculated with the compensating bending moment showed that the column cross-section with a diameter of 20 cm already failed at the determined head deformations. The measurements in the failure area exceeded the calculated value of 53 mm by the end of 2004 (Figure 7). Even if some of the columns in the edge area were already broken after two years of service, this would not necessarily lead to the failure of the entire embankment. It only becomes critical when too many columns fail, as the stability calculations showed.

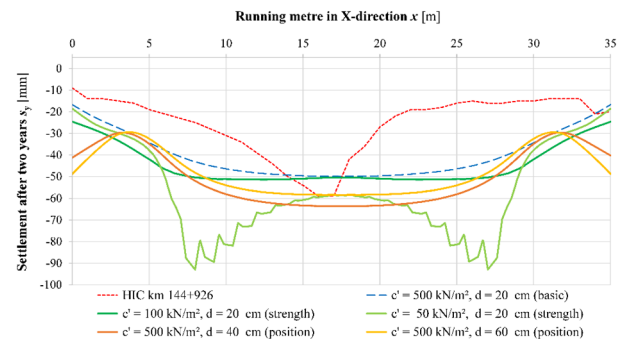
Figure 11 shows the results of the numerical simulation for these variations compared with HIC measurements taken two years after the embankment completion. For the basic model with the planned strength ($c' = 500 \text{ kN/m}^2$) and position ($d = 0.2 \text{ m}$) of the binder-improved layer (blue), the settlement curve across the embankment cross-section is parabolic. This differs qualitatively from the measured curve (red), which has a sharp peak in the centre. The maximum settlement in the centre of the embankment is around 59 mm in the measurements and 50 mm in the basic model. Decreasing the strength of the binder-improved layer changes the settlement pattern. For $c' = 100 \text{ kN/m}^2$ (dark green), the parabolic curve shows a plateau in the core area of the embankment. Rather than one maximum in the middle, there are two slight maxima closer to the embankment shoulders. For $c' = 50 \text{ kN/m}^2$ (light green), the plateau in the core area changes to a pronounced inverted parabola. The calculated settlements at the centre of the embankment correspond to the measured values. However, in the model, the maximum settlements of 93 mm occur approx. 9 m away from the centre of the embankment. Between these maxima, the graph shows increasingly pronounced spikes towards the peaks. These indicate differences in settlement between the columns and the ground. Increasing the thickness of the leveling fill d results in a significantly different settlement pattern to that of the previous variation. Compared to the basic model, changes to the position of the binder-improved layer primarily affect the curve at the edges of the embankment. The curve remains parabolic between the embankment shoulders, but is somewhat flattened in the inner core area. At the shoulders, the settlements reach a minimum at a turning point. From these two minima, the settlements increase almost linearly towards the foot of the embankment. With an increased thickness of $d = 0.4 \text{ m}$ (orange), the maximum settlement at the centre of the embankment is just under 64 mm, whereas the settlement at the outer edges is approximately 41 mm. With an increased thickness of $d = 0.6 \text{ m}$ (yellow), the maximum settlement at the centre is 58 mm, which is almost equal to the measured value. In contrast, the settlements at the edges increase to 48 mm. Interestingly, the model with $d = 0.4 \text{ m}$ shows the greatest maximum settlement.

Figure 11. Comparison of HIC measurements (km 144+926) with numerical results (strength and position variation binder-improved layer)

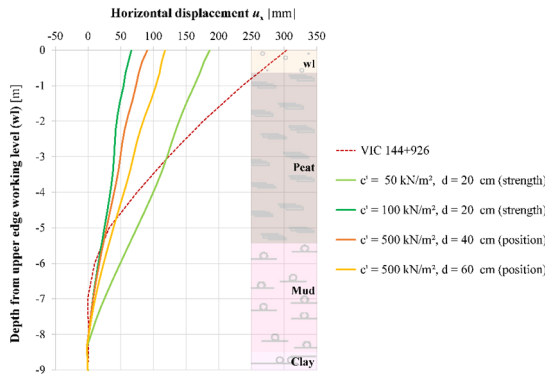
Figure 12 illustrates how these parameter variations affect horizontal displacements at the embankment toe at the end of the calculation, which represents the time shortly before the BAB A 20 failure. The curves for variation in strength and in position of the binder-improved layer are qualitatively similar. As with the HIC measurements in the area of failure, horizontal deformation increases from the base point and reaches a maximum at the upper edge of the working level. The measurements show a significant bend in the layer transition area from mud to peat at a depth of about 5 m. Since the mud is stiffer and has a lower creep tendency than the peat, it exerts greater lateral resistance to the VIK's deformation. However, as peat and mud were combined in the model, this bending cannot be reproduced. A max-

imum calculated displacement of 186 mm is achieved with a variation of $c' = 50 \text{ kN/m}^2$ (light green). This results in pronounced buckling, which is visible at the transition to the clay layer. As the material in the model changes from peat to clay, the difference in stiffness is significant, resulting in a pronounced bend. A smaller strength reduction to $c' = 100 \text{ kN/m}^2$ (dark green) leads to a maximum horizontal displacement of 66 mm. In the basic model according to the planned design (blue), this is only 40 mm. Variation in the position of the binder-improved layer also led to an increase in horizontal displacements at the embankment toe. In the model with a leveling fill thickness of $d = 0.4 \text{ m}$ (orange), the maximum displacement at the upper edge of the working level is 91 mm, and for $d = 0.6 \text{ m}$ (yellow) it is 118 mm. The numerical simulations could not replicate the high measurement of 304 mm.

Figure 12. Comparison of VIC measurements (km 144+926) with numerical results (strength and position variation binder-improved layer)

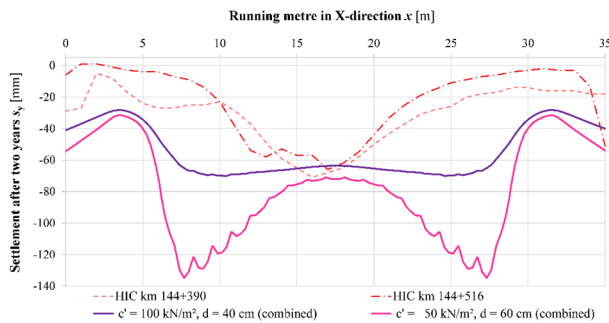
Although the numerical results of the settlement for the two examined variations differ qualitatively from the HIC measurements at km 144+926, a comparison with other cross-sections to the west of the Trebel bridge reveals similarities for both curves (Figure 13). The measurements at km 144+516 and 144+390 exhibit characteristics similar to those of the calculated curve for the models with increased leveling fill thickness. A turning point is reached in the outer areas of these measurements, after which there is a sharp increase in settlement towards the embankment toe. Meanwhile, the measured values in the middle of the embankment at km 144+516 and 144+715 show a decrease in settlement towards the embankment axis. This corresponds to the inverse parabola in the middle of the curve for models with reduced strength in the binder-improved layer. Figure 13 also shows the settlement for combinations of changes in strength and position with $c' = 100 \text{ kN/m}^2$ and $d = 0.4 \text{ m}$ (purple) and with $c' = 50 \text{ kN/m}^2$ and $d = 0.6 \text{ m}$ (pink). Comparing these combined models with the VIC measurements shows that they match the settlement curve at km 144+516 qualitatively. However, the calculated maximum horizontal displacements at the upper edge of the working level are larger, at 134 mm and 336 mm respectively.

Figure 13. Comparison of different HIC measurement cross-sections with numerical results (combined variation binder-improved layer)
