Factorial analysis of lateral flow induced damage in Uchinada Town due to the 2024 Noto Peninsula Earthquake, Japan

ABSTRACT: The 2024 Noto Peninsula Earthquake caused widespread liquefaction and significant ground deformation across Ishikawa Prefecture. Uchinada Town, located approximately 100 km south of the epicenter, experienced particularly severe damage, especially in low-lying coastal and reclaimed areas. This study focuses on the Muro district of Uchinada Town, where intensely localized lateral flow occurred. To investigate the deformation mechanism, field surveys including boring investigations, Standard Penetration Tests (SPT), and Piezo Drive Cone (PDC) tests were conducted. Results revealed that the subsurface primarily consists of fine, loose sand highly susceptible to liquefaction under seismic loading. The area's gentle slope and catchment topography promoted groundwater accumulation, resulting in a shallow groundwater table (~1 m depth) that further contributed to the severity of lateral flow. PDC tests identified a continuous weak soil layer (N-value 0–1) along the reclamation side of Prefectural Route 8, corresponding with the most severe lateral spreading. Lique

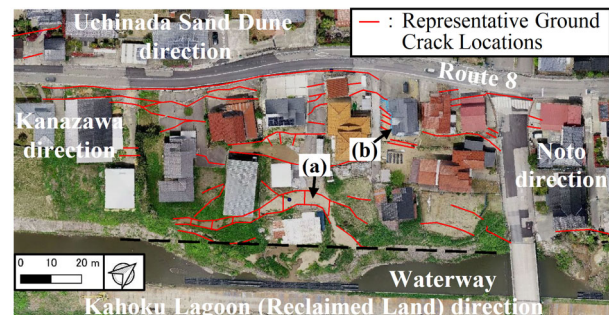
Figure 2. Lateral flow in the Muro District

Figure 2 illustrates the extent of lateral flow damage and the locations of representative cracks in the Muro district. In this district, intense lateral flow occurred on the gentle slope toward the Kahoku Lagoon. This resulted in the displacement of revetments, accompanied by waterway blockage.

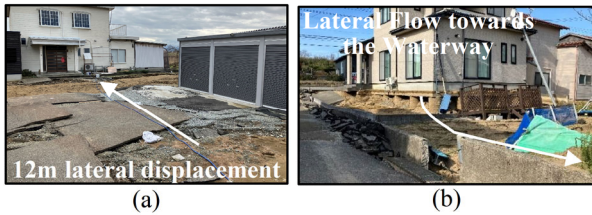
Figure 3. A house in the Muro District

Moreover, Figure 3(a) shows a house that was displaced approximately 12 meters toward the waterway due to lateral flow. On the other hand, Figure 3(b) shows a house that remained undamaged by lateral flow because of ground improvement piles. While subsidence and lateral flow were observed in the surrounding ground, the house itself showed no significant damage.

A comprehensive analysis of the field survey results suggests that liquefaction is considered to have taken place at a very shallow depth (approximately 2–4 m) within the reclaimed soil layer in the Muro district. Moreover, due to the high groundwater level and the gentle surface slope toward the reclamation area, lateral flow was induced, leading to widespread damage such as 12 m displacement of the house shown in Figure 3(a).

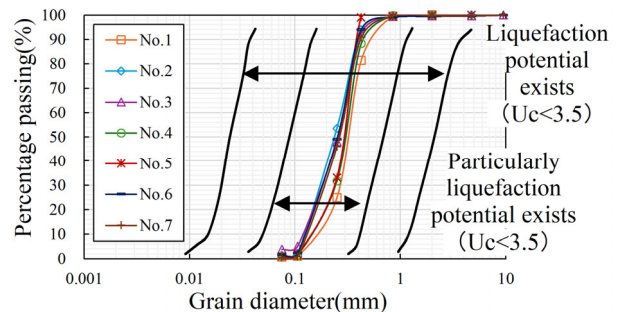
Figure 6. Grain Size distribution of Samples Collected in Uchinada

Figure 6 shows the grain size analysis of sand samples from Uchinada Town. Sample No. 1 was taken from a site without any signs of soil liquefaction, while the other samples were collected from locations exhibiting sand boils. The grain size distributions at the dune top and sand boil locations were similar, both classified as highly liquefiable sands.

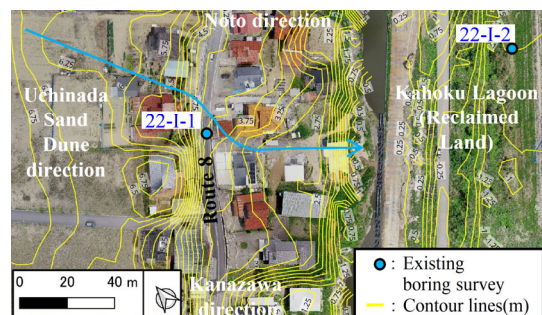
Figure 7. Contour map created using pre-disaster elevation data

Figure 7 presents a contour map based on pre-disaster elevation data. The Muro district exhibits a gradual surface incline directed toward the Kahoku Lagoon reclamation zone, forming a concave landform characteristic of a catchment area.

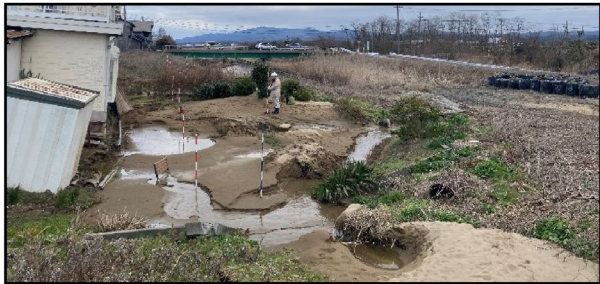
Figure 8. Ponding conditions in Muro District

Additionally, existing geological surveys recorded groundwater levels at approximately 1 m depth (Table 2). Furthermore, post-disaster investigations confirmed flooding, as shown in Figure 8. This suggests that groundwater tended to accumulate in this region, resulting in a higher groundwater level compared to the surrounding areas.

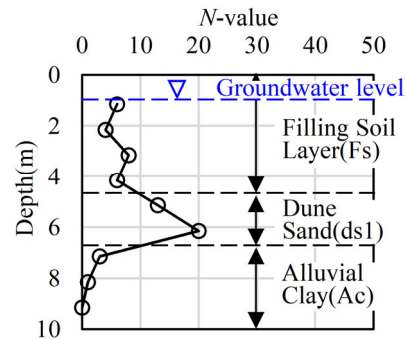
Figure 9. Boring Survey and SPT Results at Muro-No.1

Figure 9 illustrates the results of the boring survey and SPT at Muro-No.1. The identified soil layers are a reclaimed layer (Fs) (0–4.5 m), a dune sand layer (ds1) (4.5–6.7 m), and an alluvial clay layer (Ac) (6.7–9.5 m). The *N*-values of ds1 (13–20) were higher than those of Fs (4–6), while Ac (0–3) indicated extreme

softness. The groundwater level was confirmed at 1.0 m, indicating a highwater table.

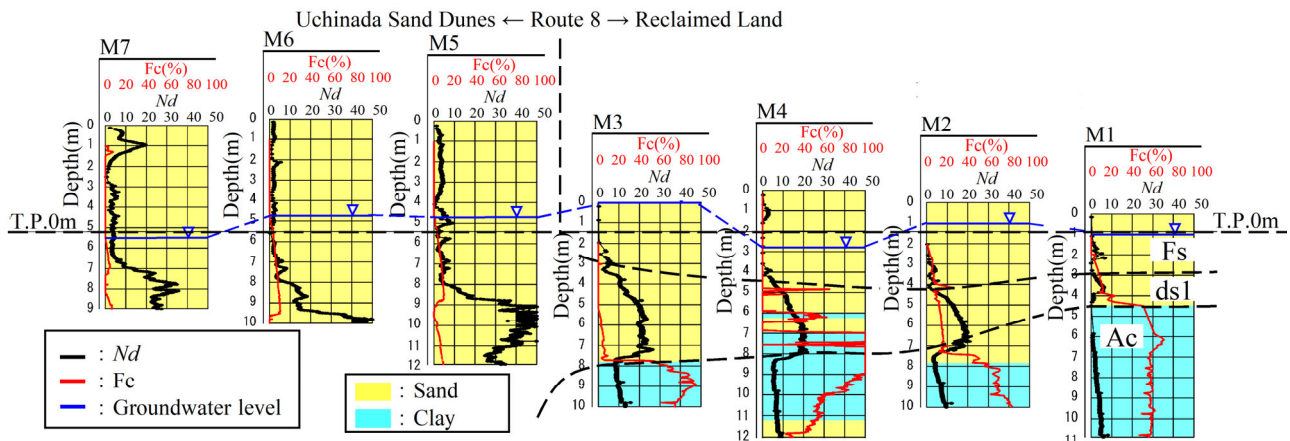
Figure 10. PDC Test Results in the Muro District (Classification of Sand and Clay)

Figure 10 illustrates the converted *N*-values derived from the PDC test (hereinafter referred to as *Nd*-values), along with the corresponding fine content (Fc). Also, it presents the soil classification based on these results. Both the reclaimed soil layer (Fs) and the dune sand layer (ds1) on the reclamation side primarily consist of sandy soil layers with minimal fine-grained content. Beneath these sandy soil layers, a weak alluvial clay layer (Ac) with *Nd*-values of 10 or less is distributed. Figure 11 presents a visualization of the *Nd*-values obtained from the PDC test, categorized by color. In the area from Route 8 to the reclamation side, where significant deformation due to liquefaction-induced lateral flow was observed, the *Nd*-values at depths of 0–2 m at survey points M2 to M4 were approximately 0, indicating an extremely loose state.
