# Radar interferometry-based approach to assess damage patterns induced by the climate-driven geohazard of soil shrinkage

**Julia-Isabelle Ruopp, Hauke Zachert**

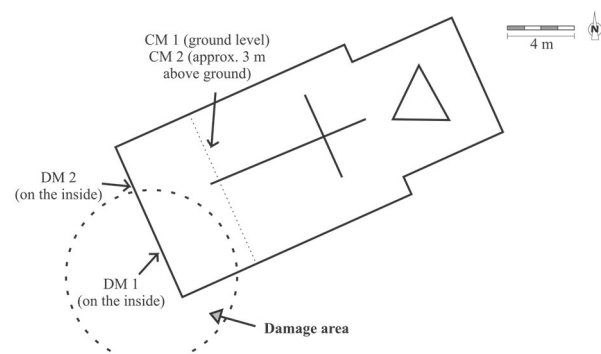
The generally severe damage is on the west wall of the building, see Figure 1. Damage first occurred in 1930 and was documented between 1930 and 1960 in the masonry on this west wall. Structural issues persisted through to 2001, when the cracks were extensively repaired. However, they reappeared in 2003, affecting both the interior and exterior of the west wall this time. Due to concerns about the structural integrity, a further investigation into the cause of the problem was initiated (Beroya-Eitner et al. 2022).

Figure 1. Top view of the protestant church in Massenheim with damage area and monitoring locations (DM 1 and DM 2). Modified after Beroya-Eitner et al. (2022).

The outcome of the damage assessment in Beroya-Eitner et al. (2022) stated that non-uniform shrinkage-induced settlement, most likely occurring within the susceptible fat clay layer, is the primary cause of the observed cracking on the west wall. Additionally, observed cracks on the floor are parallel to the slope face indicating a creeping towards downhill. The presence of nearby trees was not excluded as a contributing factor to the soil shrinkage.

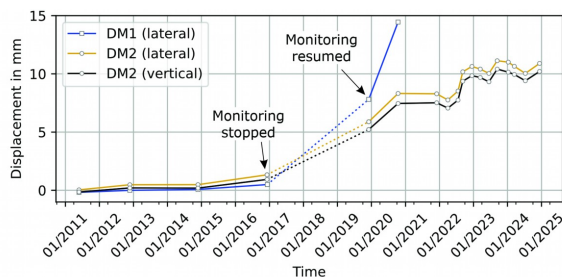
Following the continued crack growth after the renovation in 2001, displacement (DM) and convergence (CM) monitors were installed to evaluate movement behaviour. Between 2004 and 2016 no significant movements were observed (see also Beroya-Eitner et al. (2022)), leading to stop monitoring and starting renovation on the affected west wall. Afterwards, only two convergence monitors remained in operation. However, in December 2019 large deformations were observed again (see Figure 2), why the monitoring was resumed.

At that point, movement was presumed to be in downslope direction, as the lateral movement of 6 mm at DM 2 and 8 mm at DM 1 was recorded, along with a vertical movement of 5 mm at DM 1. Since October 2020, only DM 2 remained operational due to a technical defect at DM 1.

Figure 2. Displacement Monitoring movement over time at different measurement points, shown in Figure 1.

Comparing these with the crack monitors in Figure 2, DM2 recorded for the first period a displacement of 2.2 mm in vertical and 2.4 mm in lateral direction, while the more southern located DM1 shows a significantly larger movement at the crack edges of 6.6 mm. In accordance, the convergence monitors in Figure 3 show an increase in deformation with a difference between the measurement points of 4.2 mm in October 2020.

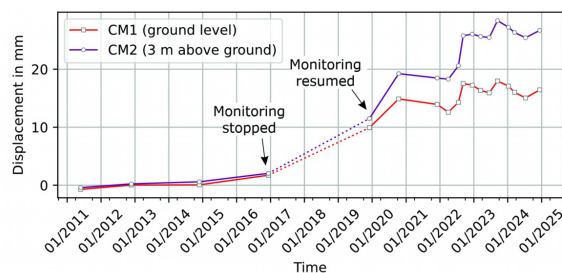
Figure 3. Convergence monitoring movement over time at different measurement points, shown in Figure 1.

Only one year later, in December 2021, measurements started to have been conducted at quarterly intervals. This allowed the measurement of seasonal crack displacements with an increased movement starting in April 2022 and stabilization during the following winter months 2022/2023. Onward movement in summer 2023 and summer 2024 are of smaller magnitude than the previous ones. The same measurement intervals and patterns are valid for the convergence measurements shown in Figure 3.

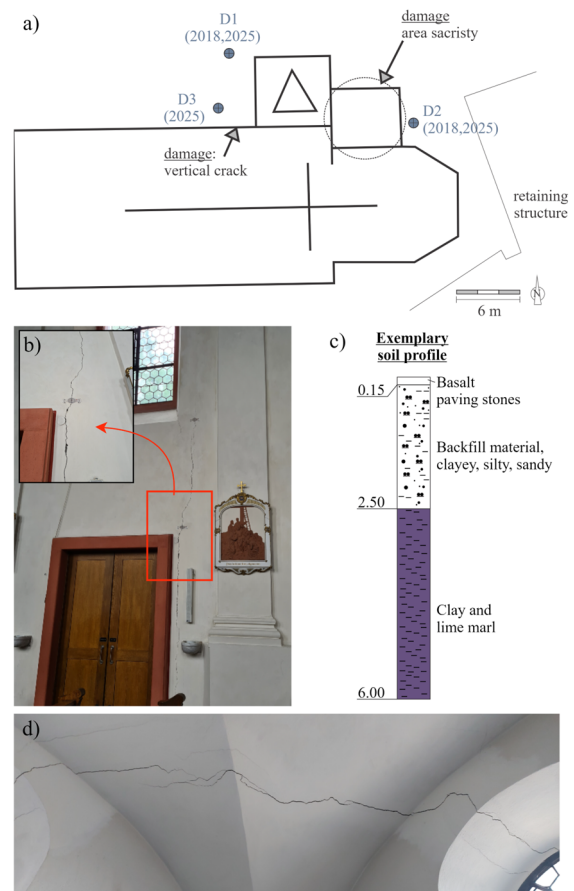
Crack formation is primarily concentrated in the northeastern part of the building, resulting in two main cracks: one in the ceiling of the sacristy and another as a vertical crack along the nave wall, west of the church tower, as illustrated in Figure 4 (Landesamt für Denkmalpflege, no date).

Figure 4. Damage patterns in the catholic church of Hochheim, with a) damage and soil investigation locations (D1, D2, D3) in top view. Modified after LfD (no date) b) picture and detail of vertical crack (photo from 2024); c) soil profile (2025) at location D1 (BGS 2025); d) crack in ceiling of sacristy (photo from 2022).

The vertical crack exists at the inner and outside wall and evolves from the door up to the window and the ceiling. According to the buildings administration, increased crack propagation was observed in the sacristy, at a pre-existing crack present for some years, during the summer of 2018. That is why detailed investigations into the cause of the problem were carried out, leading to damage reports and site investigations. A crack reparation of the damaged area in the sacristy was carried out in 2020. Further crack propagation was detected in summer 2022 in the sacristy, as well as a new vertical crack in the northern part of the nave.

The outcome of the damage assessment showed a settlement causing inclination of the sacristy to northeast. The influence of the shrink and swell-prone soil on the damage patterns was confirmed by the water content testing on the site investigation probes, with low values near the damaged areas at the sacristy and the tower. Furthermore, the retaining structure supporting the church terrace in the southeast could have an influence on the church's movement, especially after the retaining wall maintenance work in 2014, which may have changed the hydraulic conditions in the soil.

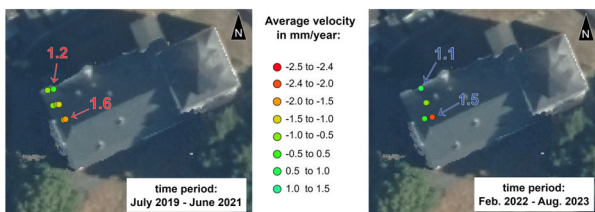
The PS on the western part exhibits a pattern of settlement towards the south, as shown in Figure 5. The data covers two time periods, from July 2019 to June 2021 and February 2022 to August 2023. This observation is consistent with the on-site damage assessment as well as the findings reported in Beroya-Eitner et al. (2022), both of which indicated a southward movement of the west wall.

Figure 5. Overview of PS coverage for MH case study and average velocities in the Line of Sight per PS for two evaluated time periods.

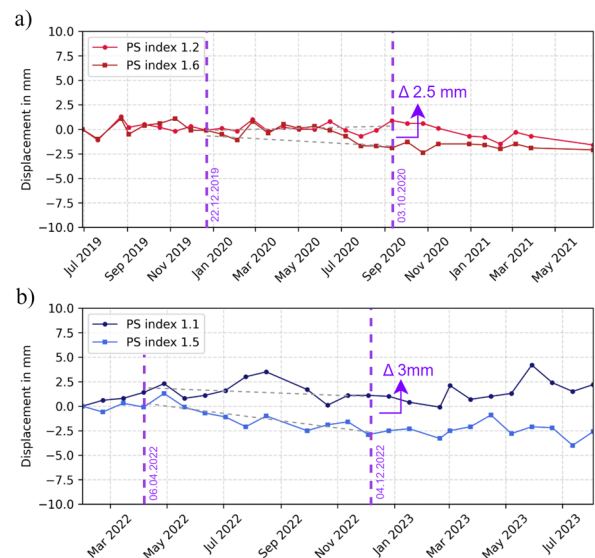
Figure 6. Relative vertical movement of two PS on the west wall evaluated on the moving discrepancy over time periods from a) July 2019 to June 2021 and b) Feb. 2022 to Aug. 2023

Evaluated for two PS on the west wall, the most northern and the most southern one in Figure 5 show a vertical displacement difference of 2.5 mm from December 2019 to October 2020 (see Figure 6a) and of 3 mm from April 2022 to December 2022 (see Figure 6b).

The increased inclination from north to south is clearly visible in both measurements. A similar magnitude is evident when comparing the relative crack opening movements at DM2 and DM1 with the corresponding PS-derived displacements.

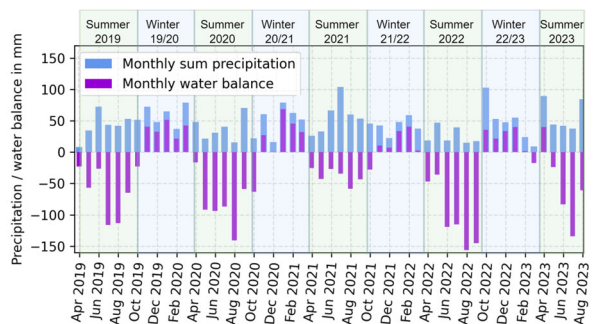
Figure 7. Monthly precipitation (blue) and water balance (purple), calculated as the difference between precipitation and potential evapotranspiration, based on data from the DWD weather station Frankfurt (station ID 1420).

The weather patterns between 2019 and 2022 are shown in Figure 7. It can be observed that the already derived subsidence from April 2020 to September 2020 corresponds to a period with long-lasting low precipitation and high evapotranspiration. Comparing these with the PS located on the western wall in Figure 8a, it can be seen that the dry weather period first influenced the more southern PS and, with a delay of a couple of months, also affects the more northern PS. Similar pattern is seen during summer 2022 in Figure 8b. Furthermore, the data link reveals a tendency toward subsidence during drought, but no link between wet periods and building heaves could be detected. If this trend continues, the settlement is expected to progress further over time.

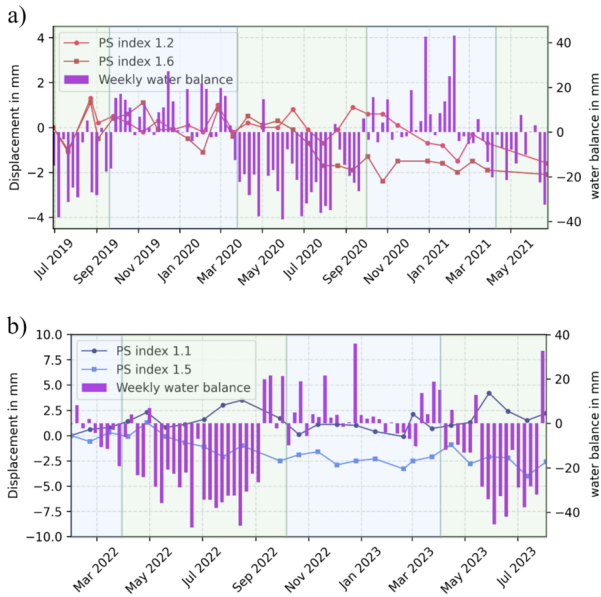
Figure 8. Water balance (purple) calculated by the difference of precipitation and potential evapotranspiration, based on data from the DWD weather station Frankfurt (station ID 1420) combined with the PS and time frames shown in Figure 5.

A clear indicator of vegetation influence on the shrinkage process and thus on ground movements would have been a seasonal pattern of subsidence during summer and in reverse heave during winter, due to the growth periods of vegetation. This pattern was not observed at the MH case study site, which may indicate that vegetation-related water uptake is not a primary cause of the observed crack damage, or that potential heave pressure is not transmitted to the building structure.

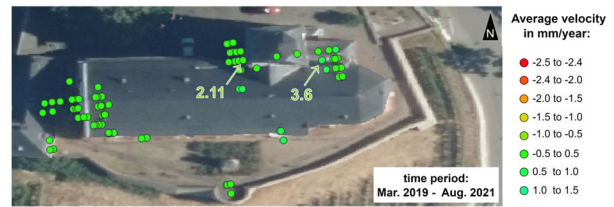
In contrast to the MH case study, the Catholic church in Hochheim does not exhibit any clear settlement trend or directional movement for the evaluated period from March 2019 to August 2022 based on the PSI, illustrated in Figure 9. As the velocity is derived from displacement over the entire observation period, it is possible that periods of movement in opposite directions may offset one another, potentially masking short-term dynamics.

Figure 9. Overview of PS coverage for HO case study and average velocities in the Line of Sight per PS.

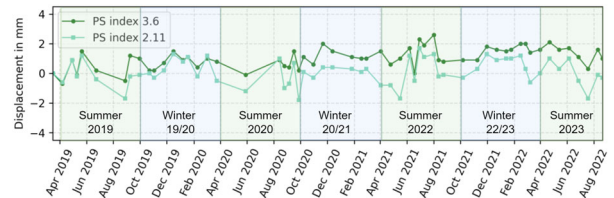
Therefore, it is necessary to analyse specific time periods and spatial areas separately. As the damage area is located in the northeastern part of the structure, Figure 10 focuses on the differential movements in this zone. There is a seasonal trend apparent. However, starting in summer 2020, the winter recovery phases no longer fully compensate for the increasing discrepancy in summer, resulting in a growing residual deformation visible through winter 2021/22 and summer 2022. Total and differential deformations remain very small.

Figure 10. Differential movement of two PS laying in the damage area of the sacristy (3.6) and the vertical crack (2.11), with the evaluated PS highlighted in Figure 9.

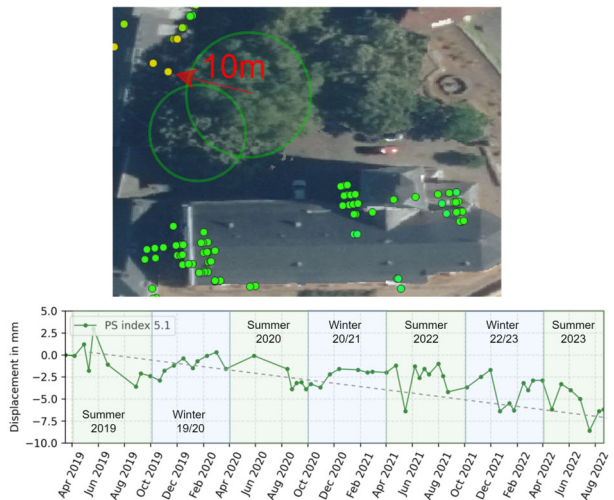
Since the trees in the churchyard exhibit significant crown volume, potential vegetation influence should be assessed. The resulting seasonal movements are proven by a benchmark PS located at distance of approx. 10 m to the tree north of the church (see Figure 11). Patterns of subsidence and heave of up to 5 mm are visible, following overall a lasting settlement trend. Since such seasonal patterns are not observed at the PS points on the damaged building, based on this study, tree influence as damage cause is unlikely. However, conclusively this must be verified by further measurements, such as long-term ground observations or seasonal soil moisture analysis.

Figure 11. PS located approximately ten meters away from a tree showing seasonal ground movements of a magnitude up to 5 mm.
