## Case study on emergency measures for maintenance and re-support of an embankment supporting a bridge abutment

Sarmad Al-Tameemi, Oliver Bernecker  
GrundWerk GmbH & Co. KG, Stuttgart, Germany, [al-tameemi@gw-gi.de](mailto:al-tameemi@gw-gi.de)

**KEYWORDS:** Slope stability, anchors, soil nails, monitoring, bridge abutment.

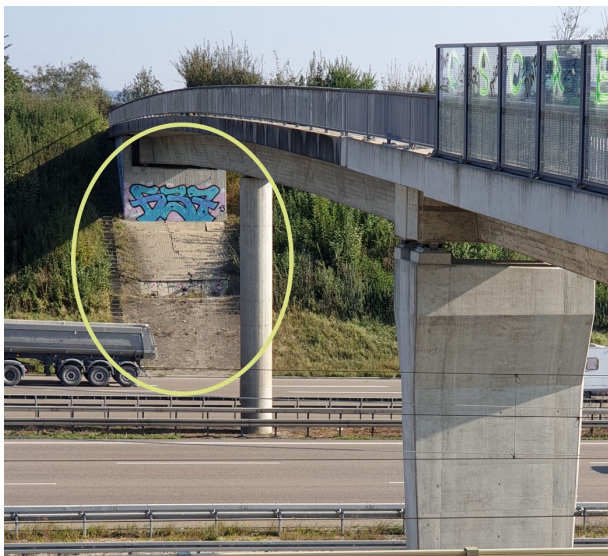
The bridge, constructed in 1980, serves as a connection between two sides of a landscaped area spanning a highway in southern Germany. The bridge length is about 71 m, which is supported by two abutments and two piers, with both abutments founded on sloped terrain. Figure 1 shows a view toward the north.

Figure 1. General view of the bridge toward the north abutment.

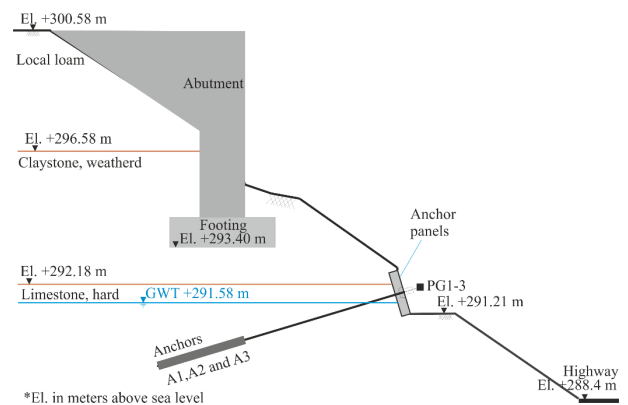
The subsoil profile consists of a 4.0 m thick layer of local loam, underlain by approximately 4.4 m of weathered claystone, followed by a layer of hard limestone. The groundwater table was observed at a maximum level of approximately 9.0 m below the highest ground surface. To

relieve hydrostatic pressure, a drainage pipe was installed above the level of the anchors. Figure 2 presents a side view for the embankment with the existing anchorage system.

Figure 2. Side view of the embankment and abutment with the existing anchorage system.

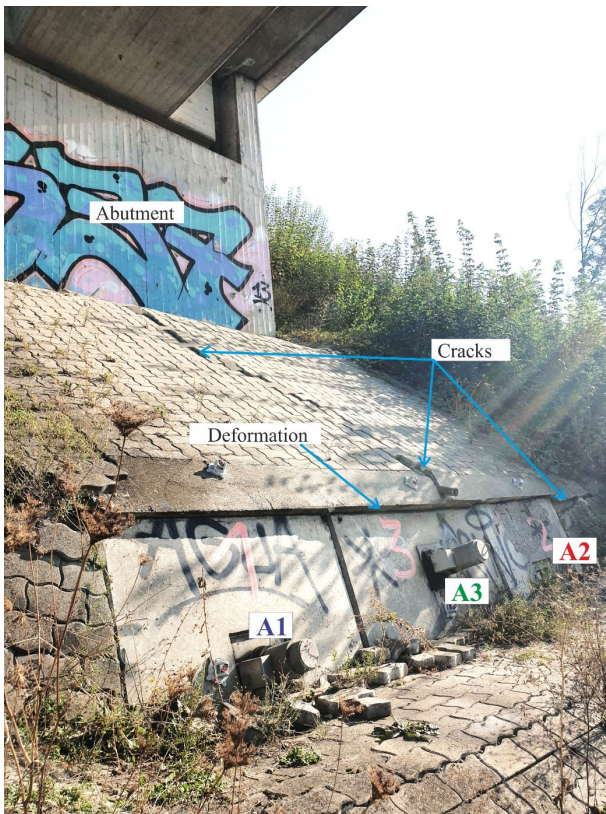
In 2024, noticeable slope movements and service damages were observed in the area adjacent to the northern abutment, raising concerns about the safety of the slope and the bridge foundation. At the interface between the anchor panels and the overlying cobblestone layer, deformations of up to 10 cm were recorded. Significant cracking was observed in the slope surface with maximum crack depths reaching 40 cm and up to 5 cm widths. In addition, the stairway exhibited noticeable horizontal displacement, which caused it to become partially non-functional. Numerous cobblestones became dislodged and fell as a consequence of ongoing slope deformation. Figure 3 and Figure 4 show the deformations and damages in the embankment and stairway.

Figure 3. Cracks and deformation in the cobblestone.

In parallel, the visible damages and deformations were repaired. Specifically, the cobblestone surface and the steps of the stairway were restored to reinstate both serviceability and aesthetic appearance. The remediation includes the additional anchors and soil nails depicted in Figure 14 and Figure 15.

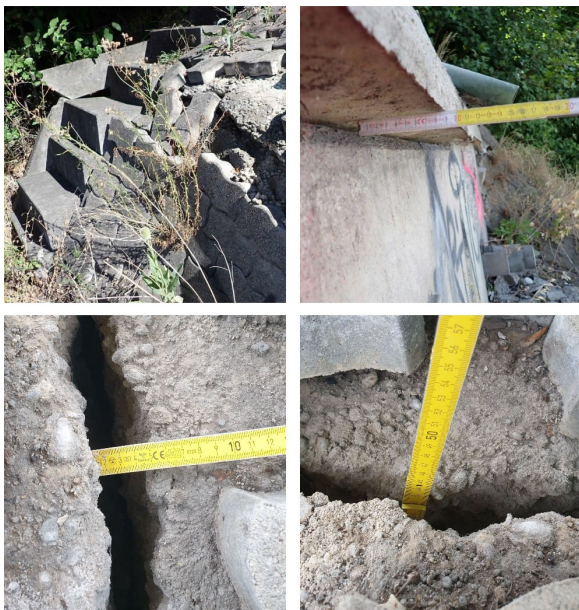
Figure 4. Deformation of the steps and crack measures.

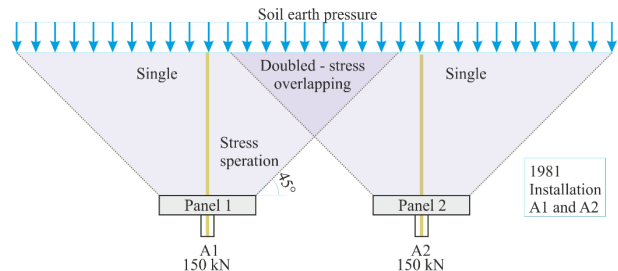
The anchors were originally designed to generate a uniform reaction stress to stabilize and retain the soil mass behind the anchor panels. Figure 5 illustrates in top view the reaction distribution of stress behind the anchor panels and the overlapping zones of stress influence between the anchors by assuming a simplified 1:1 stress dispersion model.

Figure 5. Stress distribution in soil after installing anchors A1 and A2.

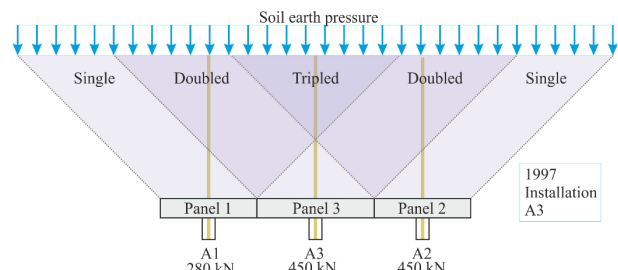
In 1997 (16 years after the original installation), it was observed that the anchor forces had increased to  $A1=280$  kN and  $A2=450$  kN, thereby exceeding their design capacities. To mitigate the risk of structural failure and ensure long-term stability for the slope, it was decided to install an additional anchor A3 located between the two old anchors. This measure aimed to redistribute the loads more effectively, transferring the forces from two to three anchors. The load at anchorage (lock-off load) for this anchor was  $A3=450$  kN with designed carrying capacity of 600 kN. In this stage, the resulting stress distribution in the soil behind the anchor panels increased, especially in the middle and right side around anchors A2 and A3, as shown in Figure 6.

Figure 6. Stress distribution in soil after the installation of anchor A3.

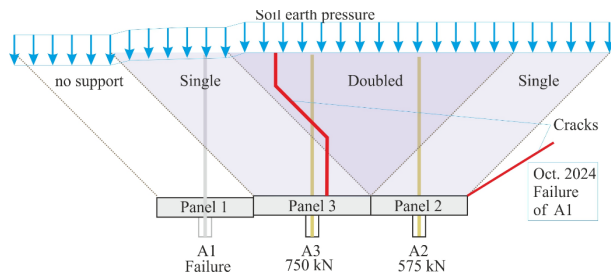
The failure occurred in anchor A1 after the reaction force exceeded its proof load of 150 kN and reached approximately 300 kN. This overload results in a complete loss of its anchorage function. This unbalanced distribution of loads disrupted the equilibrium of the soil-structure interaction,

particularly behind the anchor panels, and led to stress concentrations on one side of the system. The resulting asymmetry in soil pressure between the left and right sides of the slope triggered a local overstressing and ultimately caused cracking and deformation in the slope surface as presented in Figure 7. The resulting stress fields correlate well with the observed crack patterns and provide a logical interpretation of the failure progression.

Figure 7. Stress distribution in soil after the failure in anchor A1.

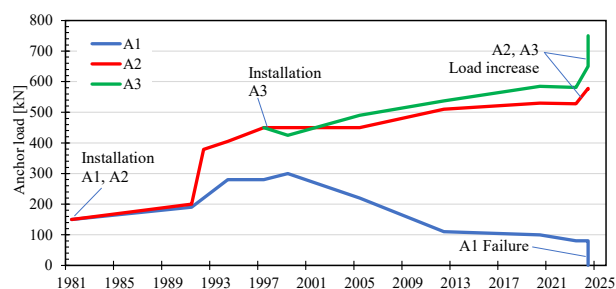
Over the years, the anchor forces continued to increase until 2023, when a sudden drop in the load carried by anchor A1 was recorded, decreasing to 80 kN. Concurrently, the forces in anchors A2 and A3 rose to 528 kN and 581 kN, respectively. One year later, anchor A1 failed completely, without any remaining load contribution, resulting in further increases in the loads carried by anchors  $A2=575$  kN and  $A3=750$  kN. These values significantly exceeded the original design capacities of the respective anchors. This behavior is comparable to the finding of Daxer et al. (2024) that noticed in a 3D numerical simulation and analysis, that the stress redistribution after an anchor failure in an anchor group, caused an increase in load of the adjacent anchors up to 21%.

The anchor specifications are listed in Table 1. While the development of anchor loads from the installation of A1 and A2 in 1981 till the failure of A1 in 2024 are present in Figure 8.

Figure 8. Measured the load of the existing anchors.

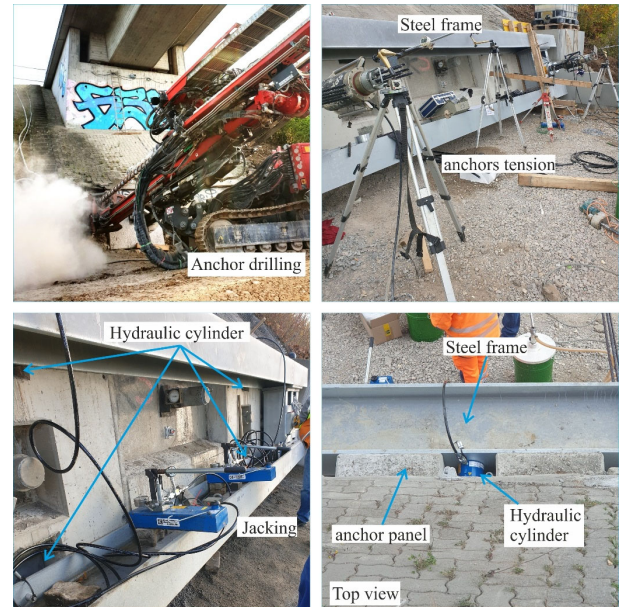
Figure 10. Installation of the additional anchors with jacking system.

The initial loading steps were carried out on the outer anchors A4 and A7 at the same time, in increments of 50 kN up to a total load of 150 kN. Subsequently, the same loading procedure was applied to the inner anchors, A5 and A6. Shortly after the lock-off of anchors A5 and A6, a redistribution of loads occurred within the system, resulting in an increase in the load on anchor A7 to 173 kN and a reduction on anchor A5 to 140 kN. To restore balance within the system, hydraulic jacking was performed, primarily on Panel 1 (left side), in order to increase the load carried by anchors A4 and A5. Following this adjustment, the anchor loads stabilized at A4=160 kN, A5=147 kN, A6=146 kN, and A7=169 kN. This final load configuration reflects a symmetrical distribution across the new anchorage system.

After 20 days, a reduction in anchor loads was observed, which was likely due to the strand strain (elongation) in the free length of the anchors. As a result, re-jacking was necessary to restore adequate support loads and to prevent further displacement of the slope. The re-jacking procedure was carried out similarly to the previous adjustment, with a focus on the left side of the system where the load reduction was more pronounced. Following the re-jacking, the loads stabilized at A4=171 kN, A5=162 kN, A6=128 kN, and A7=150 kN. The loading steps are listed in Table 3. The installation of the additional anchors with the jacking system is shown in Figure 10.

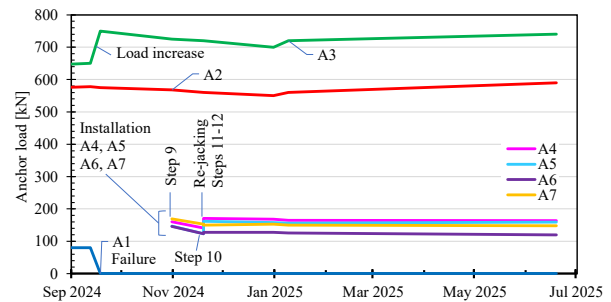
During the installation of the additional support system and in the subsequent monitoring period, the existing anchors A2 and A3 exhibit slight fluctuations in the recorded load measurements. These variations are likely attributable to temperature changes, which can influence the accuracy of pressure gauges and load cells. Figure 11 shows the measured load for the existing as well as the new additional anchors.

Figure 11. Measured load of the anchors after the installation of the additional anchors.

The newly installed anchors (A4–A7) effectively carried the reaction loads, fully compensating for the failed anchor A1. Since then, no significant change in anchor forces has been observed; therefore, the load distribution has remained stable and within the design limits, as it is clearly noticed in Figure 11.

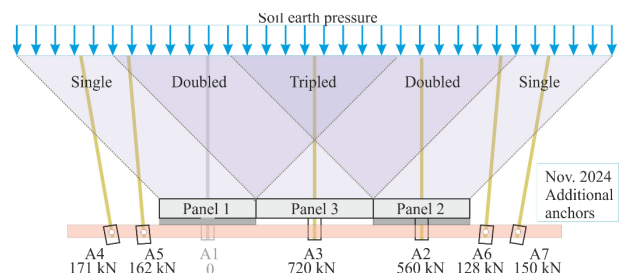
The four additional anchors were installed and connected to the compensatory steel frame. This frame was supported by the new anchors and braced exclusively against the existing panels 1 and 2 corresponding with anchors A1 and A2. Using hydraulic jacks, particular emphasis was placed on reactivating the soil reaction behind the left-side panel 1, thereby rebalancing the load distribution and restoring stress equilibrium behind the anchorage system. As illustrate in Figure 12, a redistribution of the stress behind the anchor panels is ensured, which has a considerable contribution to the reduction of the stress asymmetry behind the panels.

Figure 12. Stress distribution in soil after installing the additional anchors A4, A5, A6 and A7.

The supporting additional anchorage system has the capacity to support more increments in load and redistribute the associated stress on the both sides for the long-term lifespan of the structure. Furthermore, any stress unbalanced in the system can be controlled and adjusted via the hydraulic jacks.

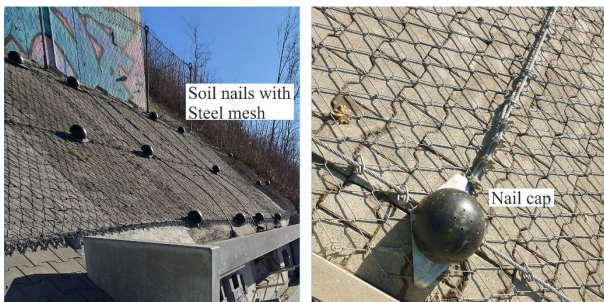
Figure 13. Soil nail with steel mesh.

The soil nails were combined with a high-tensile steel mesh installed across the surface of the embankment. This mesh facilitates the distribution of loads between the nails over the surface area of the embankment, thereby providing surface stability and preventing shallow slips. In addition, it serves as a protective barrier, preventing cobblestones from detaching and falling onto the highway below, as shown in Figure 13.

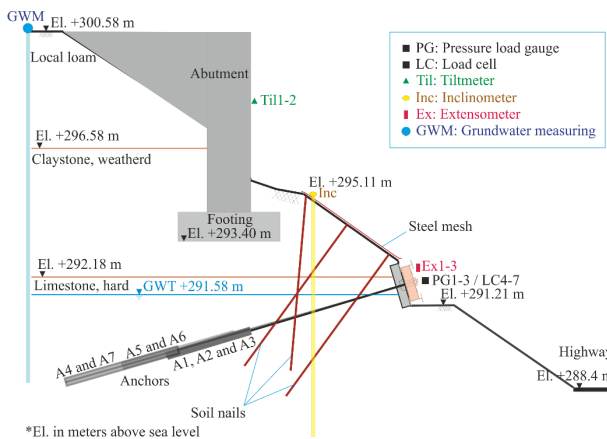
Figure 14. Side view – remediation measures and monitoring system.

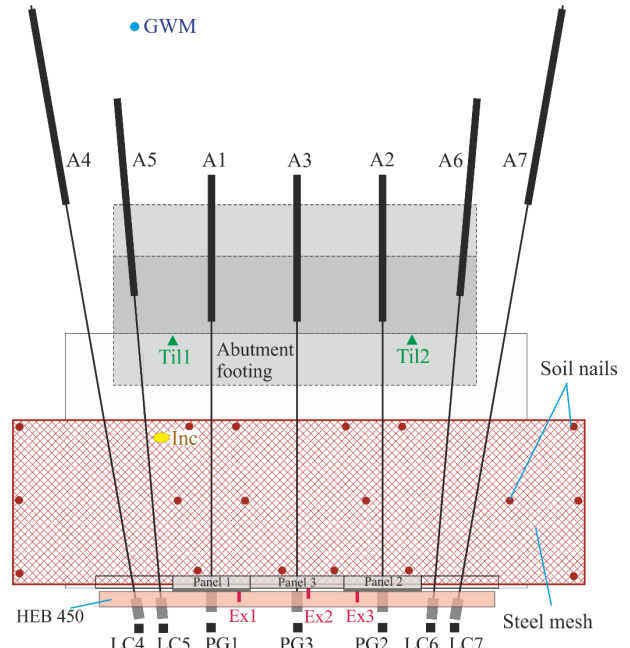
Figure 15. Top view – remediation measures and monitoring system.

The instrumentation includes: Load cells installed at the heads of the newly added anchors to continuously measure anchor forces; An inclinometer, was used in a vertically cased borehole, recorded lateral ground movements at various depths of the embankment; Extensometers were used to monitor the displacement of the existing anchor panels along the direction of the anchor strands; Tiltmeters used on the abutment to detect rotational movements around two axes; And a groundwater monitoring well implemented to observe real-time changes in the groundwater table, which could affect slope stability. Figure 14 and Figure 15 display the location of the sensors over the embankment and the anchorage system. Figure 16 displays a view after the implementation of remediation measures.

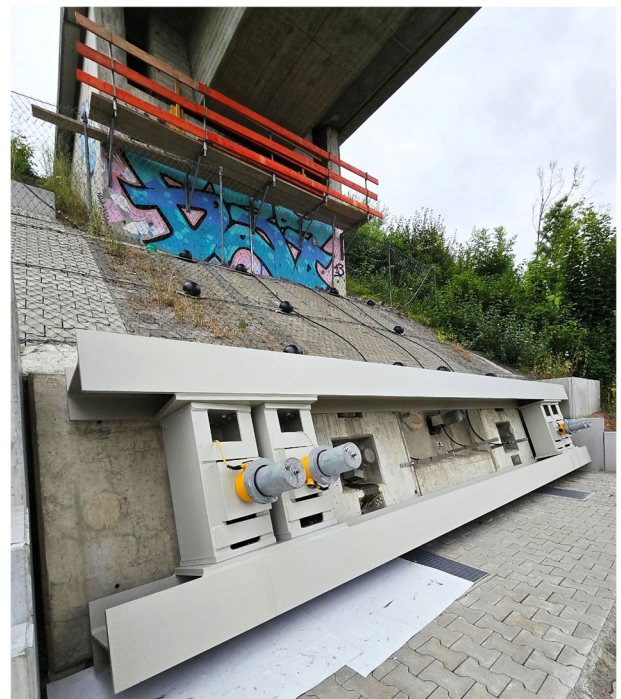
Figure 16. General view for the embankment after the remediation.

The consistent results from the monitoring system confirm that the slope remains in a stable condition. Furthermore, no additional visible cracks or structural damages have been observed on the embankment surface or the stairway.

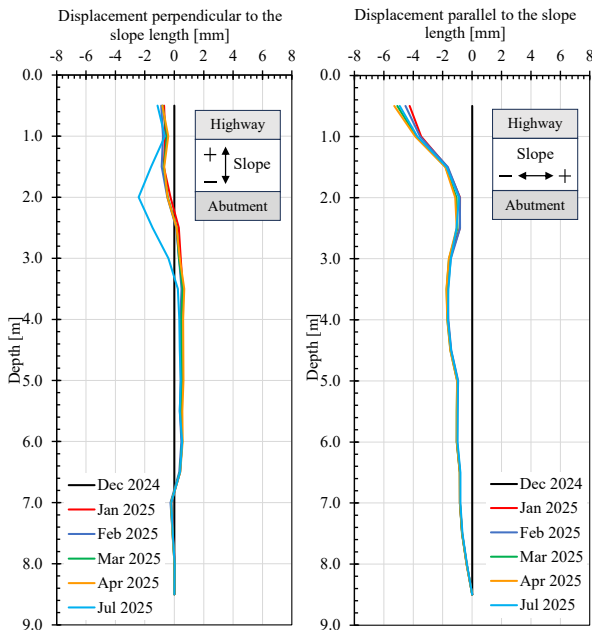
Inclinometer data revealed that within the first month following the remediation, the slope experienced a lateral displacement parallel to the highway direction of approximately 4.5 mm. Thereafter, the rate of movement decreased significantly. Within the subsequent measurements, an additional displacement of about 1 mm takes place, as shown in Figure 17.

Figure 17. Slope deformation in both directions – inclinometer results.
