# Failure Analysis and Proposed Repair and Retrofit Schemes for a Mechanically Stabilized Earth Wall System in Metro Manila, Philippines

**Francis Jenner Bernales, Marielle Gwen Martinez, Desz Justinne Ocampo, Roy Anthony Luna**  
*AMH Philippines, Inc., Quezon City, Philippines, [francis.bernales@amhphil.com](mailto:francis.bernales@amhphil.com)*

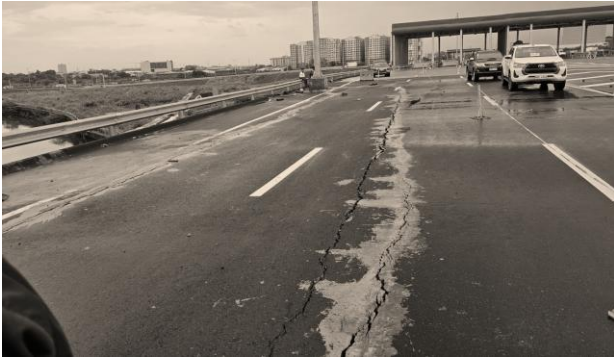
The severity of the reported damage was evaluated through a coordinated field reconnaissance. The most prominent manifestation was observed on the asphalt concrete pavement, where longitudinal cracks extended along the shoulder and outermost lane (Figure 1). Initial repairs using concrete infill and sealant temporarily mitigated the issue; however, the cracks continued to propagate over time.

Measurements taken during a follow-up site inspection, conducted about a month later, showed that the tension cracks widths increased to 15 to 30 mm and differential settlements of approximately 20 mm. Closer examination of the crack openings on the pavement raised concerns about possible subbase erosion or migration. To investigate, an exploratory excavation pit measuring 0.6 m in width, 3 m in length, and about 1 m in depth was opened to check for signs of material loss. However, no definitive evidence of aggregate subbase migration due to internal water flow was observed.

Figure 1. Pavement cracks with differential settlement.

Site inspections have confirmed progressive propagation of longitudinal pavement cracks, with widths of 15–30 mm and differential settlements of approximately 20 mm. To prevent further deterioration, immediate measures are recommended to limit water ingress and restrain ongoing deformation until permanent works can be implemented.

The first measure involves covering the pavement cracks with polyethylene (PE) sheets—commonly referred to as tarpaulin—to act as temporary drainage barriers (Figure 9). These will prevent surface water infiltration into the cracks, which could otherwise accelerate subgrade weakening, reduce shear strength, and increase hydrostatic loading in the embankment due to inadequate internal drainage. The sheets shall be securely fastened using traffic barriers or equivalent means.

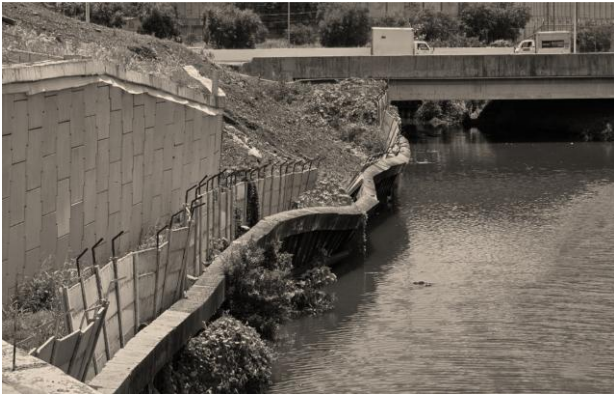
Some sheet piles, originally installed for creek or riverbank protection at least three years before the expressway project, have also exhibited significant tilting. The excessive deflection is likely attributable to a combination of factors, including erosion, scouring along the outer bend, and additional lateral loading from the road embankment, which may have effectively reduced the embedment depth of the sheet piles.

Figure 2. Tilting of sheet pile walls.

Measured deflections of 2 to 3 m in the existing sheet pile wall indicate yielding and irreversible deformation of the steel section. A new sheet pile wall is therefore recommended, to be constructed with a minimum offset of 3 m from the MSE wall facing to allow working space for subsequent MSE wall retrofit works. Deadman anchors will be installed near the top of the new sheet pile wall to provide additional lateral restraint.

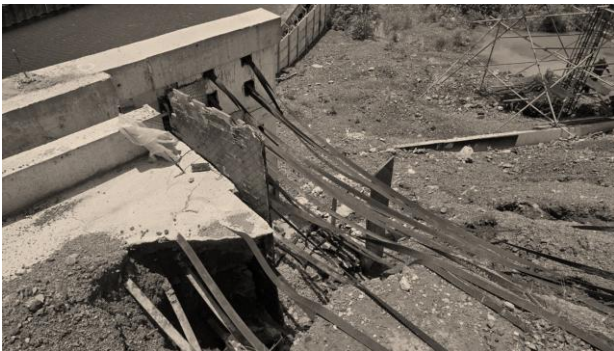
Further inspection of the slope protection system revealed that portions of the embankment at the start and end sections of the MSE wall had been eroded, with displaced material sloughing onto the wall fence and creek revetment (Figure 2). Consequently, the geosynthetic strip reinforcements (“geostrips”) of the MSE wall have become exposed in these areas (Figure 3).

Figure 3. Exposed geosynthetic strips of the MSE wall due to erosion.

evidence (Figure 3) suggests that only single-reinforcing action may have been achieved, reducing available tensile capacity. Deviatoric strain plots (Figure 8) identify a sliding surface associated with pullout failure, which, when analyzed for FS, yields a value of 1.33—slightly higher than the LEM-derived FS but still below acceptable thresholds.

Certain site phenomena could not be fully modeled in either method. Notably, localized scouring beneath the U-ditch drainage outlet at the MSE wall terminations (Figure 3) has caused loss of reinforced fill and exposure of geosynthetic strips, reducing facing support and accelerating distress. Additionally, the concave plan geometry of the MSE wall (Figure 2) may induce arching effects that inhibit outward deformation, suggesting that the 2D analyses may be conservative when applied to back-analysis and retrofit design.

Reconnaissance surveys identified localized washout at both ends of the MSE wall. To ensure smooth transition from the wall termination to the natural ground and to eliminate scour at U-ditch outlets, the MSE wall should be extended at both ends. Terminations will be daylighted to the existing ground profile and provided with erosion protection. The external drainage (U-ditch) will be connected to catch basins or piped outlets. To accommodate the MSE wall extension, the existing slope will be regraded and stabilized using soil nails with shotcrete facing (Figure 10).

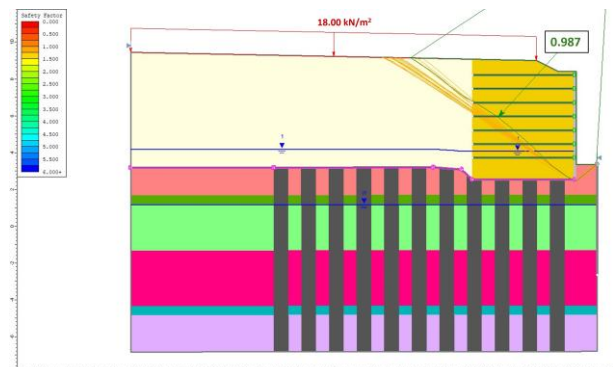
Limit equilibrium analysis for the MSE wall section (Figure 4) indicates that some critical slip surfaces have FS values below the allowable threshold. The slip surface with the global minimum FS (0.987) is shown in green. Analysis results suggest that ground improvement using soil–cement columns (SCC) and geotextile reinforcement constrained slip surfaces to the zone between the geotextile and the MSE wall levelling pad. Critical slip surfaces extend through the reinforced fill and daylight at the finished grade line beneath the pavement layers.

Figure 4. LEA critical sliding surfaces at MSE wall section.

Elevated porewater pressures, associated with a perched groundwater table above the geotextile (Piezometric Line 1), further reduced stability. Even under static loading without the full highway live load, the calculated FS at the MSE wall section indicates that the 5.5 m reinforcement length is likely insufficient.

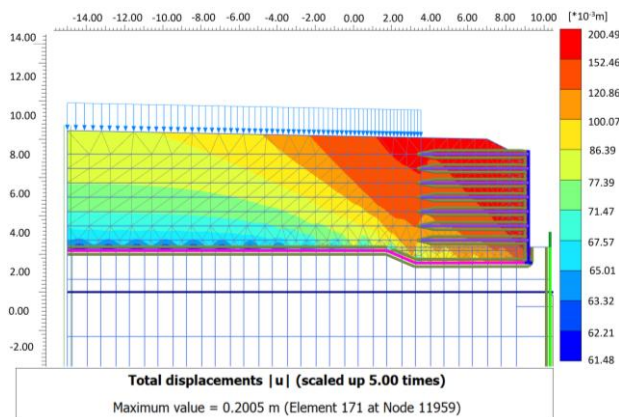
Figure 6. Color plot of total (resultant) displacements in the MSE wall section with the adjacent sheet pile.

FEM results show large lateral displacements (up to 0.2 m) concentrated within the reinforced soil zone (Figure 6), indicating outward movement of the MSE wall. The analysis also captured a potential pullout mechanism at the geosynthetic strip–fill interface. The two lowermost strips developed peak axial forces of 23.05 and 22.86 kN/m (Figure 7), approaching their design tensile strength of 25.3 kN/m.

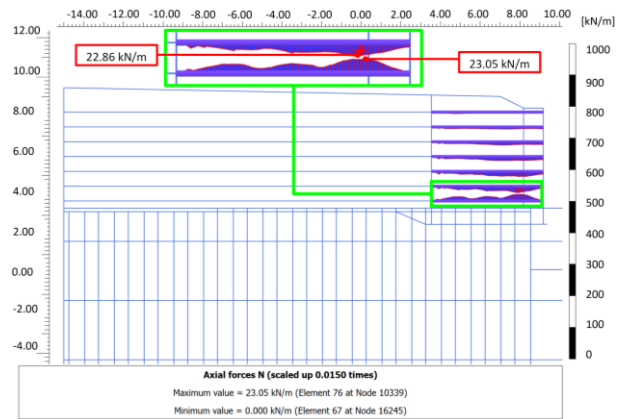
Figure 7. Axial force distribution in geosynthetic strip reinforcement.

FEM results provide further detail, capturing a potential pullout mechanism in the two lowermost geosynthetic strips, with peak axial forces of approximately 23 kN/m approaching their design tensile strength. While the recommended geosynthetic strip configuration should result in a double-reinforcing action, field

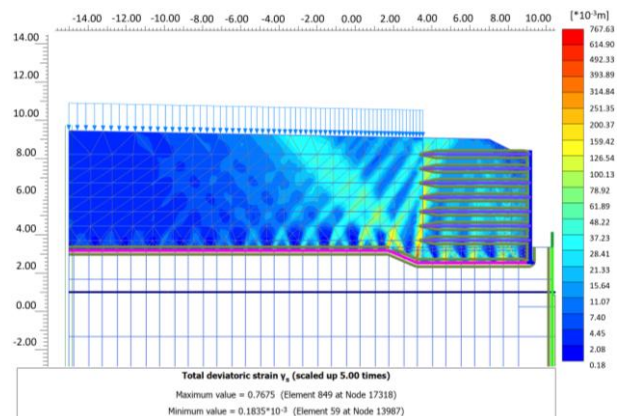
Figure 8. Color plot of total deviatoric (distortional) strain plot in the MSE wall section with the adjacent sheet pile (FS = 1.33).

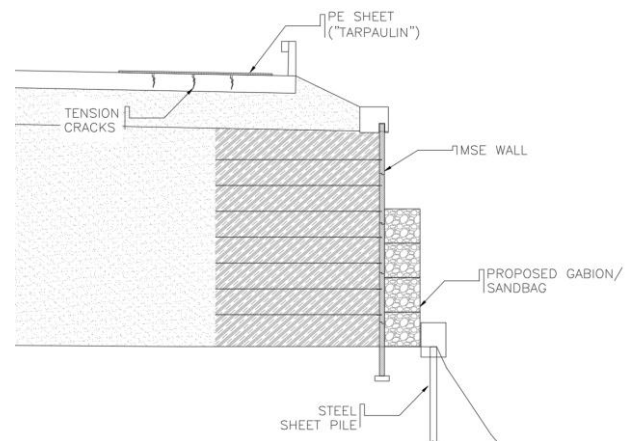
Figure 9. Polyethylene sheet cover and temporary buttress.

Monitoring records indicate that the MSE wall is out-of-plumb and undergoing outward displacement. To provide interim structural restraint, a temporary buttress using gabion baskets or sandbags is proposed at the wall toe (Figure 9). This countermeasure will partially offset the overturning moment acting on the wall and stabilize its facing until the installation of long-term reinforcement systems.

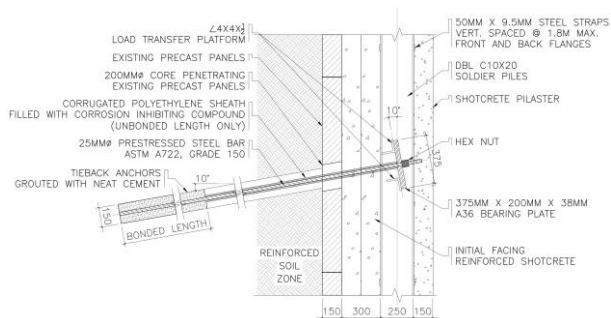
Figure 11. MSE wall retrofit using prestressed anchor, shotcrete facing, and soldier pile construction: section view.

Grouted, prestressed tieback anchors will be installed to prevent additional wall movement (Figure 11). Reinforced shotcrete will be applied to the wall facing to increase bearing thickness during prestressing. Anchor and pile positions will be marked using reinforced shotcrete pilasters to facilitate future inspections and maintenance (Galvan, 2010).
