Modelling Sand Boiling of a Detention Basin due to Internal Erosion During River Flooding

ABSTRACT: A detention basin was constructed below ground level adjacent to a river bridge abutment in northern NSW, Australia. The basin is located approximately 100 m landward of a levee designed for a 27-year return period flood. The subsurface profile comprises continuous sand and gravel layers up to 25 m thick, creating strong hydraulic connectivity between the river and the basin. During a 1-in-12-year flood, the river level rose to RL 6.5 m. Groundwater ingress and sand boiling were observed at the basin floor when its water level reached RL 1.5 m (i.e. about 0.5m above basin floor level). There was also observation of substantial loss of soil strength at the peripheral of the basin floor at the time of sand boiling. Shortly after sand boiling was detected, tension cracks and slope slippage were observed at the basin batter and the adjoining approach embankment of the highway. This paper presents a detailed numerical modelling study using transient flow analysis to investigate groundwater flow leading to sand boiling at the detention basin. A novel approach using a dummy material was em

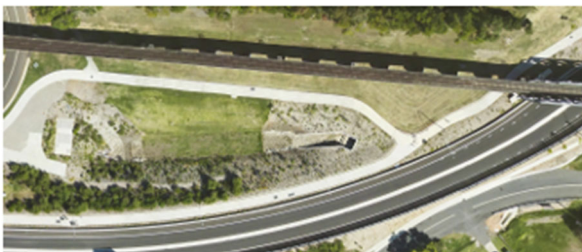
The basin floor was turfed and was normally dry when it was not used to store stormwater runoff. Sandy loam topsoil of about 0.3 m thickness was placed at the basin floor and batters to promote growing of the native grasses. Figure 2 shows the basin shortly after construction.

Figure 2. View of the basin shortly after construction

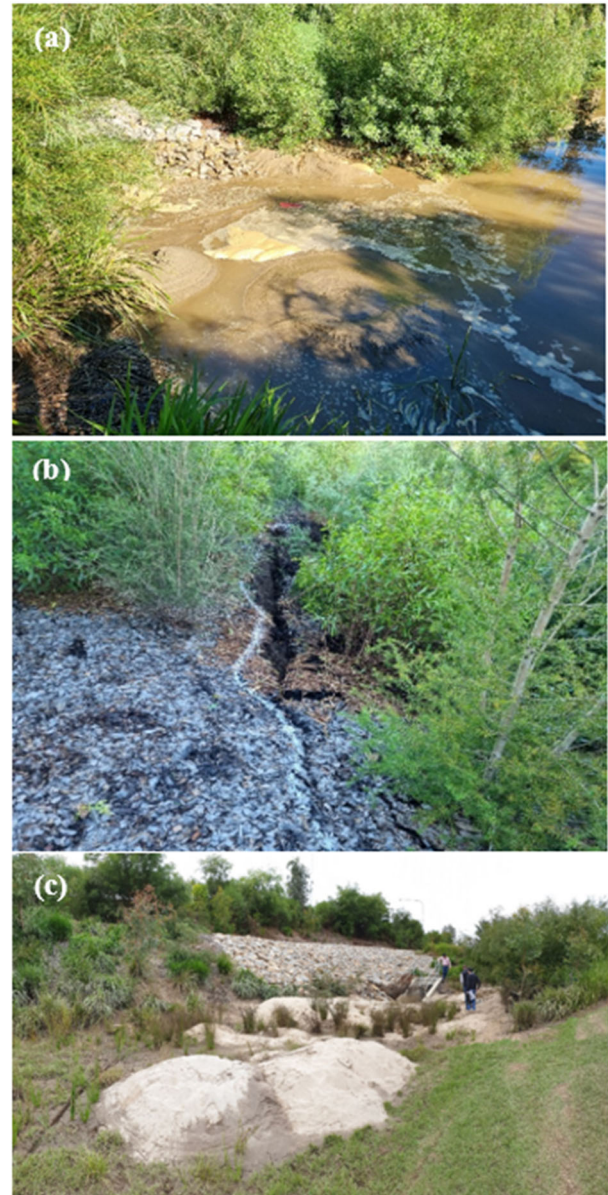
On 24 March 2021, the water level in the river was recorded as high as RL 6.5 m, equivalent to approximately a 1 in 12-year flood event, but remaining below the crest of the levee without overtopping failure. At the same time, there was minimal raining within the region and flooding of the nearby town was not observed. Ingress of groundwater and sand boiling were observed at around 8:00 am (Figure 3a) when the water level in the basin reached around RL 1.5 m, i.e. about 0.5 m above basin floor level. There was also observation of substantial loss of soil strength at the peripheral of the basin floor. Tension cracks (Figure 3b) were observed at the basin batter at around 3:00 pm and movement was also observed at the top of the road embankment. Sand boiling was observed to gradually subside when the basin water level rose to approximately RL 2.5 m (Figure 3c).

Figure 3. Observations of (a) water ingress and sand boiling in basin; (b) tension cracks on basin batter on 24 March 2021; and (c) sand deposited on basin floor after water subsided.

Another major flood event occurred on 28 February and 1 March, 2022 reaching a maximum level of RL 7.6 m for a few hours. Further sand boiling was observed resulting in significant erosion of the basin floor. Further embankment movement occurred with cracking at the embankment bench and tension crack opening up at top of the road embankment. Over 30 mm of lateral displacement at the road embankment was recorded. Settlement of the box culvert at the southern side of the basin of about 1 m was also detected. It was also observed that sand boiling appeared to have occurred at similar locations to those in March 2021.

Emergency measures were implemented at the time of sand boiling, which included allowing the basin water level to rise to RL 2.5 m and backfilling the slip zone of the basin batter with rock fill.

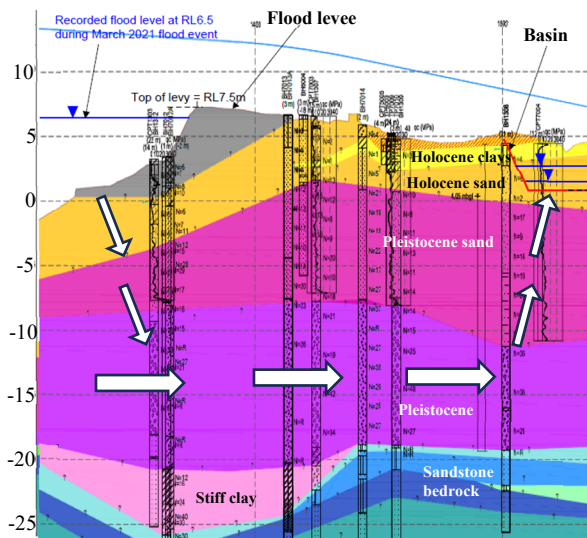
A typical long section is shown in Figure 4 together with the approximate outline of the existing basin and notable water levels reported during the March 2021 flood event.

Figure 4. Typical long section and outline of the basin (exaggerated vertical scale)

The preferential flow path has been assessed in seepage analysis as shown in Figure 10a and has also been shown diagrammatically in Figure 4. As the river water rose to RL 5.6 m (at approximately 5 am on 24 March per Figure 9), the groundwater was assessed to have entered the basin with a basin water level at RL 1.3 m (0.3 m above basin floor). Pore water pressure was assessed to have built up below the sandy loam layer at this point of time as it has a lower permeability than that of the underlying Holocene sand. For example, the assessed total stress at Point A (see Figure 10b) below the sandy loam was 11 kPa, which was lower than the assessed pore water pressure of 16 kPa. The assessed effective stress was -5 kPa, hence indicating the occurrence of sand boiling. As the basin water rose further to RL 2.4 m (1.4m above basin floor, see Figure 10c), it was assessed that sand boiling subsided as indicated by the positive effective stress at Point A (+2 kPa = total stress of 22 kPa – pore water pressure of 20 kPa). The assessed results outlined above are consistent with the observations outlined in Section 4.1.

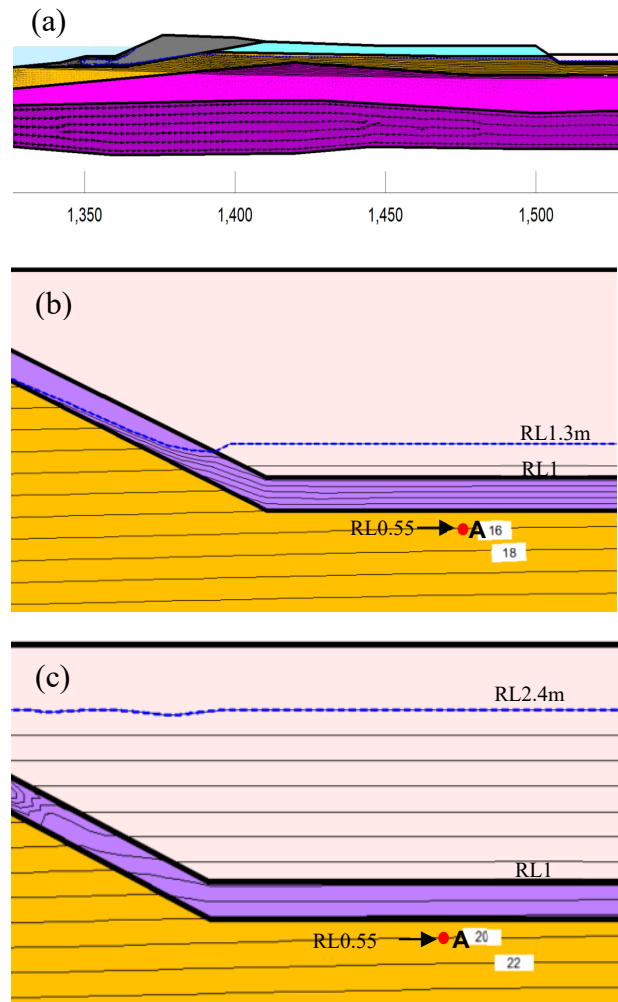
Figure 10. SEEP/W transient flow analysis results: (a) water flow vector, (b) pore water pressure contour with basin water level at RL 1.3m, and at (c) pore water pressure contour with basin water level at RL 2.4 m

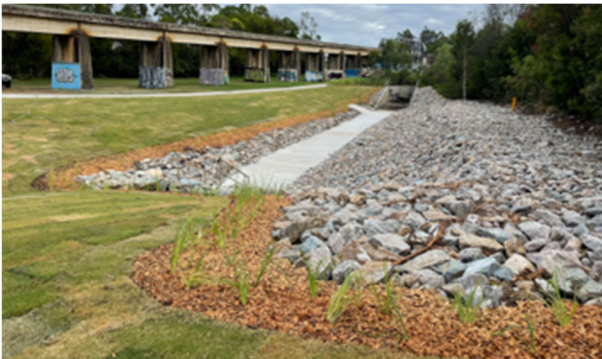
Figure 11. View of the basin shortly after construction of the remedial works

The adopted final solution was essentially Option 1 where invert of the basin was lined with 150 mm thick concrete over 1 m thick rockfill and high strength geotextile. The selection of this option was mainly based on aesthetic and public preference considerations.

The low permeability sandy loam at the basin floor was removed prior to placing the rockfill layer. The completed remedial work is shown in Figure 11.
