# Rainfall-induced collapse of old railway embankments in Norway

Heyerdahl H., Høydal Ø., Nadim F., Kalsnes B.G.  
*Norwegian Geotechnical Institute*

Børsting T.  
*Norwegian National Rail Administration*

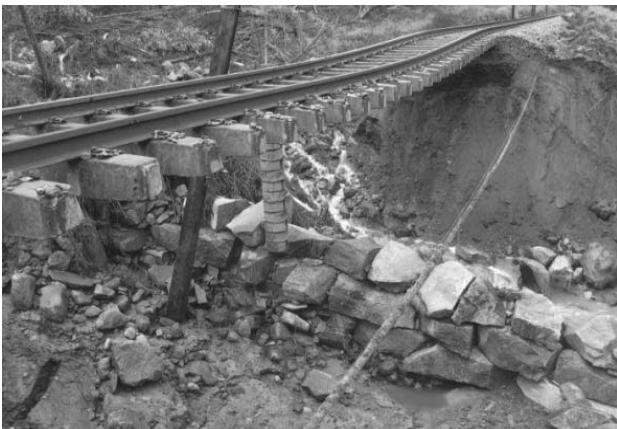
In 2011 damage was frequently caused by flash floods following intense short-duration rainfall. High discharge may result in upstream damming of water due to the culvert being unable to transport the discharge from the catchment, unless the water finds alternative ways underneath or through the embankment (which in turn destabilized several embankments constructed of sand during the same period). Damming of water will increase pore-water pressures in the embankment and lead to collapse of a construction which needs drained conditions to remain stable. Overtopping of embankments is particularly disastrous, especially for embankments constructed of materials that are easily eroded, as sand and silt. Embankments may experience rapid and total destruction under such conditions. A photo showing an example of complete destruction of the embankment around a culvert is shown in Fig. 1. Note that the embankment is mainly constructed of relatively fine, sandy soil.

Figure 1. Example of total destruction of embankment around culvert near Ål, Bergensbanen railway line (Oslo to Bergen).

Improved maintenance, redesign and reconstruction of culverts may reduce problems in the future. However, the high number of culverts lines (tens of thousands) indicates that similar collapses of embankments may still be a problem in the future. Improved design of culverts with built-in safeguards (increased cross section, double pipelines etc.) is possible, but costly judged from normal maintenance budgets. Modernization normally is restricted to already known problem areas. This will keep existing culverts mainly unaltered and still contributing to a high future risk.

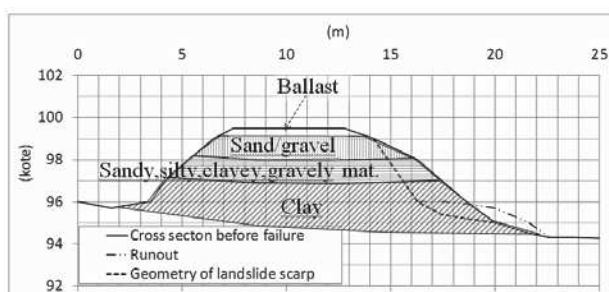
A slope failure at a railway embankment at Tomter occurred on 23<sup>rd</sup> December 2011. The line was not physically cut off, but train traffic was stopped until inspection by geotechnicians from NGI was made the following day. A cross section is shown in Fig. 2. Field survey was somewhat hindered by low temperatures and a thin frozen crust that had developed through the preceding night. It was found that the embankment consisted of a bottom layer of clay on top of the natural terrain (marine clay), followed by a layer with high sand and silt content. Above this layer there was a 1 m thick layer of sand and gravel, added in a general uplift of the track around 1950-60, and at the top crushed rock ballast. In spite of the elevation above the surrounding terrain, the sandy/silty layer was observed to be very moist, and appeared almost liquefied. The water content  $w$  of a bag sample was measured to 17.5 %. In situ saturation rate of the sandy/silty layer may not be determined from a bag sample (in situ density is unknown and water is lost during sampling), but this indicates that the sandy/silty layer may in fact have been close to full saturation prior to the slope failure.

**Figure 2.** Cross section of failed embankment at Tomter, Østfold county railway line. Geometry of slope failure 23<sup>rd</sup> December 2011 is indicated. Natural soil below embankment is marine clay.

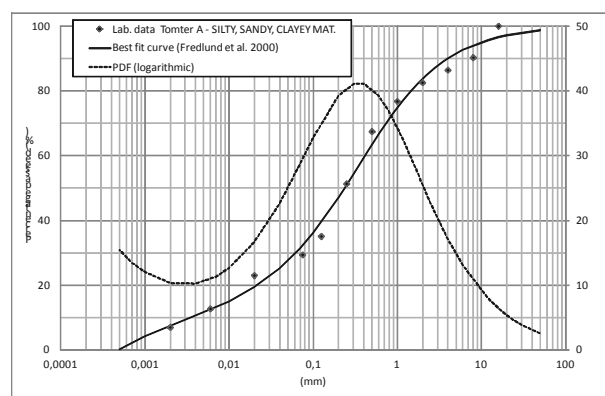
Results from grain size distribution (GSD) analysis of the sample are summarized in Table 1 and Fig. 3. The moist layer described in field as a sandy/silty layer is characterized as sandy, silty, gravelly and clayey material, according to terminology and grain size limits defined in Norwegian Geotechnical Association (1982). The soil is well graded.

differentiating the GSD-curve. The PDF will correctly represent the most frequent particle size when first taking the logarithm of the particle size, see Eq. 2 (Fredlund et al. 2000), in which  $P_f(D)$  is the logarithmic PDF. For the analyzed sample the most frequent particle sizes are found in the sandy fraction, with a peak at 0.3-0.4 mm. This corresponds with the laboratory description of the soil, where the first adjective (“sandy”) nominates the largest mass fraction.

**Figure 3.** Results from laboratory GSD analysis, empirical GSD function and logarithmic PDF (Fredlund et al. 2000).

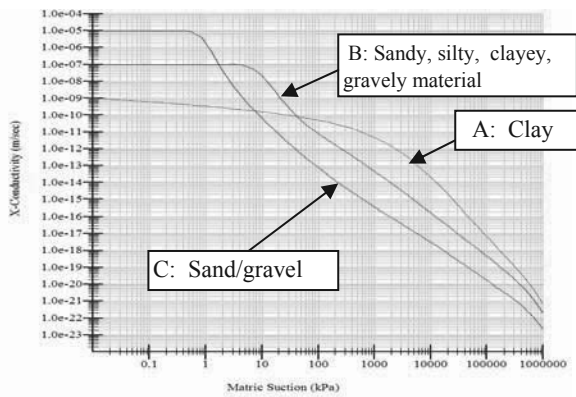
The hydraulic conductivity curves show the well-known effect that less permeable clay (when saturated) is more permeable than coarse-grained soils for high matric suction.

Figure 4. Hydraulic conductivity curves used in seepage analysis for layers A, B and C.

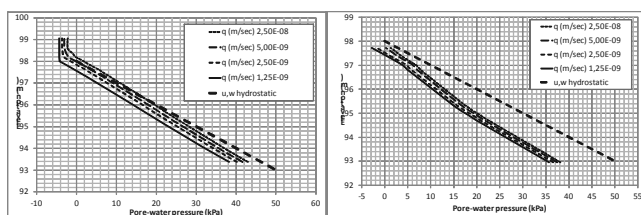
To get an idea of the range of pore-water pressures resulting from infiltration seepage analyses were made for varying values of constant infiltration. Annual rainfall in the region corresponds to ca. 2.5E-08 m/sec, ~800 mm/year (Norwegian Meteorological Institute 2011). Runoff will result in infiltration being smaller than the rainfall. Constant infiltration on the surfaces of the embankment has been varied between 1.25E-09 and 2.5e-08 m/sec. Results are shown in Fig. 5 for two profiles, one at the centre and one at the edge of the embankment. Applied infiltration rates are equal on top of the embankment and on the slopes. Subsequent analyses reducing infiltration rates on the slopes did not result in substantially different results. Seepage boundaries are used to find the extension of seepage zones at the bottom of the slopes. From the seepage analyses, it appears that even low infiltration rates produce positive pore-water pressures in layers A and B. The pore-water pressures at P1 at the centre of the embankment vary between 80 and 90 % of hydrostatic pore-water pressure for the chosen range of infiltration rates. For P2 at the edge of the embankment the pore-water pressures vary between 70 and 75 % of hydrostatic pore-water pressure.

Figure 6. Calculated and hydrostatic pore-water pressure vs. depth for profile P1 (left) and P2 (right) as indicated in Fig. 5.

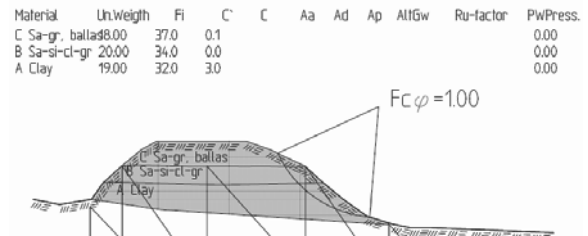
may be used. Stability calculations for the embankment with positive pore-water pressures from top of layer B result in critical values the safety factor (~1.0) for realistic choices of shear strength parameters. In Fig. 7 results are shown for 75-90% of hydrostatic pore-water pressure distribution from top of layer B. It is underlined that strength parameters were not measured. Stability analyses were done by the limit equilibrium method using the software package GeoSuite Toolbox (ViaNova Systems 2007).

Figure 7. Stability calculation. 75-90% of hydrostatic pore-water pressure from top of layer B. Shear strength parameters shown at top.

The soils in the embankment prevent water from being drained from the construction. The situation probably varies through the year, and factors not taken into account in the analyses may improve or worsen the situation. Additional water may be transported along the embankment from other areas, on top of the clay layer which may be deformed by settlements, or by capillary suction in layer B. The particular worry for this kind of slope stability problem is that there are normally not clear any precursors to the failure and destabilization of the embankment is not easily observed.
