The geotechnical analysis corresponding to the high road embankments close to a bridge

Chirica A.

ABSTRACT: The paper presents a complex study case corresponding to a road embankment until 10m height placed at Iassy, Romania. It is about the access embankments at a bridge with total length of about 300m. After one year of service the studied embankments presented the following geotechnical problems: longitudinal cracks parallel and along with road axis, lateral knobs corresponding to each compacted layer, infiltrations through the backfill from the top (faulty pluvial system) and from the bottom (flooded foundation soil without drainage system). Foundation soil is metastable clay. Triaxial tests type CKoD on stress loading paths has shown that this soil is sensitive to moistening at shear stresses. The embankment is made also from a clay unusually used for such type of structures and several geosynthetic layers. At the top there is an elastic pavement. The footwalks over the embankment are from reinforced concrete and are bracket assembled. The finite element model has taken into account various hypothesis: 1. Model with the soils in natural state, 2. Model with foundation soil i

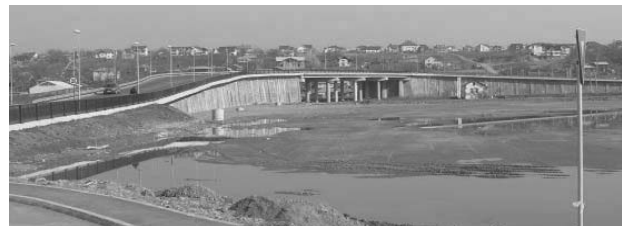
Figure 1 General view of the embankment

The object of this paper is to present the analysis of a road embankment with variable height (between 4-10m) placed at Iassy, Romania (Fig. 1, 2, 3, 4). This embankment presents from the first year of service longitudinal cracks parallel with road axle, lateral knobs corresponding to each compacted layer, infiltrations through the backfill from the top and from the bottom. The owner employed an investigation team to identify, analyse and propose consolidation work for this embankment.

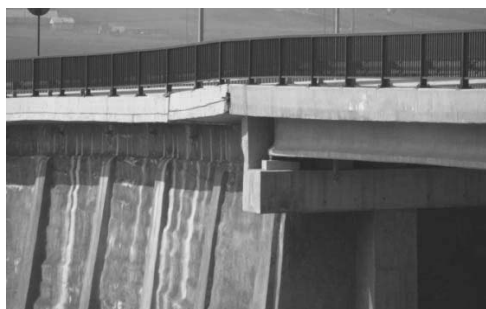
Figure 4 Zone between embankment - bridge.

- Foundation soil of embankment is almost every time of the year floded. Bahlui river is not flood controlled in that area.
- Backfill was loose on the edges of the embankment due to the lack of technology used in civil works (Fig. 4).

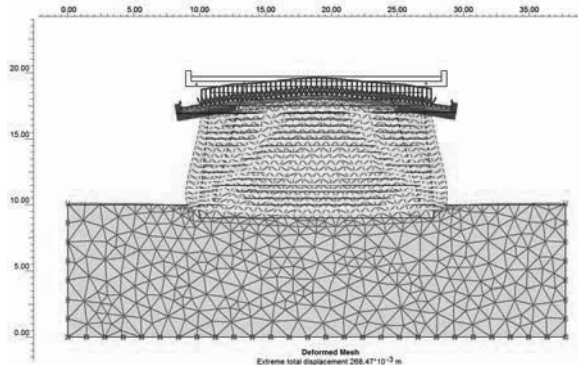
Figure 6 Deformed mesh.

- a) Model 1: the maximum total displacement is 280mm (at the edge the sidewalks - Fig. 6). As it can be seen in Fig. 10 the plastic points appear at the edges of the embankments and in the central part of soil foundation at a approx. depth of 5m. Also, a very important notice is that the plastic points also appear at the edge of the embankment at maximum 1m around the body of backfill.

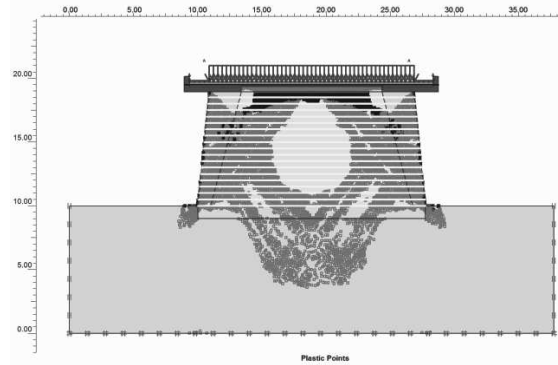
Figure 10 Plastic points.

The conclusion of this calculus is that the maximum total displacement is 280mm (at the edge the sidewalks - Fig. 9). As it can be seen in Fig. 10 the plastic points appear at the edges of the embankments and in the central part of soil foundation at a approx. depth of 5m. Also, a very important notice is that the plastic points also appear at the edge of the embankments at maximum 1m around the body of backfill.

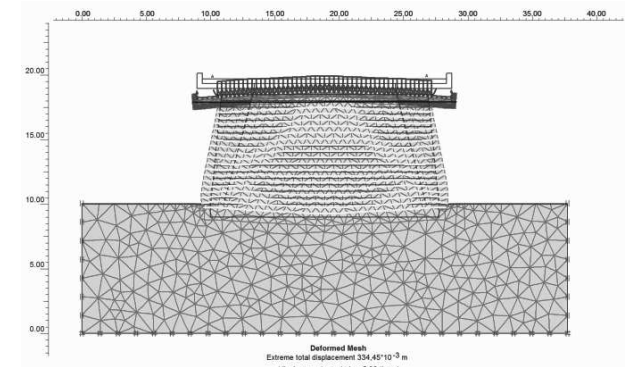
Figure 11 Deformed mesh.

- b) Model 2: maximum total displacement is 33,5mm (at the edge the sidewalks - Fig. 11). As it can be seen in Fig. 15 the plastic points appear at the edges of the embankments and in the central part of soil foundation at a approx. depth of 10 m. Also, a very important notice is that the plastic points also appear at the edge of the embankments at around 5m around the body of backfill. From Stability analysis we can see that the structure is almost permanent at limit having a factor of safety 1,105. Fig. 16 show us that the embankment structure has a very small reserve in strength for seismic action.

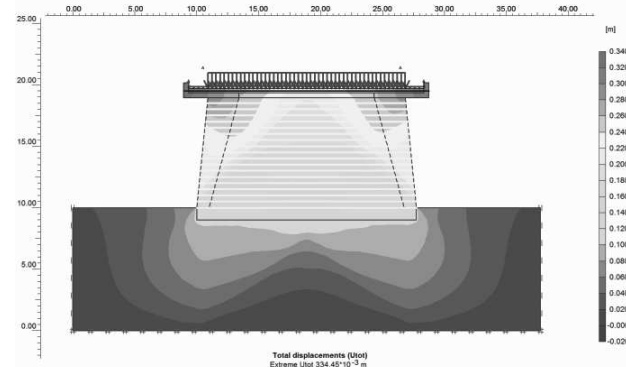
Figure 12 Total displacements.

The conclusion of this calculus is that the maximum total displacement is 33,5mm (at the edge the sidewalks - Fig. 12). As it can be seen in Fig. 15 the plastic points appear at the edges of the embankments and in the central part of soil foundation at a approx. depth of 10 m. Also, a very important notice is that the plastic points also appear at the edge of the embankments at around 5m around the body of backfill. From Stability analysis we can see that the structure is almost permanent at limit having a factor of safety 1,105. Fig. 17 show us that the embankment structure has a very small reserve in strength for seismic action.

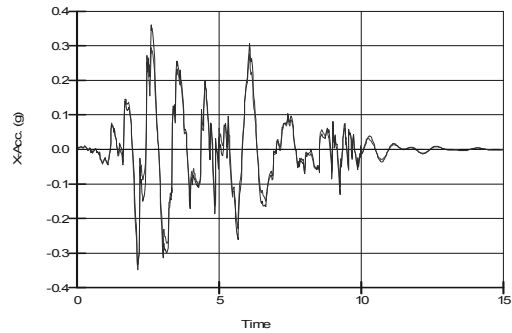
Figure 17 Time history (x-acceleration) - output.

The conclusion of this calculus is that the maximum horizontal acceleration at the top of the embankment is 0,35g. From stability analysis we can see that the structure is unstable having a factor of safety 0,995.

- c) Model 3: the maximum horizontal acceleration at the top of the embankment is 0,35g. From stability analysis we can see that the structure is unstable having a factor of safety 0,995. Fig. 17 shows that the embankment structure has no reserve in strength.

- f) To realize this works uncohesive soils are recommended; all tests on Bahlui clay show that this material is not proper to be used safely for embankments.
