Investigation of Reinforced Earth Structures Following the 2011 Tohoku Earthquake

Otani Y., Takao K.

ABSTRACT: An investigation of mechanically stabilized earth (MSE) structures constructed with Reinforced Earth (Terre Armée) technology¹ was carried out after the 2011 Tohoku Earthquake in Japan. Reinforced Earth walls examined for the survey were ranked according to associated disaster-caused damages. The results of this research indicated high levels of earthquake resistance in the steel-reinforced structures constructed with this technology method.

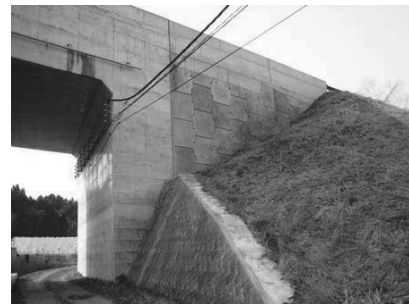
Photo 1. Wall in the area of seismic intensity upper 7 (Rank II)

Damage to a pair of wing walls constructed adjacent to an abutment in an area hit by intensity 7 tremors (shown in Photo 1) was evaluated as Damage Rank II, and the only defects that

could be observed were displacement in the foundation of a protective fence and broken corners of a single wall panel.

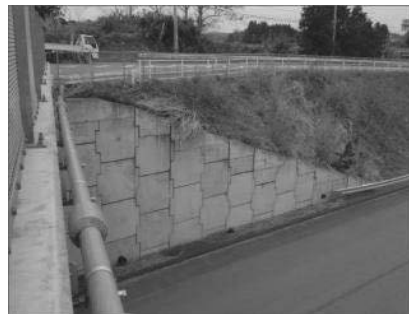
Photo 2. Wall in the area of seismic intensity 7 (Rank I)

All of the 10 walls in the surveyed area that were subjected to high-intensity tremors (upper 6 to 7) resulted in classifications of only Damage Rank I or II. In the wing wall shown in Photo 2 that was constructed adjacent to an abutment in an area hit by intensity 7 tremors, no distress could be observed at all, hence its classification as Damage Rank I.

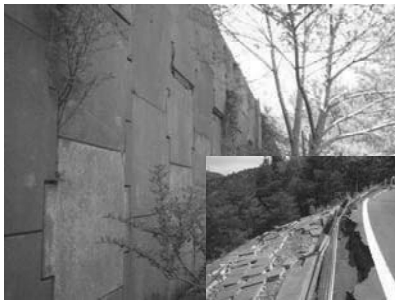
Shown in Photo 3 is a wall whose panels displaced, not because of earthquake tremors, but rather from increased earth and water pressures coupled with decreased pullout resistance by steel

Photo 3. Collapse of embankment and the deformation of wall's surface

reinforcing strip members. Damage was brought about by incursion of rain water into the wall due to inadequate drainage and earth turning into mud, because of slaking earth fill, normally unsuitable for the use in reinforced fill structures. Since the wall facing panels displaced, earth fill flowed out of the wall, and the surface pavement of a road over the earth fill subsided approximately 700 mm. The structure was determined to be at Damage Rank VI.

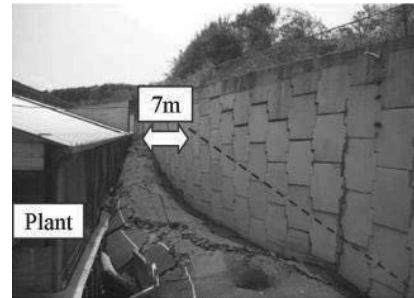
Along the boundary of a manufacturing site located in an area hit by lower intensity 6 tremors, a wall slipped forward by up to 7.0 m, accompanied by the uplift of the ground in front (by 3.0 m) and the subsidence of the embankment at its back (Photo 4). The structural integrity of the wall itself was confirmed through a strength test on the steel reinforcements and panels, an in-situ pull-out test on the reinforcing strips and laboratory tests on the embankment fill. The presence of very soft foundation ground was confirmed as a result of the in-situ boring and SPT tests carried out after the earthquake (Figure 5); the entirety of the reinforced earth fill seems to have slipped forward due to general movement at depth with soil characteristics lower than assumed during the design stage. This mechanism of general sliding was confirmed by an analysis of safety rating carried out considering soil characteristics assumed to have been present at the time of the earthquake.

Photo 4. TA wall damaged by slipping forward

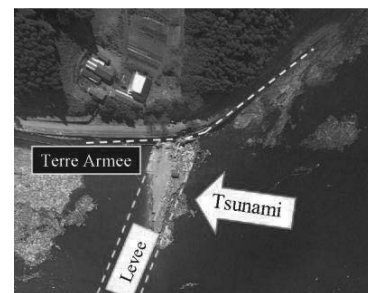
A levee for land reclamation which was retained with a Reinforced Earth wall was washed away by the tsunami (Photo 5). Scouring of the foundation soil, loss of fill, and road subsidence on top of the structure were observed near the intersection point between the levee and the wall (Photo 6). The height of the tsunami that went upstream exceeded the height of

Photo 5. Upper view around wall and direction of the tsunami

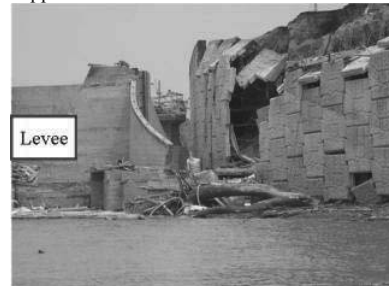
Since the earth levee was washed away, the bottoms of the walls along the levee were exposed and subjected to severe erosion. It can be presumed that this strong scouring caused the Reinforced Earth fill to wash away and panels to fall down. Also, at some locations, there were lower panels that may have been removed because the foundation structure near the intersection with the earth levee was exposed by the tsunami that washed away earth fill from this point, which certainly further increased the local water flow rate.

The noted phenomenon of erosion seems to have occurred due to the shallow depth of wall embedment at 0.5 m, which was similar to the standard depth provision for support of local road sections. Another wall situated at a different point on the same peninsula, with a 1.5m depth embedment, was subjected to the same magnitude of tsunami waves and only rated Damage Rank I.

Photo 6. Damages of facing panels caused by the tsunami

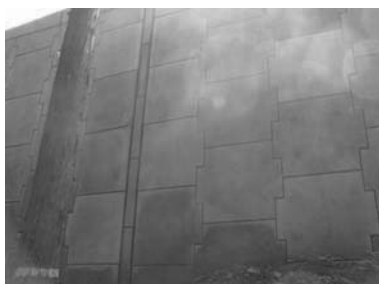
Photo 8. No damage Section of Anti-frost heaving (After the 2011 Tohoku Earthquake)
