# Evaluation of diaphragm wall as-built data to determine the risk of leakage for the Kruisplein car park excavation in Rotterdam, The Netherlands

Hannink G.

Thumann V.M.

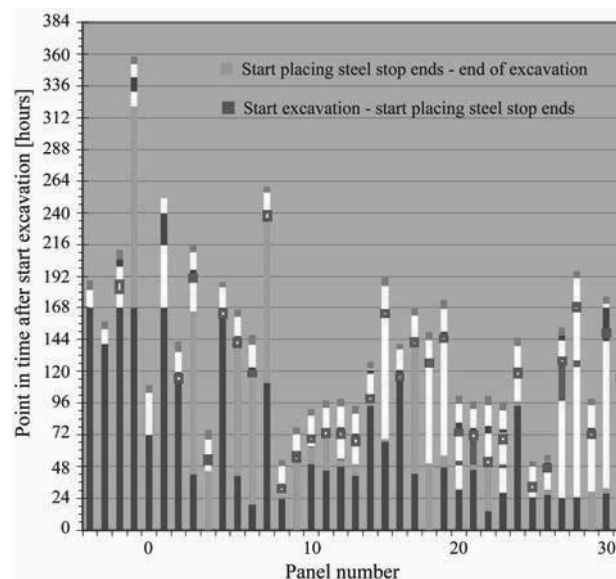
Figure 3. Continuity of the production process.

Information from as-built documents has been thoroughly examined to detect any hazardous sections of the diaphragm panel. These data have been visualized as for example shown in Figures 3 to 5. Figure 3 shows amongst other things the elapsed time between:

- the start of the excavation of the trench and the start of the installation of the steel stop ends;
- the start of the installation of the steel stop ends and the end of the excavation of the trench;
- the end of the excavation of the trench and the start of the cleaning of the concrete surface;
- the start of the cleaning of the concrete surface and the start of the installation of the reinforcement cage;
- the end of the installation of the reinforcement cage and the commencement of concreting.

Long periods of elapsed time for a particular activity may indicate an increased risk of imperfections.

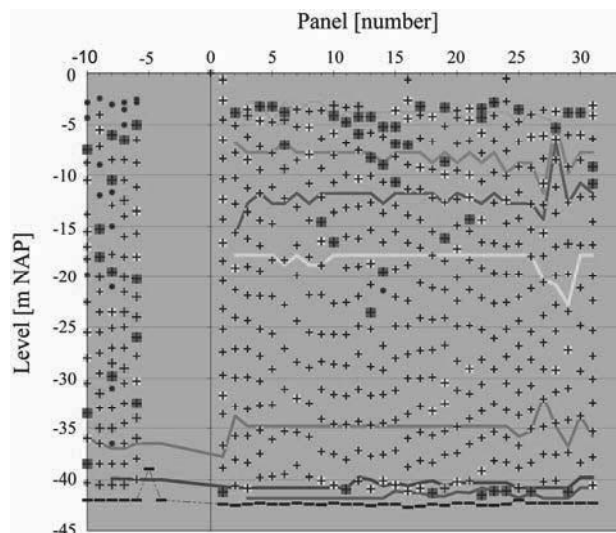
Figure 4 shows the calculated deviation of wall thickness as can be calculated from the concreting progress reports. From Figure 4 it can be identified where the panels are suspected to have a reduced thickness of more than 0.2 m. However, it is recommended to have more detailed information on the progress of the concreting process for future projects, as to increase the resolution (reliability) of this graph.

Figure 4. Deviation of panel width (data originating from leveling data and concrete consumption). The separation of the different soil layers as derived of excavation data and of geotechnical investigations is also indicated.

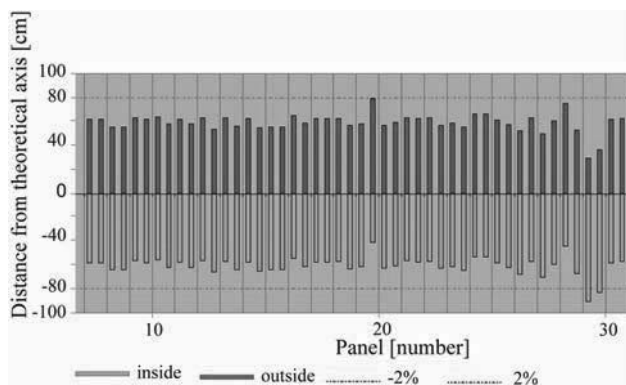
Figure 5 shows the position of all diaphragm wall panels at 40 m depth, as derived from crane operating monitoring equipment. Most of the panels have been excavated in two or three parts, thus giving at least two monitoring records (inclination and deviation vs. excavation depth) per panel. From Figure 5 it can be identified where the panels are suspected to have insufficient overlap. The diaphragm wall thickness as designed was 1.20 m; the allowable position with respect to overlap (zone width of 1.60 m at 40 m depth) follows from the 2% deviation of the verticality.

Figure 5. Relative position of the panels at 40 m depth. Dark represents the outside of the diaphragm wall; light the inside. The dotted red lines represent the 2% deviation of the verticality.

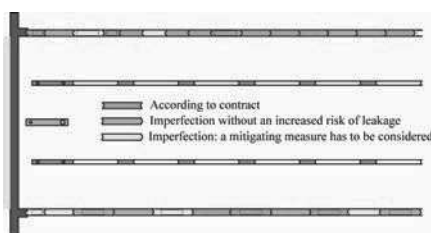
Figure 6. Increased risk of leakage.

Combined interpretation of Figures 3 to 5 reveals areas where an increased risk of leakage has to be anticipated for, as compared to normal conditions. Following aspects have been evaluated using the outcome of the interpretation of the as-built records:

- a missing/damaged water-stop;
- no cleaning of the concrete surface;
- the elapsed time between refreshing of the bentonite and the commencement of concreting greater than 24 hours;
- encountered problems during the stop end removal works;
- concrete characteristics;
- wall thickness reduction > 0.20 m (Figure 4),
- reduced overlap < 0.80 m (Figure 5).

An overview of locations with an increased risk of leakage along the excavation circumference has been generated as shown in Figure 6.

Subsequently, a number of mitigating measures has been defined for each individual panel as to compensate the increased risk. It appeared from the overall risk analysis that careful positioning of four ‘sleeping’ wells around the excavation would provide sufficient means for acting in case of leakage at any of the identified weak spots as shown in Figure 7. Additionally, for a number of panels it has been recommended to call for an intensified inspection and repair program (when necessary) during the excavation works.

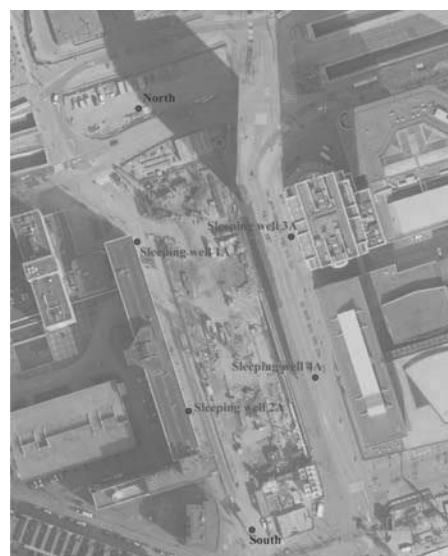
Figure 7. Positioning of the four ‘sleeping’ wells east and west of the building pit. Additional wells may be installed at the north and south side in case of a calamity in the northern or southern wall.

The positioning of ‘sleeping’ wells can be considered as a major mitigating measure, and is a lesson learned from the construction of the (leaking) diaphragm wall at metro station CS.
