Managed remediation of a large Victorian gravity quay wall using the observational method

Turner M J, Smith N A
Applied Geotechnical Engineering, UK

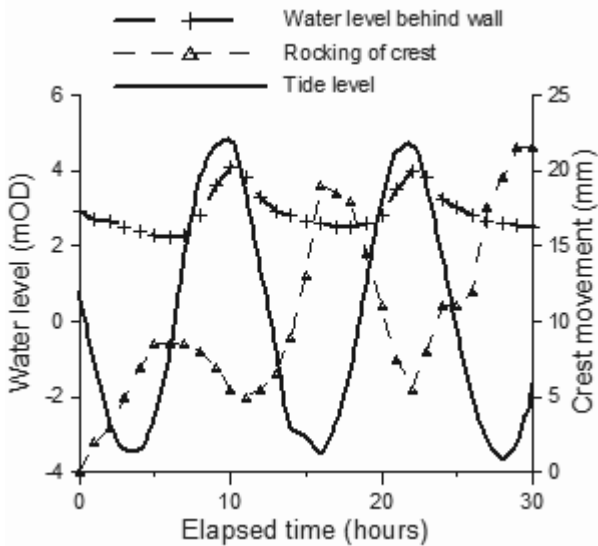
It was soon apparent from the monitoring data that the movement of the wall was driven by the groundwater held behind it. The rate of drainage of the water below the wall was relatively slow, so that the difference in water levels between the front and the back of the wall was highest at low tide, as shown in Figure 3. At these points the wall would ratchet forward, and not quite recover its original location as the tide level rose. By inference, the effect was greatest at times of high tidal difference (Spring tides).

Figure 3 Water levels and crest movements, 13-14 Oct 2000.

The analyses showed that the high groundwater level behind the quay wall was the predominant driver of the instability and the observed wall movements.

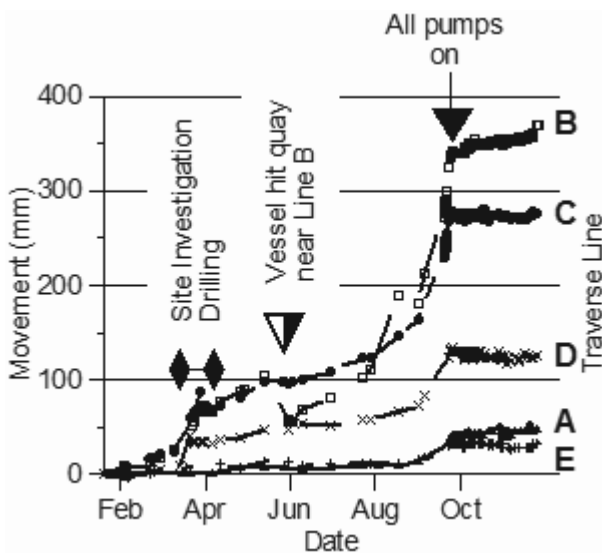
Figure 4. Crest movements during 2000.

The displacements of the quay wall measured at the traverse lines are illustrated on Figure 4. It can be seen that there was a noticeable effect upon outward wall displacements while the site investigation works were being undertaken in April 2000. Figure 4 also shows that the rate of outward movement also began to increase markedly in September of that year, and was accelerating. By September 2000 the worst affected area of the quay wall (Traverse Lines B and C on Figure 4) had recorded between 270 and 350mm of outward movement, relative to their

As soon as the first pumps were started, the wall movement virtually ceased, as can be seen from Figure 4. Measurements eight days later showed that the amplitude of the rocking motion was less than half its magnitude prior to pumping. With the wall stabilised, work on installing permanent drainage and ground anchors could begin. The effects of the dewatering upon the groundwater levels behind the wall are illustrated on Figure 5.

values in January of that year. At this time the analysis, design and procurement of the remedial works was still being progressed, but, based upon the evidence of the increased wall movements during the investigation work, contingency plans had already been put in place to deal with such a situation. Eleven dewatering wells were installed in a line behind the quay wall at approximately 10m centres, to lower the ground water level behind the wall. At that time the wall was moving forward by more than 10mm per day at the worst affected part, and was rocking measurably with the tide. The pumps were started as soon as the wells were connected, over a three day period, the first three being commissioned on 17 October and the balance by 19 October 2000.

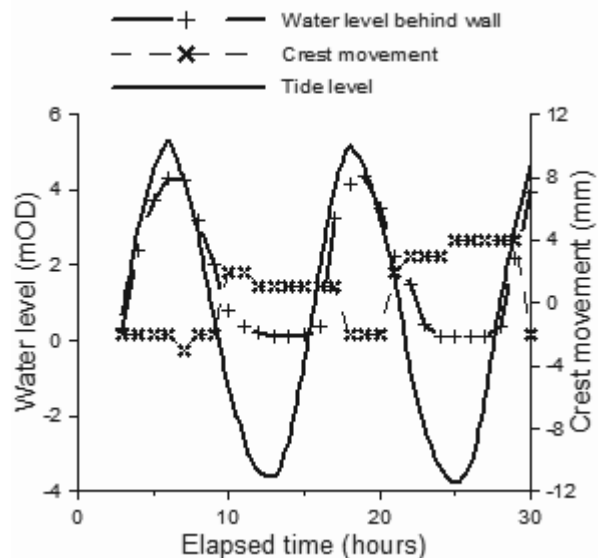
A feature of Figure 5 is that a distinct 'plateau' can be seen in the levels recorded for the water immediately behind the quay wall. The level of the retained water is drawn down to 0.0mOD by the pumping wells as the tide falls. It does not fall below this level, however, giving the step-like feature in the graph. The 0.0mOD level coincides with the invert level of the lower access-ways through the quay wall, which were open to the sea. When the tide was above 0.0m, on a falling tide, the retained water was clearly draining through these accessways, as well as being removed by the pumping wells. Once the tide fell below this level, then the pumping wells alone were removing the retained water, and, on the evidence of these readings, could only maintain the retained water at about the 0.0mOD level against the fresh water flowing from the landward side of the quay wall.

Figure 5. Water levels and crest movements 27-28 Oct 2000.

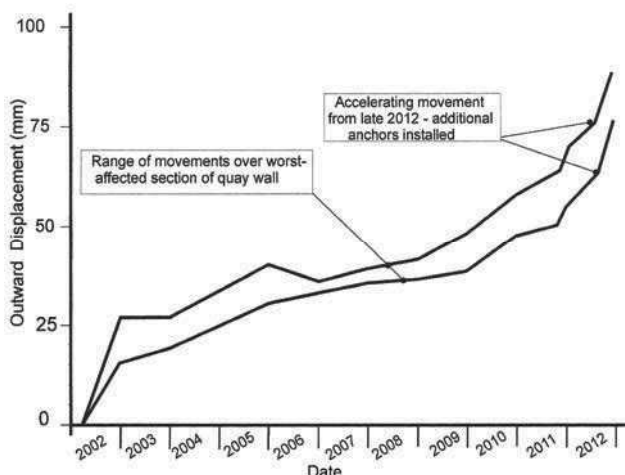
Figure 6. Wall displacements at crest level 2002 to 2012. (Toe displacements similar but generally smaller.)

Initial wall movements over the first 5-6 months were between 5 and 10mm at the crest and toe of the wall as the anchors took up further load. Load increases in the 43° anchors were typically between 50 and 200kN over this period.

By the end of 2002 the movements had stabilised at around 16 to 26mm at the crest, and 15 to 20mm at the toe. These data confirmed that the predominant mode of movement of the quay wall in the most active area was by sliding along a plane coincident with or close to the interface between the base of the wall and the underlying strata.

Over the next 3 years outward crest movements over the anchored section had increased to 30 to 40mm relative to the April 2002 readings and toe movements were between 35 and 40mm. Loads in the 43° anchors had increased by between 200 and 250kN. It had been planned to complete the main remediation works within this 3-year timeframe, but the monitoring works had demonstrated that movements were remaining controllable. The main works were put on hold, therefore and a watching brief was maintained on the wall. Based upon the previous readings, a movement criterion of 10mm/year had been adopted as a signal that further support works needed to be put in place.

By 2012, however, inclinometer and traverse line readings were indicating that outward wall movements were reaching 10 to 12mm per year, and the loads in the 43° anchors were increasing at an average of around 150 to 300kN per year. Additional interim measures were undertaken at the end of 2012, when a further six 1800kN capacity 43° anchors were installed through the face of the wall over the anchored section.

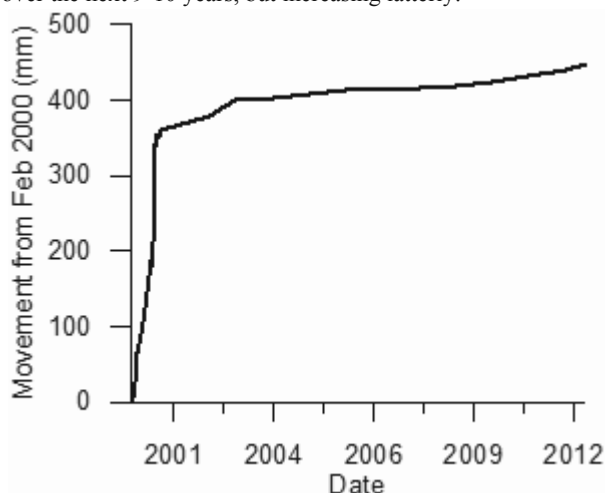
For reference, the data from Figures 4 and 6 have been combined on Figure 7 to illustrate the relative degrees of movement measured at the crest of the quay wall over the worst affected section from 2000 to the present day. The figure clearly shows the rapid, and probably catastrophic, accelerating rates of movement in 2000, before the dewatering was switched on, followed by the relatively slow but continuing movements over the next 9-10 years, but increasing latterly.

Figure 7 Wall crest movements between February 2000 and June 2012
