Value of Landslide Investigation to Geotechnical Engineering Practice in Hong Kong

Lo D.O.K., Lam H.W.K.

Geotechnical Engineering Office, Civil Engineering and Development Department, Government of the Hong Kong SAR

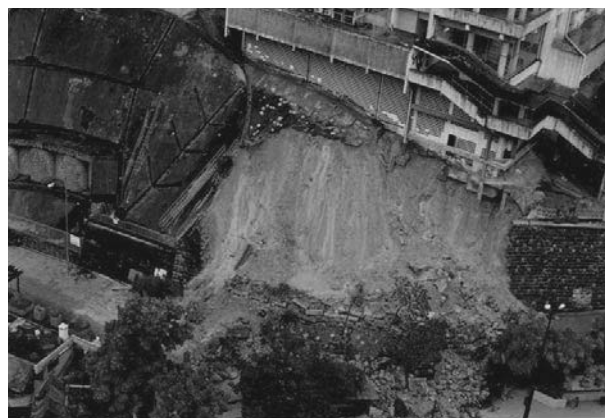
Figure 1: The Kwun Lung Lau Landslide in July 1994

Hong Kong. Following the Kwun Lung Lau landslide of 23 July 1994 (Figure 1), which killed five people and seriously injured three others (Morgenstern & GEO 2000), the GEO introduced a number of new enhancement initiatives including a systematic LI programme. The scope of landslide investigations includes examination of all reported landslide incidents and in-depth studies of selected landslides to identify the causes of failure and necessary follow-up actions. The objectives of the systematic LI are to identify those slopes in need of early attention, and undertake forensic investigation of landslides that involve coroner inquests, legal actions or financial disputes. Through landslide investigations, the performance of the Government's slope safety system will be reviewed and areas for improvement identified. Landslide investigations help advance the understanding of causes and mechanisms of landslides and enhance slope engineering practices and the reliability of landslide preventive or remedial works.

A few major landslides involving retaining wall failures had occurred in the past, the most notable one being the 1994 Kwun Lung Lau landslide. The landslide involved the a brittle collapse of a 100-year old masonry wall (Morgenstern & GEO 2000) releasing 1000 m³ of debris causing 5 fatalities. No tell-tale sign was reported prior to the failure. The failure was triggered by saturation of the soil behind the masonry wall as a result of leakage from nearby defective buried water-carrying services. The incident highlighted the importance of regular inspection and maintenance of water-carrying services affecting slopes. Following the incident, a guidance document entitled "Code of Practice on Inspection and Maintenance of Water Carrying Services Affecting Slopes" was issued by the Government, setting out the recommended good practice for regular inspection and maintenance of water-carrying services affecting slopes.

Furthermore, the landslide investigation findings indicated that the failed wall was 10 m high but only about 0.8 m thick. The wall thickness is much less than that indicated in the record available. This incident highlighted the danger of slender masonry walls that are liable to fail in a brittle manner without any prior signs of distress, and the importance of verifying the wall thickness in stability assessment. This lesson learnt was incorporated in the guideline for stability assessment of old masonry walls (GEO 2004a).

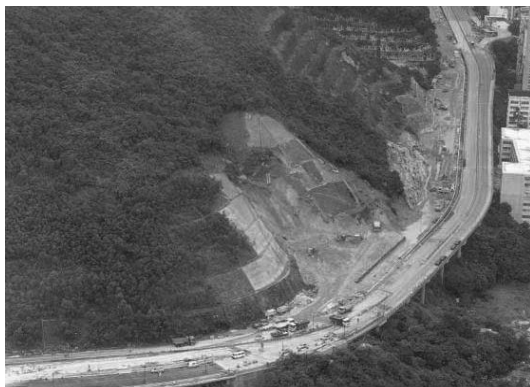
Figure 2: The Ching Cheung Road Landslide in 1997

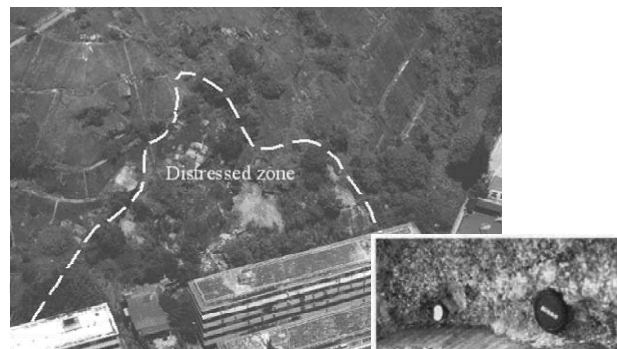
Figure 3: Laterally-persistent discontinuity infilled with slickensided kaolin and manganese oxide deposits at the 1999 Shek Kip Mei failure

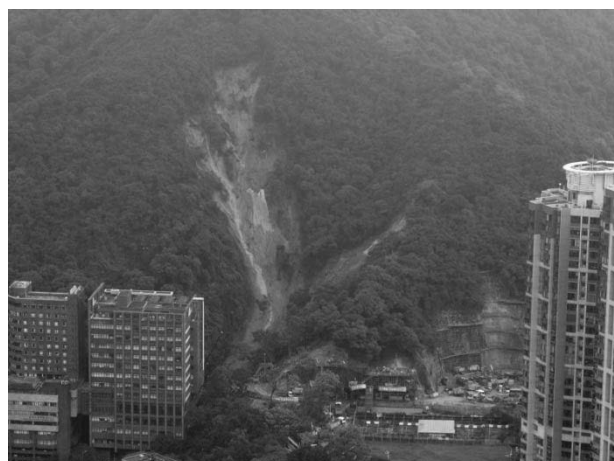
Figure 4: Landslide on the hillside behind the Hong Kong University

Detailed landslide investigations on selected June 2008 landslides showed that past failures could have a significant implication to the scale of the landslides. Past failures could lead to extensive colluvial accumulations on hillside, which are susceptible to give rise to a laterally extensive and a much larger scale failure during heavy rainstorm than those in the past (Figure 4) (Maunsell 2009). If the debris of previous failures deposited along the drainage line, it could become 'entrainable', giving rise to a larger scale of a channelized debris flow (CDF) event (Figure 5) (AECOM 2009). In the 2008 rainstorm, significant entrainment was noted in many of the long runout CDFs with entrainment ratio up to 10 or higher (the entrainment ratio is the volume of additional material that has been entrained by a landslide expressed as a proportion of the source volume). The amount of the pre-existing 'entrainable' materials in a drainage line is dynamic and may change significantly after a rainstorm. This highlights the implications of the deposition of debris from past failures on occurrence of some large-scale failures in natural hillsides.

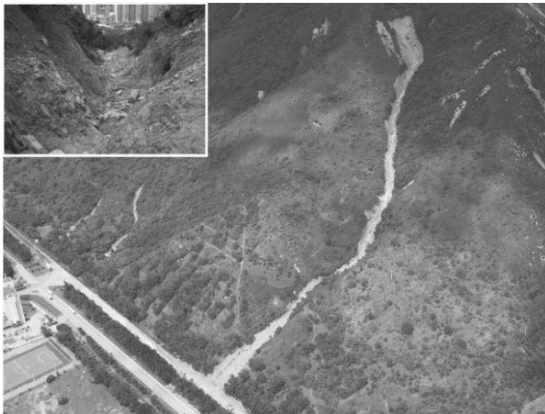
Figure 5: Yu Tung Road channelized debris flow

Detailed studies on selected CDFs revealed that some of the CDFs with long runout generally involved debris with high water content, e.g. the failure near Yu Tung Road (Figure 5). After detaching from the source of failure, the debris mixes with a large amount of water along the drainage line, and results in higher debris mobility. LI revealed that a number of circumstances may lead to such ‘watery debris’, such as:

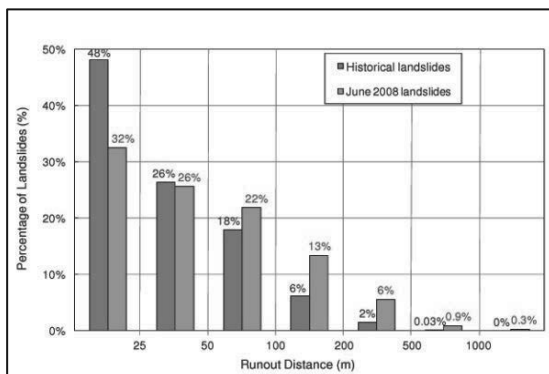
In general, the June 2008 landslide debris was found to be more mobile when compared with the previous historical natural terrain landslides in Hong Kong (Figure 6). About 20% of the June 2008 landslides have runout distances over 100 m, as compared with about 10% in past landslides that are observed from old aerial photographs.

Figure 6: Distribution of landslide runout distance
