Reconstitution of foundation platform of Prasat Suor Prat by compaction of original soil with slaked lime, Angkor Ruins, Cambodia

Akazawa Y.

ABSTRACT: Angkor ruins are situated at Siem Reap in Cambodia and are composed of many masonry structures of temples, moats and large earth embankment for a reservoir. They were constructed from the 9th to the 15th centuries. These cultural heritages in ancient Angkor have been in dangerous states that have resulted in collapse from various severe natural forces. The individual masonry towers of Prasat Suor Prat at Angkor Thom were studied and investigated. The N1 Tower was deemed as the most dangerous tower among them for restoration work. It has inclined 6.6 degrees towards a nearby pond with a northwest direction. The compacted sandy formation was found from -1.5m from the original ground surface and to +3.5m above the ground. The safety factor for the ground bearing capacity in rainy season was calculated with $S.F=1.1$. When its bearing strata were reconstituted, it was designed to have a sufficient safety factor value of $S.F>1.5$. To achieve this purpose, the original sandy soils were mixed with slaked lime and compacted by tamping wit

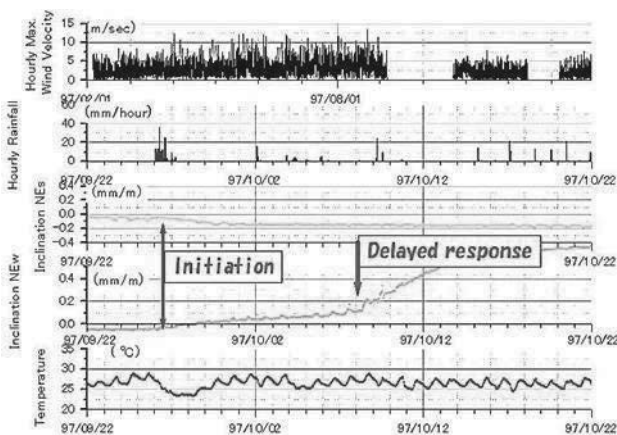
Figure 1. The measuring results of the amount of inclinations, the wind velocity, precipitation, and temperature of N1 tower.

The change in N1 tower's inclination with progressing time has been monitored by plumbing, however there was no significant change. During the rainy season in October in 1997, when there was wind velocity of over 10m/s blew for a few days, 0.5mm/m of the lateral displacement was measured. Figure 1 shows this monitoring data with inclinations, wind velocity, rainfall and temperature for N1 tower. This fact shows that the tower's displacement was increased by the external force acting against the tower (in this case, gust wind during rainy season), and this displacements will be accumulated.

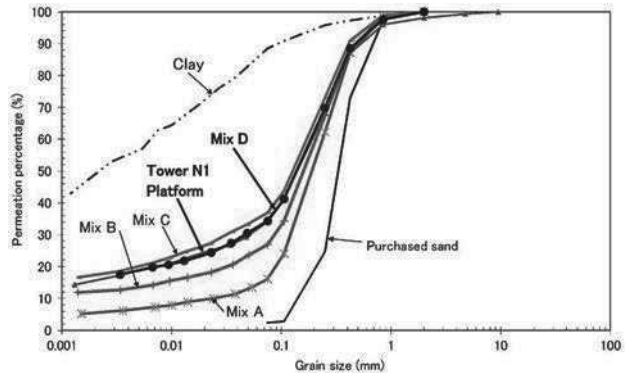
Figure 3. Grain size distribution curve of each soil

Photo. 2 and Figure 2 show soil strata under the platform of N1 tower. The compacted sandy formation was found from -1.5m from the original ground surface and to +3.5m above the ground, which the average thickness of one stratum was measured about 20cm. Figure 3 shows the grain size distribution curve of them. Figure 4 shows N-value distribution (by using standard penetration test) with depth. In figure white dots show the values in the dry season and the polygonal line shows them in the rainy season.

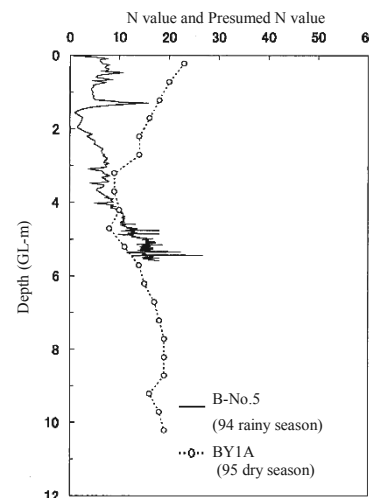
Figure 4. N-value distribution

Plate bearing in-situ test of plate loading on original compacted sandy ground showed the yield load of 290 - 340 kN/m² under wet condition. Since the contact pressure in the ground beneath the foundation of the tower was estimated at 270kN/m², the safety factor against the ground bearing capacity in rainy season was calculated at SF=1.1, which was considered as small and not safe. When the external force acts on the tower in the rainy season, the inclination, the subsidence and the differential settlement of them will increase.
