Slope stability of the Włocławek Dam frontal earth dam in the light of the modernisation works carried out in the period 2000-2011

Leszczynski M., Lipiecki B.

Ove Arup & Partners

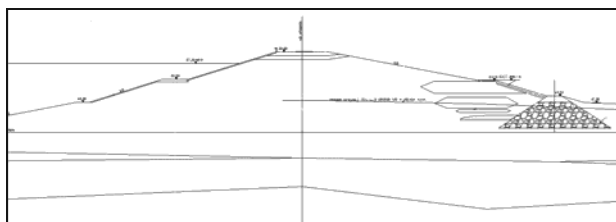
Drawing 2 Cross-section V with low density material zones marked

It has been identified that the observed phreatic level within the earth dam significantly differs from the designed one, calculated for stable downstream level (W.Wolski & others; 2000). Based on archival data analysis the scheme of low density material extent has been prepared (W.Wolski., J.Mirecki. 2011) within cross-section V – see Drawing 1. Drawing 2 presents the zones of loose material within dam body (with $D_R < 0,33$). Based on the scheme of material zones the numerical model of the dam has been generated, taking into account the zones of low density material. Calculations have been performed using Z_SOIL2011v.11.13 software, the commonly used software based on final elements analysis method used for geotechnical, hydrotechnical and environmental engineering calculations (Data Preparation & Tutorials Z_SOIL PCv2010).

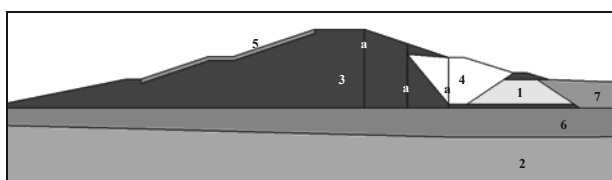
Drawing 3 Variant 1 Material zones scheme – location of the insulation at upstream slope

Variant 1 – the zones of low density material as shown on Drawing 3. The academic assumption (based on expert's recommendation) was, that low phreatic level within the dam is being induced by proper work of surface insulation of upstream slope. The watertight facing adopted within zone of known upstream slope surface strengthening. The scheme of material zones as shown on Drawing 3.

The analysis results were presented in form of phreatic level projection across the dam body cross-section. Variant 1 is shown on Drawing 7. This drawing presents the low arrangement of groundwater level, which closely reproduces the one observed at the dam.

The arrangement of phreatic level is due from calculation based on the assumption that there is an impermeable facing on upstream slope. The aim of variant one of calculations was to demonstrate whether it is possible to achieve the low level of phreatic level as described in professional literature. Despite the convergence of a solution obtained from the calculations and the observed in nature above mentioned situation does not occur in the area of Włocławek Dam. Structures situated on upstream slope were qualified to repair and do not meet conditions made in the calculations for Variant 1.

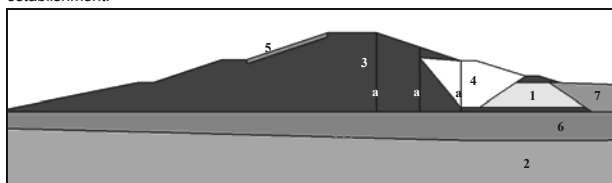
Drawing 4 – Variant 2 Material zones scheme – location of the insulation at upstream slope, within zone of concrete panels

Variant 2 – assumptions as per Variant 1. The watertight screen adopted within zone of known concrete panels location at upstream slope surface.

The results of phreatic level calculation in Variant 2 are presented on Drawing 8. This variant of calculations was based on the assumption that there is a watertight facing in the area of slope with reinforcing concrete panels. The results of numerical analysis for Variant 2 were not in the compliance with the position of phreatic level observed in nature.
