# The use of hydro test results for design of steel tanks on stone column improved ground - a case history

Matešić L.

**ABSTRACT:** This paper describes hydro tests performed on five large storage tanks (80.000 m<sup>3</sup> each) located at the Sisak Oil Terminal, Croatia. Because of its small stiffness and low water permeability, foundation soil for each tank was improved with 660 stone columns. In order to reduce the risk of accidents, such as fire, breach or leak, a crude oil storage tank requires stringent security measures. In the case of the Sisak tanks, the hydro tests were conducted as part of technical monitoring to determine a set of documented and interconnected activities which would provide proof of proper functioning of all elements of a tank structure. In case of critical deviations from the operation expected, such activities ensure that such deviations are removed or corrected on time by taking necessary measures approved by experts. Under a procedure for the hydro tests, the phases of tank and bund filling were defined and each phase was followed by visual inspection and measurements of settlements and deformations of the steel structure. Design directions for

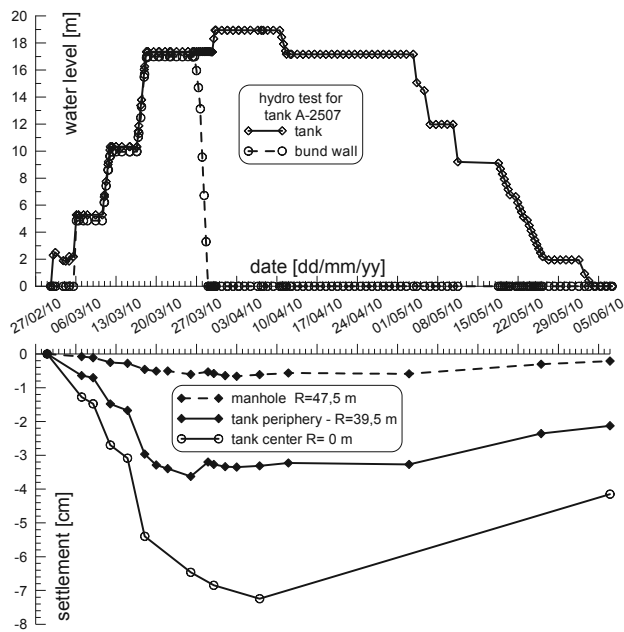
By way of illustration, the results of settlements obtained from the hydro test carried out on Tank A-2507 are given. Figure 2 shows time history of tank and bund filling and emptying together with the graphs showing averaged settlements of HI pipes at manholes HI, points on the foundation perimeter and centre.

Figure 2 Time history of the hydro test performed on Tank A-2507

According to settlement criteria (Marr et al 1982), the design defined allowable total and differential settlements for different settlement patterns. Thus, during the hydro test, the allowable total settlement of the tank perimeter and tank centre were 15 cm and 31 cm respectively. In a calculation, they were estimated to be 11 cm and 19,5 cm respectively. However, the results of measurement obtained for such settlements as shown on the graph were 3,6 cm and 7,2 cm respectively.

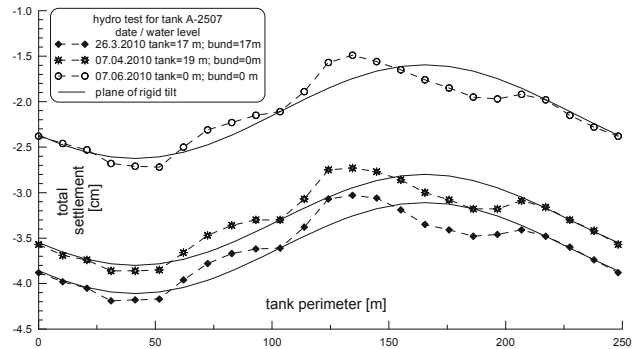
Figure 3 shows total settlements of the tank perimeter for the two representative phases of the hydro tests in which the largest settlements occurred at the highest loads. In the third phase, i.e. when the tank was emptied, permanent (plastic) deformations occurred.

Figure 3 Total settlements of the tank perimeter occurred during the hydro test on Tank A-2507

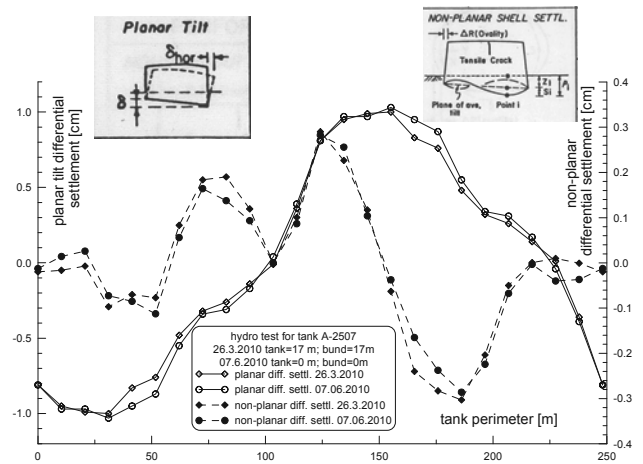
Figure 4 illustrates the two phases in which the largest differential settlements of tank perimeter at the highest load occurred as well as the phase following tank emptying in which permanent (plastic) deformations occurred.

Design allowable differential settlements for the cases of planar tilt settlement and non-planar differential settlement was 44 cm and 0,8 cm respectively. The planar tilt settlement and non-planar differential settlement obtained by calculation were 1,3 cm and 0,34 cm respectively. The results of measurement obtained for such settlements were 1,0 cm and 0,32 cm respectively.

Figure 4 Differential settlements at the perimeter of Tank A-2507

It was found that the settlements, after the tank had been emptied, were smaller although they had the same shape. This proves that the deformations after tank emptying are mostly elastic (Figure 4). As tank loads by crude oil are less than those by water, it is expected that subsequent displacements at operating load will be less than those recorded in hydro tests, and that no further non-planar differential settlement of the tank bedding will occur. The same goes for the other four tanks (Figure 7). The diagram of the settlements of all five tanks shows that such settlements are about the same when the tanks are subjected to the same load. As this is normally expected in the case of horizontally stratified soil, this is proof of proper and correct measurement of displacement.

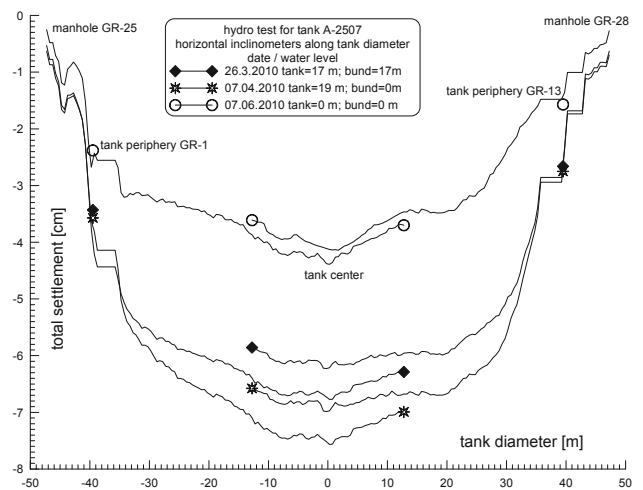
Figure 5 shows total settlements for the three representative phases of the hydro test measured by horizontal inclinometer.

Figure 5 Total settlements of Tank A-2507 (cross-section)

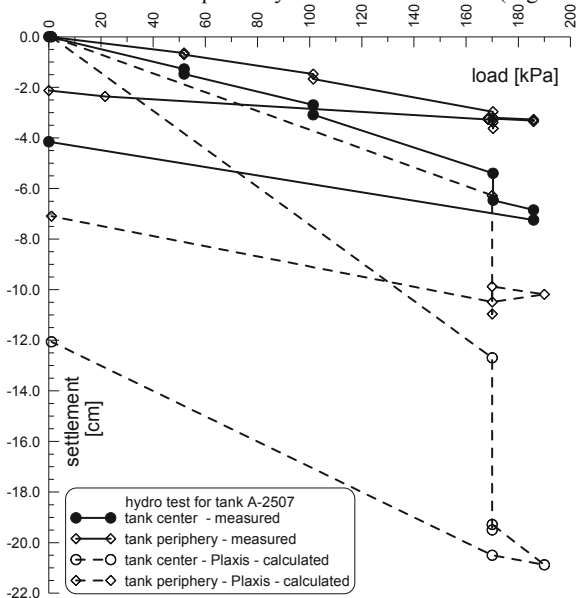
The hydro test showed, as demonstrated in the case of Tank A-2507, that total settlements are relatively small, i.e. smaller than estimated by calculation (Figure 6).

Figure 6. A comparison of measured and calculated results of settlements obtained from the hydro test on Tank A-2507.

As seen in Figure 6, the settlements obtained by calculation were significantly greater than those measured. An explanation for different values of settlements should be thoroughly investigated in further numerical analysis which will take into consideration the fact that columns and soil act together as recommended in Ambily and Gandhi (2004).

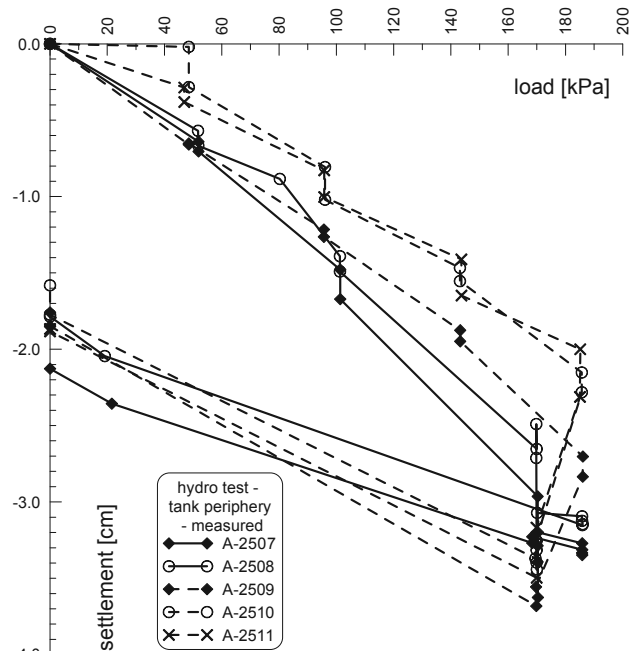
Figure 7. Total settlements of tank perimeters during hydro tests performed on all five tanks
