Full-scale field validation of innovative dike monitoring systems

Koelewijn A.R., Vries (de) G.
Deltares

ABSTRACT: Three large scale field tests on dikes have been carried out at the IJkdijk test site in the Netherlands. Two tests involved piping, micro-instability of the sand core and erosion from overtopping. Both dikes failed on micro-instability. The third test involved slope stability with a deep sliding plane. All tests were done to validate monitoring systems and dike safety information systems. Several systems performed well.

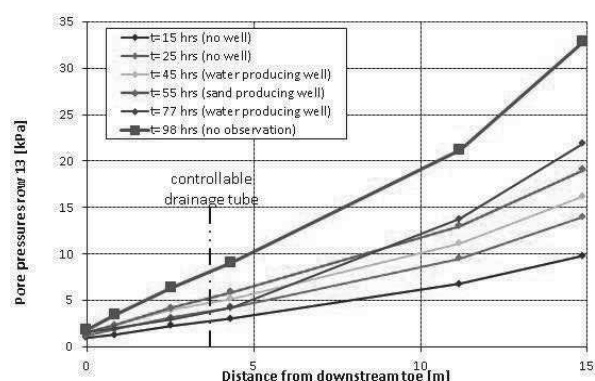
Figure 3. Pore pressures at sand/clay interface West

At 66.7 hours after the start of the test ($t=66.7$ hrs), at a head drop of 2.02m, the lower drainage tube was partly opened as piping had already been detected at the third line of pore pressure meters, i.e. upstream of this tube. This had a clear effect on the pore pressures, as shown in Figure 3, and the piping process stopped.

Meanwhile, the sand core became saturated, as measured by the upper pore pressure meters. At $t=63.6$ hrs, the upper drainage tube was opened and the pore pressures in the core were controlled. At $t=94.0$ hrs, both tubes were closed and the pore pressures rose sharply. From $t=97.6$ hrs, sliding of the downstream slope started to occur.

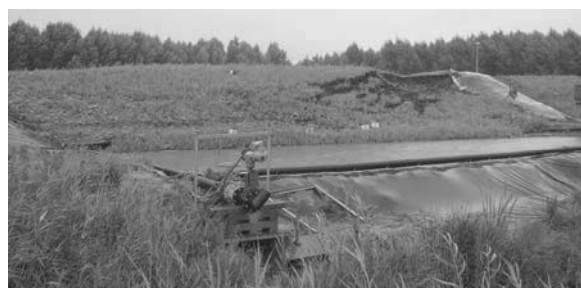
Figure 4. West dike close before failure.

At $t=110.1$ hrs, considerable sliding of the downstream slope had occurred. Piping had resumed too, but the continued sliding from micro-instability of the sand core caused so much settlement of the crest that at $t=111.9$ hrs (August 26th at 8:24 am) failure occurred.

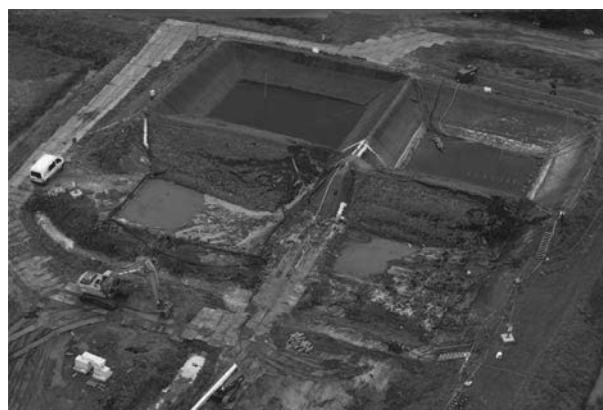
Figure 5. West and East dikes after failure.

As the last stages of the hydraulic load were delayed in comparison with the West dike, severe settlements from micro-instability of the sand core occurred later. Here at $t=138.9$ hrs (August 27th at 10:18 am) failure from micro-instability occurred. Figure 5 shows an overview of both failures.

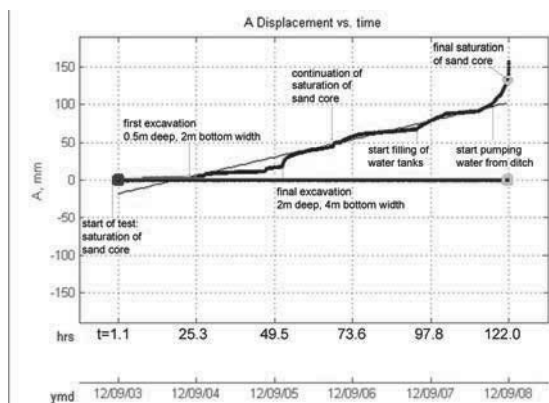
Figure 6. Horizontal displacements at toe of dike until close to failure.

by infiltration of water into the sand core. The next day, a small excavation was made in front of the dike. This had a limited effect on the dike, as shown in Figure 6 by the horizontal displacements at the toe of the dike. The next day, a final excavation was made and on the basis of slope stability calculations it was decided to continue by hydraulic loading only. In order to acquire a lot of measurement data, several days were taken to raise the phreatic surface in the sand core and to fill the water tanks on top. Finally, failure occurred on September 8th, at 2:27 pm, after 122.26 hours, see Figure 7.

Table 1 shows the results of slope stability calculations at characteristic moments applying the models of Bishop (1955) and Van (2001). The latter is a geometrically more flexible variant to Bishop's model. The results correspond well to the deformation behaviour shown in Figure 6: close to the critical value of 1, the deformations quickly increase. These results may even draw some suspicion, but it should be borne in mind that quite advanced soil investigations had been carried out prior to the test (Zwanenburg et al. 2011, Koelewijn and Bennett 2012) and detailed actual measurements of pore pressures were available. Moreover, the model by Bishop has already long ago been described as surprisingly accurate for conditions close to failure (Spencer 1967).

inclinometers except one at the East side, which failed. The pre-set deformation criterion for a successful test was exceeded at the moment the maximum pore pressures were recorded.
