Stabilisation of a soft fill slope by compacted rockfill – an example of good practice

Slobodan B. Mickovski

Martyn J. Smith

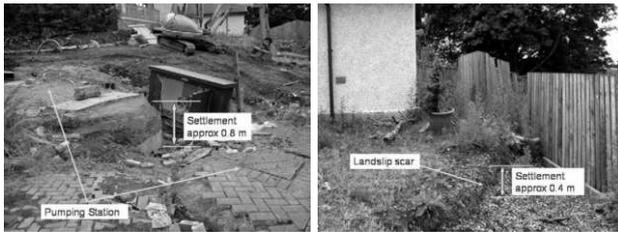
The part of residential development where the Glen Noble SPS is located was completed in 2000, when the SPS was presumably installed. Available records showed that the SPS was fully functional until noticeable ground settlement around the pumping station became evident in February 2005. On the basis of the available records and photographs, the subsidence around the SPS in 2005 is estimated to have ranged between 0.10 m and 0.60 m. The ground settlement around the SPS appeared to have increased in magnitude to 0.6 m – 0.8 m by the end of 2007, when the works described in this study began (Figure 2a).

In addition to this, during the same inspection in 2005 a tension crack (landslip backscar) became evident around 10 m to the south of the pumping station, in the garden of one of the properties adjacent to the pumping station (Figure 2b). This scar, visible over a 10.0 m length of the slope crest, ran from north to south, approximately 7.0m from and parallel to the western wall of one of the residential properties. The settlement

at the scar increased from 0.1 m– 0.2 m in 2005 to 0.4 m – 0.6 m in 2007.

Figure 2. Magnitude of settlement around the pumping station and in the garden of the adjacent house .

historical records suggested mining as a possible cause. An investigation of the available mining records obtained from The Coal Authority showed mining activity adjacent to the site. However, this mining was at depth and would have resulted in different form of settlements. A more plausible explanation for the settlement was leakage of the water pipes and seepage through the fill materials, softening and reducing shear strength, washing out fine particles and promoting settlement. This was corroborated by the Contractor's reports of displaced and broken pipes at approximately 4.0 m bgl adjacent to the PS several months prior to the commencement of the restoration works.

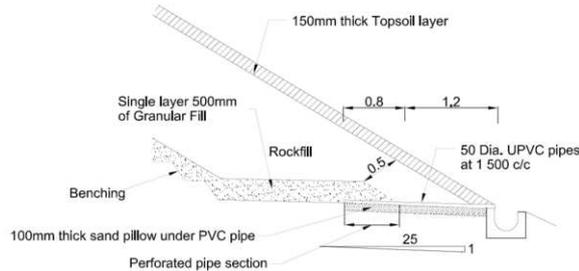
Figure 3. Typical design of filter layer and contour drain channel.

Special care was taken during the design process to allow for effective in-slope drainage in order to minimise the build-up of pore water pressures in the slope and possibly cause future instability. To this effect, 0.5 m thick granular filter layer appropriate for this grading of the rockfill (Class 6A material, grading 20-50 mm) underlining the engineered fill was designed (Figure 3). This filter layer both drained any high or perched water from the natural in-situ Glacial Till deposits and any surface seepage passing through the rockfill.

On-slope drainage was provided via a contour U-channel drain made of 1.0m long concrete sections running along the toe of the remediated slope and discharging into the new outfall structure (Figure 3; Figure 7). Permanent surface drainage in form of a new gully channel drain was installed on crest and above SPS to prevent surface water from entering the slope.

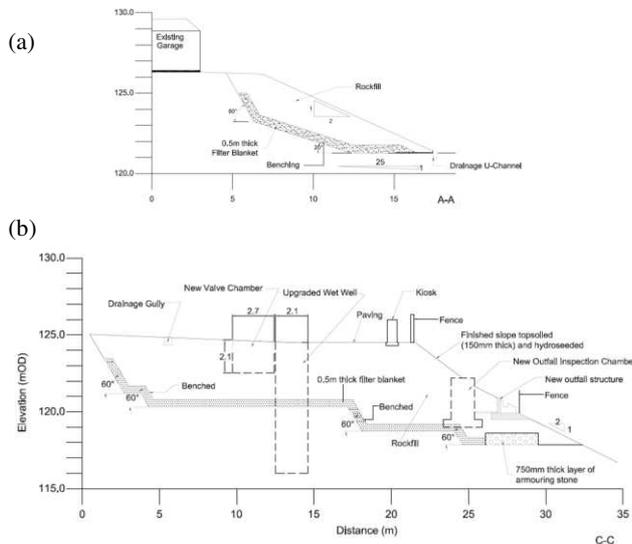
Figure 4. Magnitude of excavation and design of rockfill slope below the landslide scar (a) and around the SPS (b).

During construction, special attention was paid on the correct excavation angles for the back- and the side-cut, to ensure maximum excavated soft material at safe back-cut angles (Figure 4). All excavated slopes were benched as recommended by the Highways Agency (2007) and GEO (1984). The total excavated volume was approximately 1800 m³.

Due to the variability of the fill thickness, depth to in-situ till and/or depth to bedrock throughout the site, the thickness of compacted rockfill ranged from 2.0 m to 5.5 m, and was greatest in the area adjacent to the PS (Figure 4).

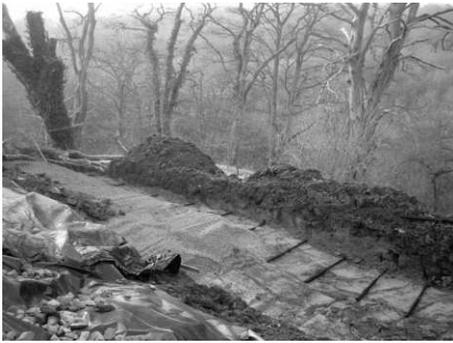
Figure 5. Laying out of the perforated drainage pipes and the filter layer.

After excavation to the base line, a 100 mm thick sand layer was laid and the perforated PVC pipes were laid on top of the sand (Figure 5). The purpose of this layer was to prevent migration of fines from the clay base and potentially blocking the drainage pipes. Granular filter layer was then laid and lightly compacted above and around the pipes, before placement of the layers of rockfill and compaction (Figure 6) in accordance with Specification for Highway Works (The Highways Agency 2009).

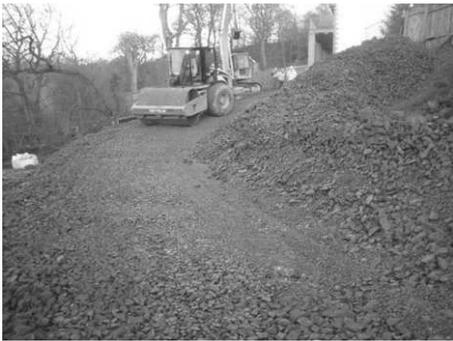
Figure 6. Compaction of the rockfill in layers.

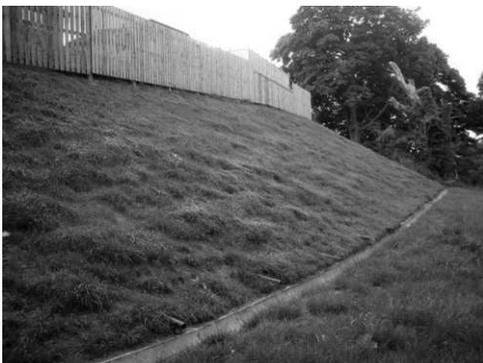
Figure 7. Completed vegetated slope with contour channel drain at the toe.

Compacted rockfill was used to stabilise a failed fill slope around and adjacent to a pumping station in a residential area south of Glasgow, Scotland. It was considered that the cause for the failed slope was connected to washout due to burst utilities. The rockfill provided advantages over the option of re-use of the existing cohesive fill such as faster, easier and safer construction. The filter layers and drainage pipes were designed remove any water entering the slope. Hydroseeding and planting has proved very successful as shown on Figure 7.
