Building damage examples due to leakage at a deep excavation in Amsterdam

Mandy Korff^{1,2}, Robert J. Mair², A.Frits van Tol^{1,3}
¹ Deltares, ²Cambridge University, ³Delft University of Technology

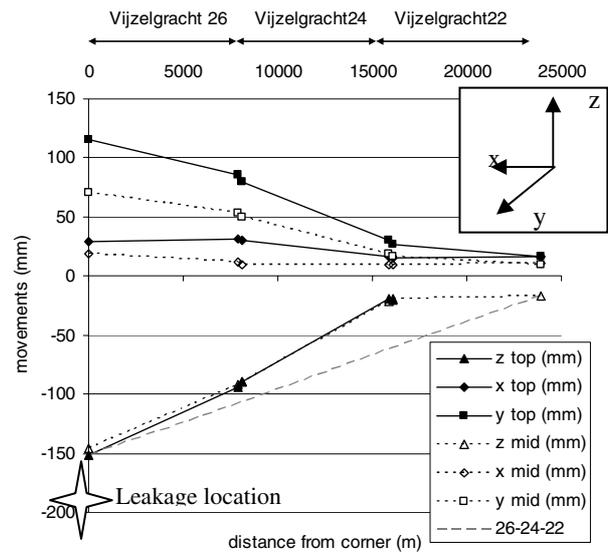
As shown in Figure 3, the block of houses Vijzelgracht 20-26 settled a maximum of 150 mm as a consequence of the incident in June 2008. The building clearly tilted towards the corner of VZG 26 and towards the excavation and the location of the leakage. Both houses 26 and 24 rotated towards the corner of the block. A slight sagging was found between VZG 26 and VZG 24 and hogging towards VZG 22. The cracks on the inside and outside of the buildings were recorded and are shown in

Figure 3 Deformations after incident June 2008 (measurements dated July, 31st 2008)

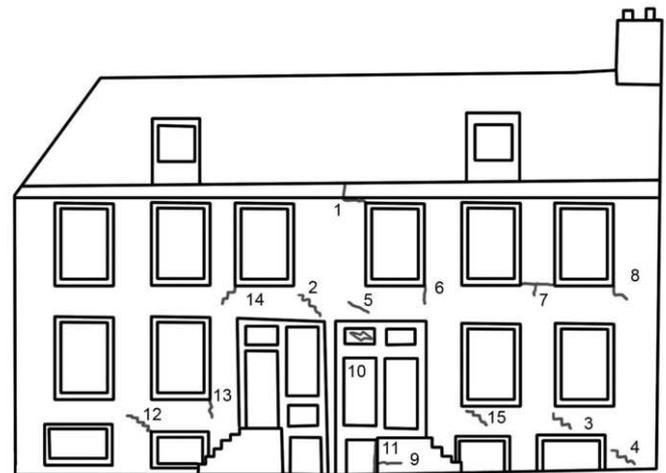
Figure 4 Cracks at the front façade (26 on the left side, 24 on the right)

Cracks 1 to 4 were found on the outside of number 24 and have a crack width of respectively 20 mm, 10 mm, 8mm and 8mm. Cracks 5 to 9 were found on the inside and are smaller than 5 mm. A cracked window was found at number 10. Number 11 is a crack out of plane of the drawing, separating the staircase from the house. Cracks 12 to 14 were found on the outside of number 26 and have crack widths of 2 mm, 7 mm and 2 mm. The location and direction of the cracks indicate a shear deformation with the largest crack width mainly in VZG 24, just as the differential settlements indicate. Cracks at the rear are not shown, but would indicate a twist movement of the building and horizontal extension. Since there are no deformation measurements of the rear façade, these can not be related to the crack directions.

The actual damage derived from the observations for these buildings (26, 24) would be category 5, very severe (Burland et al 1977). A significant tilt of the buildings was observed, with severely sloping floors. The stability of the buildings was also in question, so the buildings have been temporarily braced by wooden supports. The front façade experienced a maximum tilt of 1:78 perpendicular to the façade and 1:184 parallel to the façade at the corner of Vijzelgracht 26 and between VZG 26 and VZG 24 respectively. Both relative rotation and deflection ratio have been calculated for the front façade. For the relative rotation the calculation method of Son and Cording (2005) has been used. This method calculates the slope of the building and defines the relative rotation as $\beta = \text{slope} - \text{tilt}$. The tilt is derived from the differential horizontal movements of VZG 26 and 24 and would average 0.27% or 1:367 parallel to the façade. Combining relative rotation and horizontal strain results in damage category ‘severe to very severe’ for Vijzelgracht 26/24. If one disregards the tilt and uses the slope as the relative rotation (i.e. assuming $\beta = \text{slope}$), the damage category would also be ‘severe to very severe’. The method of Mair et al (1996) can also be used, combining deflection ratio for a central point load situation with the horizontal strain.

It can be concluded that the damage to the façade is mainly caused by shear deformation and horizontal extension in the plane of the wall. The damage categories found comply well with the actual damage. Damage to the buildings as a whole is especially severe in terms of serviceability due to the overall rotation of the building perpendicular to the facades. Severe sloping and tilting of floors and walls are clearly noticeable and separation of the rear façade from both the main house and the kitchen addition is caused by horizontal extension. Although these could not be calculated because measurements were not taken at the rear, these effects are not easily described in terms of ‘traditional’ damage criteria.

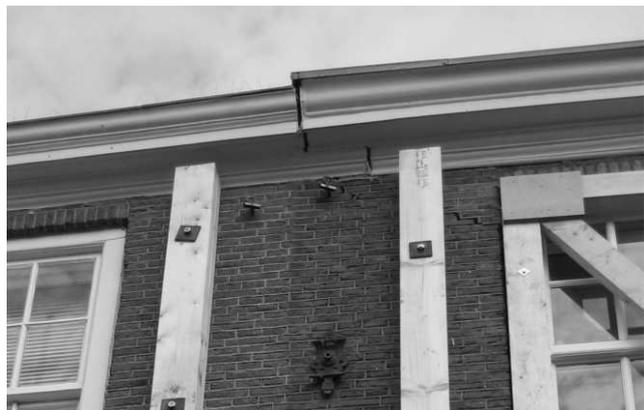
Figure 5 Detail of crack number 1 (crack width max. 20 mm)

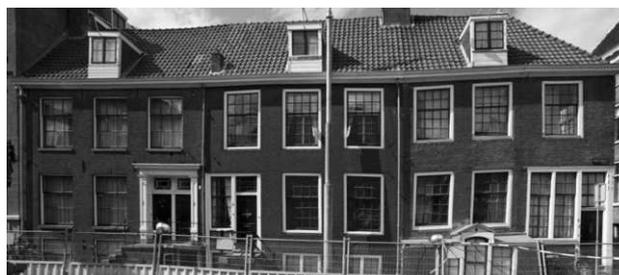
Figure 6 Vijzelgracht 8-6-4 after the incident

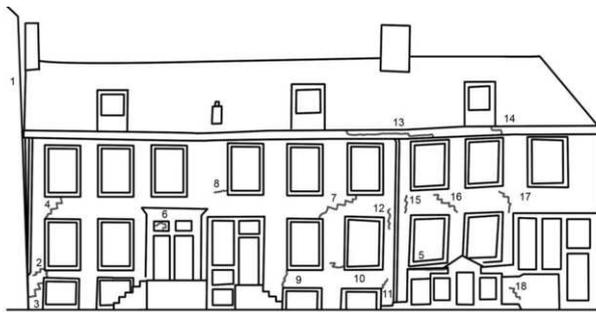
All cracks shown in Figure 7 are on the outside, because the inside was not surveyed. Crack 1 is a separation crack of about 60mm at the top, due to tilt between VZG 10 and 8. Crack widths in the masonry facades itself are generally up to 25 mm wide.

Figure 7 Cracks at the front façade VZG 8 - 6 - 4

The cracks and deformations show that the houses deformed partly in hogging mode (VZG 8-6) and partly in sagging mode (VZG6-4), with the largest differential settlement found between house numbers 4 and 6. The diagonal direction of the cracks indicates a shear deformation. Both the hogging and sagging mode are consistent with the direction of the cracks.

The damage clearly evident from the observations for these buildings (VZG4-8) is category 5, very severe. This is associated mainly with the sloping of the floors and walls and the separation of the different houses from each other, resulting in severe serviceability problems. The stability of the buildings was also in question, so the buildings have been temporarily braced by wooden supports.

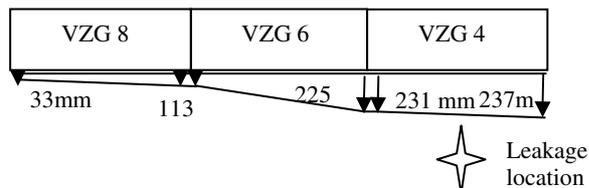
Block Vijzelgracht 4-10 settled a maximum of 240 mm directly after the leakage incident. To some extent damage was already present before the leakage occurred, such as the distorted windows. Figures 7 and 9 focus on new cracks and cracks that re-opened.

Figure 8 Vertical deformations after incident September 2008 (measurements dated 29th October 2008)

The maximum slope of VZG4 perpendicular to the Vijzelgracht is roughly $235 \text{ mm}/9\text{m} = 0.026$ or 1:38. Parallel to the Vijzelgracht the maximum slope is also extremely large, being 1:70 over Vijzelgracht 6. Vijzelgracht 10 did not experience much damage, its slope not exceeding 1:550. The deflection ratio in hogging is $\Delta/L = 71 \text{ mm} / 16 \text{ m} = 0.45\%$ and

in sagging $\Delta/L = 187 \text{ mm} / 15 \text{ m} = 1.2\%$. The average amount of horizontal extension is $31 \text{ mm}/32 \text{ m} = 0.1\%$. Combining these according to Mair et al (1996), assuming a central point load, the principal strains become 0.6% for hogging and 0.19% for sagging, both resulting in the damage category severe to very severe.

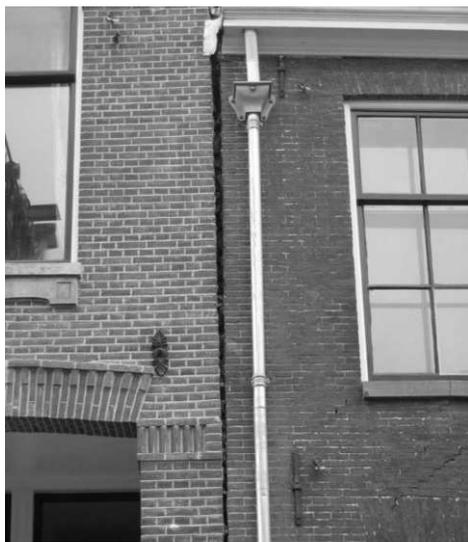
Figure 9. Detail of crack 1 between Vijzelgracht 10 and 8
