# Engineering assessment of jet-grouted structures

M. Arroyo & A. Gens

*Department of Geotechnical Engineering & Geosciences, UPC, Barcelona, Spain*

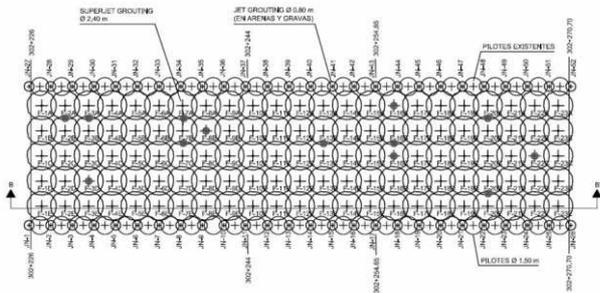
Figure 1. Layout of treatment and control soundings at site A

Post-construction treatment control was based on soundings and laboratory testing of recovered samples. A total of 10 soundings were initially considered necessary, and three more were added later. The layout of these soundings is visible in Figure 1; it can be observed that they were located both at the column axis and at column intersections.

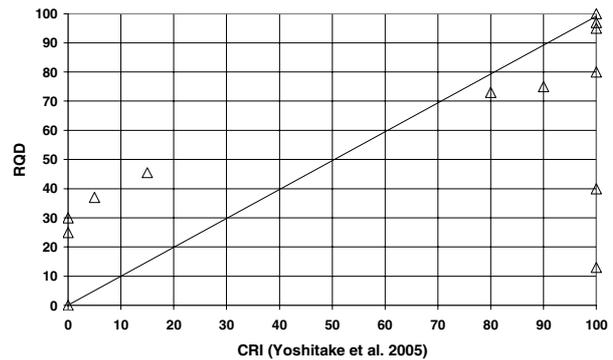
Figure 2. Qualitative evaluations of jet grout cores at site A

From the results obtained it was clear that crew A was using a drilling practice that damaged the cores, resulting in apparently poorer treatment quality. That was made even clearer when detailed inspection of the coring logs revealed that quality increased systematically when crew A switched from their favorite single-barrel tool to the double-barrel one. Curing time of the columns was long enough for not having had significant influence on the results.

It was interesting to note that the CIR results were less ambiguous than RQD and clustered at both extremes of the scale (Figure 2). Finally, it should be mentioned that the poor recovery of crew A largely diminished the expected amount of samples available for laboratory testing. Only seven samples were finally tested but the worst result recorded was more than three times larger than the target characteristic UCS.

Based on the above considerations the treatment was deemed fit for purpose, and the results with low Yoshitake index were attributed to poor boring practice. Excavation was given the go-ahead.

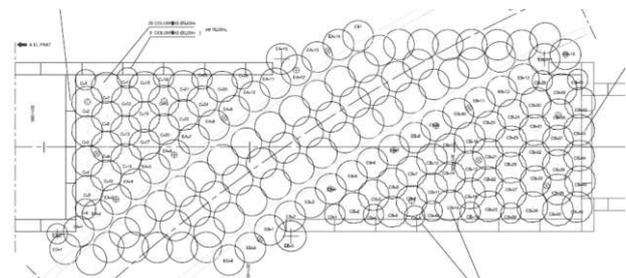
Figure 5. Inspection borehole layout

The control plan included several items. On the one hand 17 boreholes were performed for the direct inspection of the treatment outcomes. There were only 102 columns outside the tunnel shadow, thus the rate of direct inspection was fairly intense. The borehole layout is shown in Figure 5.

Core improvement ratios (CIR) were above 0.80 whenever double-barrel coring was practiced. Again, single-barrel coring produced bad results in some cases. In some boreholes the bottom seal against the clay layer of the longer columns was not fully apparent. That coincided with an area in which the gravel layer just on top of the clay turned into a hardpan, with clear signs of natural cementation.

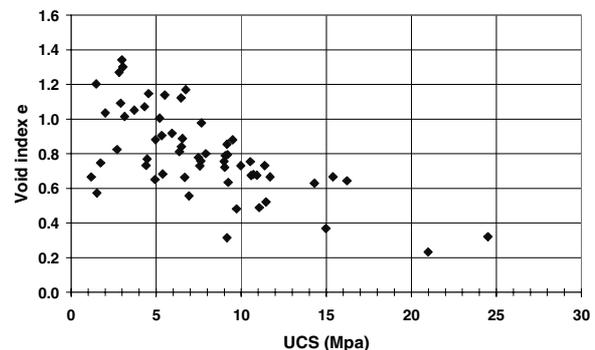
Figure 6. Site B: relationship between void index and UCS of jet-grout samples

Laboratory tests on the recovered samples showed a profile of UCS that, to a certain extent, mimicked that of cone resistance at the site. The values measured were well above those required. It was interesting to note that there was a clear inverse relation between the void ratio of the treated soil and the UCS (Figure 6). It was noted that a large number of samples had void ratios that were well above those initially estimated for the original soils. On the basis of these results the material quality of the treated soils was deemed appropriate.

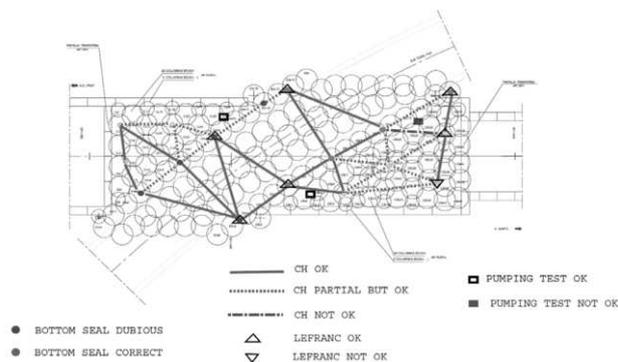
Cross-hole results were sometimes affected by borehole obstruction. This meant that alongside several paths the tests were only partially penetrating. About 25% of the 1 m spaced shots had problems in transmitting shear waves. However, whenever such failed shots were isolated, borehole sealing problems were deemed responsible. When there were several shots in series showing the same problem and different results where observed in other directions, treatment gaps were suspected. Whenever transmission was successful, the original shear wave velocity multiplied by a factor of 5 or more. The cross-hole paths were thus classified as shown in Figure 7.

Figure 7. Locations and outcomes of cross-hole (CH), pumping and Lefranc tests, and estimation of bottom jet grouted slab state

The three pumping tests were transient-type and permeability was obtained from recovery curves. Those tests resulted in significantly higher permeability values than the Lefranc tests. Two of them gave values around  $1\text{E-}4$  cm/s and the third gave a permeability of  $1\text{E-}3$  cm/s. The latter result was taken as an indication of treatment deficiencies. The locations of the permeability measurements are indicated in Figure 7.

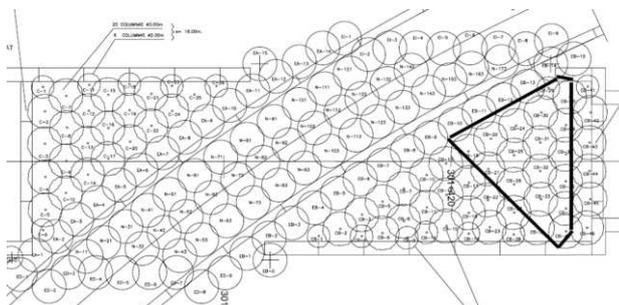
The repairs took place as indicated. Despite that, several incidents of water entry with soil erosion occurred when the tunnel excavation was undertaken, clearly related to treatment flaws on the closing lateral sides, below the existing railway tunnel. That was a zone that had not been directly inspected, because of access limitations. This situation led to increasingly urgent attempts to reinforce the treatment. In one of these, an improperly controlled grout injection resulted in damage to the existing railway tunnel and forced its closure.

Figure 8. Treatment zone that was reinforced with low-pressure grout at inter-column gap locations

As a result of the various controls, there were significant doubts concerning several areas of the treatment and a number of repair actions were advised in the accessible areas (outside the existing tunnel shadow), before starting the excavation. The main one consisted of low-pressure grouting at a series of inter-column gaps, in the area where permeability tests and cross-hole results were unsatisfactory (Figure 8).

Closure of the existing tunnel allowed a systematic repair on the area shadowed by it. The main ingredient of that repair was, again, a jet-grout treatment, trebling the thickness of the external treatment walls. Also systematic external dewatering
