Foundation improvement for a building on loess soil

M. Mulabdic & K. Minazek
University in Osijek, Croatia

A high school two store building made of bricks, about 200 years old, suffered from settlement caused by increase of water content in loess soil, as a result of leakage of sewage system. Soil improvement with use of jet-grouting was designed and applied as a measure of foundation improvement and suppression of further settlement and fissuring of the building. Grouting was executed on outer and inner foundations, in the region affected by settlement, to the depth of 12 m under surface. In order to assure most suitable grouting technique a trial piles of jet-grouting were executed, aside from the object, using different pressures, direction of jet and time of jet action in place. With the pressure of 400 bar columns of 55 cm in diameter were obtained and it was accepted as a good result having in mind distance and spacing of boreholes under foundation. During execution of soil improvement measurement of soil deformation with depth and measurement of cracks in walls was performed, as well as topographic measurement of points on building. Before start of jet –grouting tunnels un

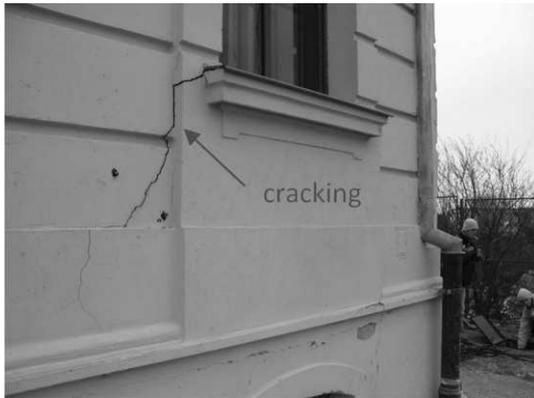
Few years after the war reconstruction (1998), some cracks had been noticed on the building. In the period between 2002-2006 the cracking progressed, regarding both the number and width of cracks throughout the object. The structure was built of massive masonry and was sensitive to settlement. In the early phase of cracking, the settlements of the object was recognized as a main cause for crack formations. There was a concern for a student's safety. The extensive exploratory works, observations and geotechnical measurements on the object and its surroundings were conducted in order to determine the exact cause of the problems. Intention was to identify the regions affected by yielding and to suggest remediation methods. The cracks and their tendency to change in width were constantly monitored so that in case of a sudden crack development the object could be closed for public use. The cracks developed on the facade and within the object are shown in the Figure 2 and Figure 3.

Figure 2. Crackings in facade.

Based on the analysis of foundation soil and structure behaviour it was concluded that it was necessary to extensively remediate the foundation soil and to improve the structure foundations. It was also needed to transmit the structure load into greater depths in the improved soil, which was achieved by jet-grouting under the structure foundation forming columns in the appropriate disposition. The tunnels under the structure, discovered during exploration works (plan view Fig 4. and cross-section Fig 7.) started collapsing, due to loss of strength in wetted loess in which they were made. This fact significantly influenced the planned remediation and was carefully studied. Before the foundation remediation, the tunnels were first vaulted (at places where they were accessible) and filled with specially prepared concrete, poured from the surface through the borehole.

Jet-grouting was the key procedure in the foundation remediation. The area of softened soil was improved by jet-grouting with columns of 60 cm in diameter, to the depth of 6 or 9 meters under the foundation (the foundation depth was cca 2m under the ground surface). The plan view arrangement of jet grouting columns can be seen in the Figure 8. The typical jet-grouted column cross-section for foundation underpinning is shown in the Figure 10. Since the soil in the remediation zone was composed of loess, which is water sensitive, compressed air was used in the jet-grouting preparation procedure (soil cutting). Water was used only to a minimal needed amount in the grout mixture. In order to assure most suitable grouting technique a trial columns of jet-grouting were executed, aside from the object, using different pressures, direction of jet and time of jet action in place. Three different methods were tested and six test columns were made, the two for each grouting procedure. Each method was evaluated by testing the strength of the column core, by means of soil improvement rate determined with SASW method (before and after the test field was made) and on

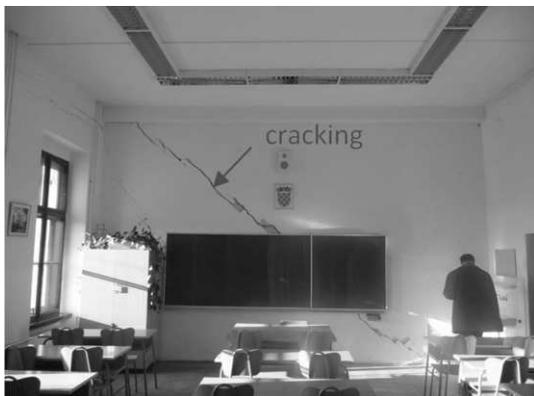
Figure 3. Crackings in one of the classrooms.

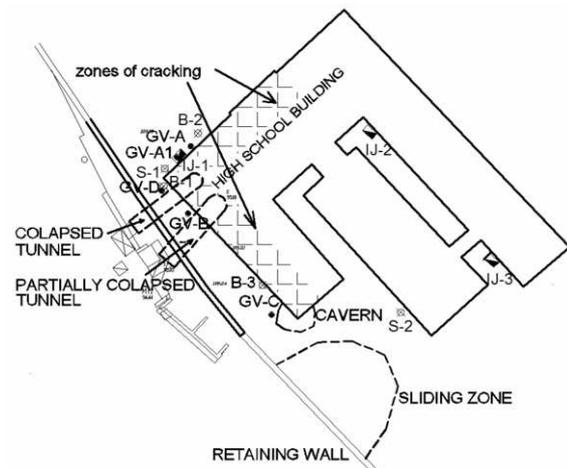
Figure 4. Disposition of boreholes, inclinometer and deformer holes, along the area of the building (boreholes: B-1, B-2, B-3, S-1, S-2, IJ-1, IJ-2, IJ-3, deformers: GV-A, GV-B, GV-D, inclinometers: GV-C, GV-D).

The exploration works have revealed the zone of increased moisture content in the soil right beneath the foundation, to the depth between 9 – 11 meters. This fact provoked collapse of the loess structure, which has been confirmed by the oedometer tests. Wetting and softening of the foundation soil did not affect the whole object equally, and the most affected area was the south-eastern part of the object under which there were tunnels (Figure 4, shaded area).

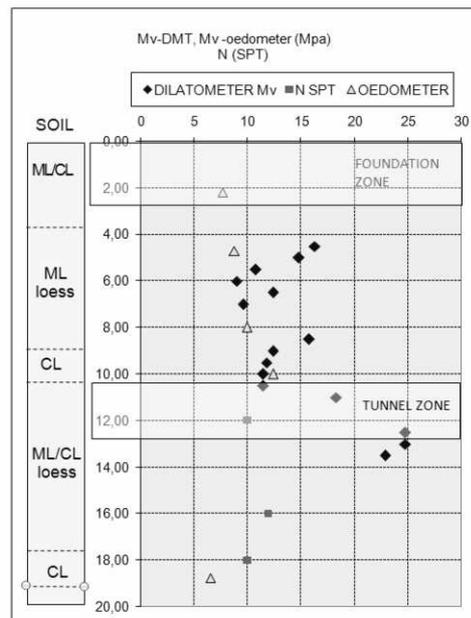
Figure 5. Soil profile and modulus of vertical deformation.

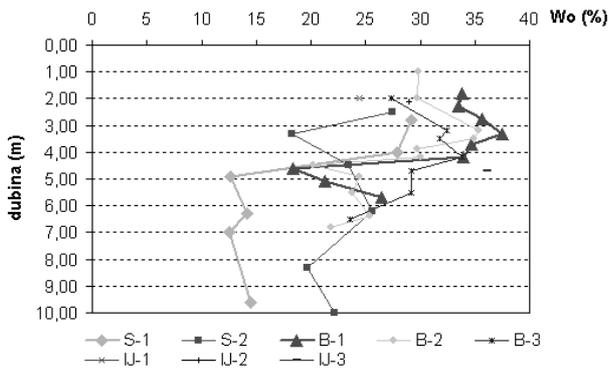
Figure 6. Moisture content versus depth for boreholes B-1, B-2 and B-3 from year 2006. and S-1, S-2 I S-3, IJ-1, IJ-2, IJ-3 from year 1998 (position - see Figure 4).

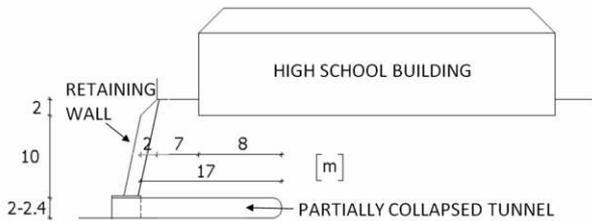
The tunnel vaults under the building (see the cross-section presented in the Figure 7) made of loess became wet because the tunnel served as a drain for the excess water in the soil. Gradually they started to collapse causing the additional soil settlement under the structure. It was therefore decided to fill the tunnels with concrete.

Figure 7. Schematic cross-section of highschool building with position of collapsed tunnels.

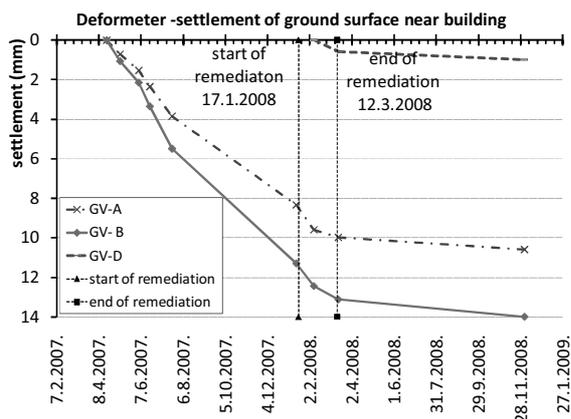
The settlements in the Figure 10 show the increase in the phase of strengthening of the jet-grouted columns and taking load structure, but with the smaller increase than before the remediation. After the grouted columns had strengthened and, after a new static foundation system was formed, the settlements started to slow down until they finally stabilized.

The observation system (cracks, geodetic points, sliding deformer, inclinometer) was used for monitoring the remediation effects and for checking the state of movements a year after the remediation. After the remediation works by soil improvement all indicators measured showed the decreasing tendency, which can be seen in the Figure 10 from the settlement data obtained by a sliding deformer .

Figure 10. Deformeter measured settlements of ground surface close to building.
