Ground improvement under historical buildings: a case history

R. Passalacqua

Dep.t of Civil, Environmental & Architectural Eng.g (DICAT) – University of Genoa -Italy

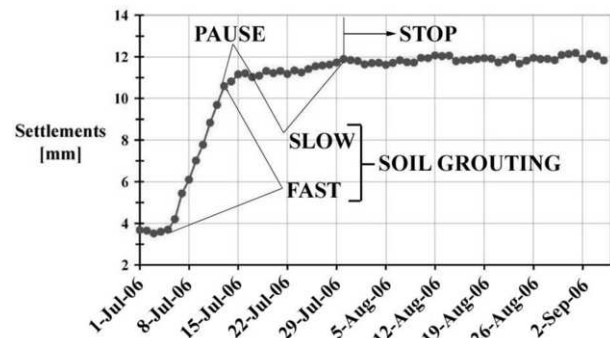
Electrolytic-Pot line 1 nr. 3: Gavotti Palace's facing wall

The grouting-liners were installed on the first week of July 2006 then, after one week from the injections' start (July the 5th), four of them were completed. On the 13th of July the soil grouting was interrupted, because the leveling system showed a steep gradient of the Palace's settling which, as remarked in the following figure 2, gained a dangerous 7 mm increment.

Having at the moment no alternatives and observing that after a five days suspension the settling faded, a lesser aggressive grouting phase was restarted, hence, other nine liners were injected up to a mean 60% of their completion.

Figure 2. The sudden rise and evolutions of the Palace's settlements, retrieved during the soil grouting sequences applied, by a water-cement mix injections, underneath its foundation's level.

The Palace's settlement arouse again, even if slower than before, without help of using a much more cautious grouting approach so, at the end of July, any neighboring activity was unconditionally interrupted.

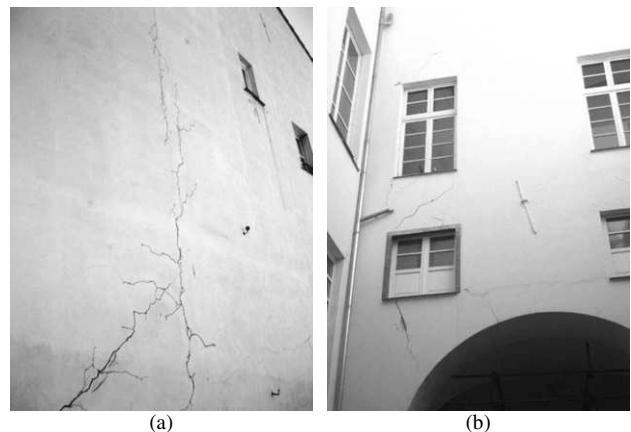
In fact, having the local settlement now reached well over than one centimeter, Gavotti Palace suffered a damagement which spread widely, as happens in structures such alike, diffusing from the perimetrical masonry wall to the inner ones, passing through a multitude of arch ribs and slabs, of barrel and groined vaults (see Fig. 3).

Figure 3. Some examples of the cracks' propagation on Gavotti Palace: along the masonry wall which borders the erecting yard (a), over one of the inner court's façades (b).

What happened during the attempted grouting is, most probably, due to a combination of effects. On the Author's opinion, the main issue is here connected to the long setting time of a Portland cement based grout; accelerators may be added in this case, such as calcium chloride, soluble carbonates, silicates or triethanolamine, to reduce sensibly the setting time but, at most, it never falls below than some hours, because lubricants are always mixed in to improve the grout pumpability and these substances, in the classes of fly ashes or rock flours, act also as retarders (U.S.A. – D.o.D. 2004).

When the injection pressure (here applied from 0.4 up to 5 MPa) is released, at the end of a staged grouting, an expanded and stressed cavity is left in place, just filled by the injected volume; but, this local pressure let gradually go as a consequence of the grout seepage through these soils, thus allowing the shrinkage (or the eventual collapse) of a "deflating" soil cavity where, in effect, is a mix which will stay in a liquid state for hours.

A soil improvement project was immediately planned, to be applied under the Gavotti Palace's foundation by following the operative procedures just established in the second test pit. In the sake of an extreme synthesis, it consisted in forming two vertically grouted screens down to the clay, made along two alignments flanking the Palace's wall on either the yard and the arcaded walkway sides; the screens shall have to confine the subsequent groutings, slant-diffused directly below the existing foundation to improve the mechanical behavior of all its loose-soil bedding. Nine CH borings were set up along the full contour of the Palace's foundation and, by them, the chemical grouting would have to be checked.

In addition, it was planned to modify the original layout of the sheet-piles, by deviating its bordering line farther from the Palace's wall and, just to stay on a safer side, the casings had also to be left in place.

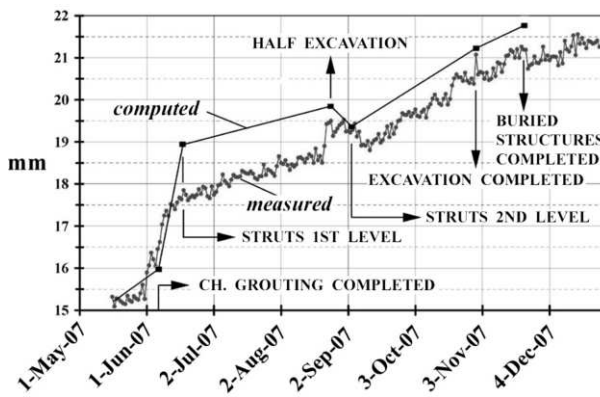
The vertical settlements of the Palace's foundation are shown in figure 5, both the computed and the measured ones, as they evolved during the staged construction; the comparison show a good agreement, even if the FEM simulation overestimated on the first stages: most probably, the chemical groutings had been better than expected.

It musty be finally observed that the full-front excavation, down to 9 meters below GL, caused a settlement of no more than 6 millimeters and, on the contrary, with the suspended first tentative of grouting alone 7 millimeters where surmounted.

Figure 5. Gavotti Palace's vertical settlements comparisons, as measured on-site by the leveling system (jagged lines) and as computed by the FEM analysis (straight lines).
