Corrective grouting in sand to restore pile foundations, Vijzelgracht, Amsterdam

A. Bezuijen

ABSTRACT

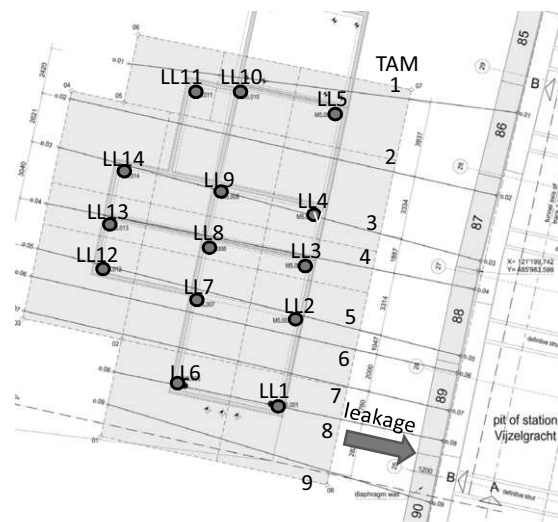
Figure 1. Top view of corrective grouting location, Vijzelgracht.

The layout of the site is shown in Figure 1. The diaphragm wall is shown on the right side of the picture. The big grey area is the corrective grouting area, the lines are the TAMs and the thick,

grey lines show the positions of the foundations of the settled buildings.

that were used for the displacement monitoring, are presented in Figure 1 as well as the position in the diaphragm wall where the leakage occurred (between panels 89 and 90).

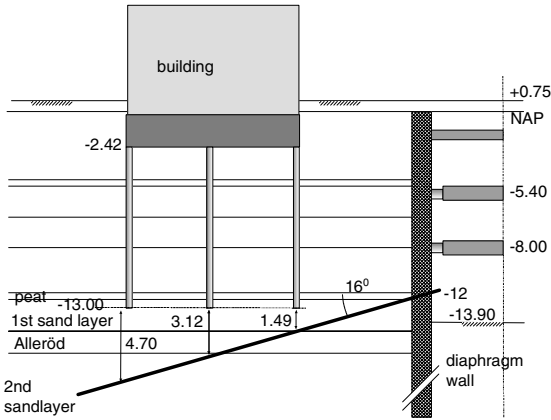
Figure 2. cross-section location. Dimensions in m.

A cross-section is shown in Figure 2. The TAM's were placed at an angle of 16 degrees. Horizontal TAM layout was not possible because it was not allowed to excavate the box further before stabilizing the buildings.

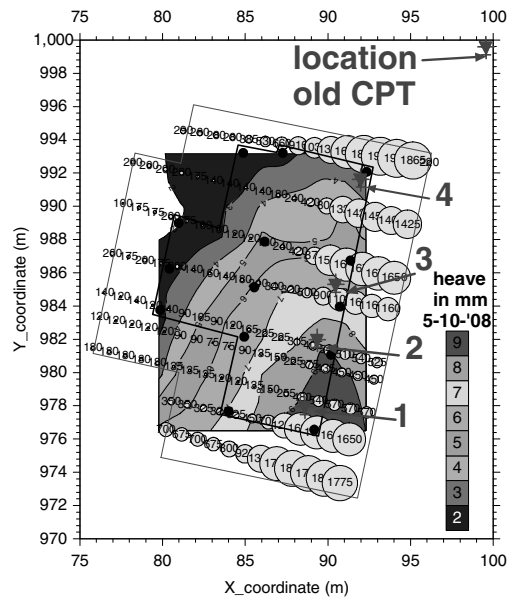
Figure 3. Overview corrective grouting at Vijzelgracht, see also text.

Figure 3 shows an overview of the corrective grouting site. The figure shows in plan view the position of the piled foundations (the black lines), the positions of the liquid leveling points (the black dots), the total amounts of grout injected in litres during the project (the grey circles) and the heave created at the end of the corrective grouting project. The heave indicated is the heave of the basement walls and is interpolated from the results of the liquid leveling system. Additionally Figure 3 shows the position of 5 CPTs: An 'old CPT' taken before the start of the works for the station, and 8 CPTs in the basements of the building. (4 taken before and 4 after the corrective grouting). Each pair of CPTs indicated with the same number are performed within a distance of 0.5 to 1 m.

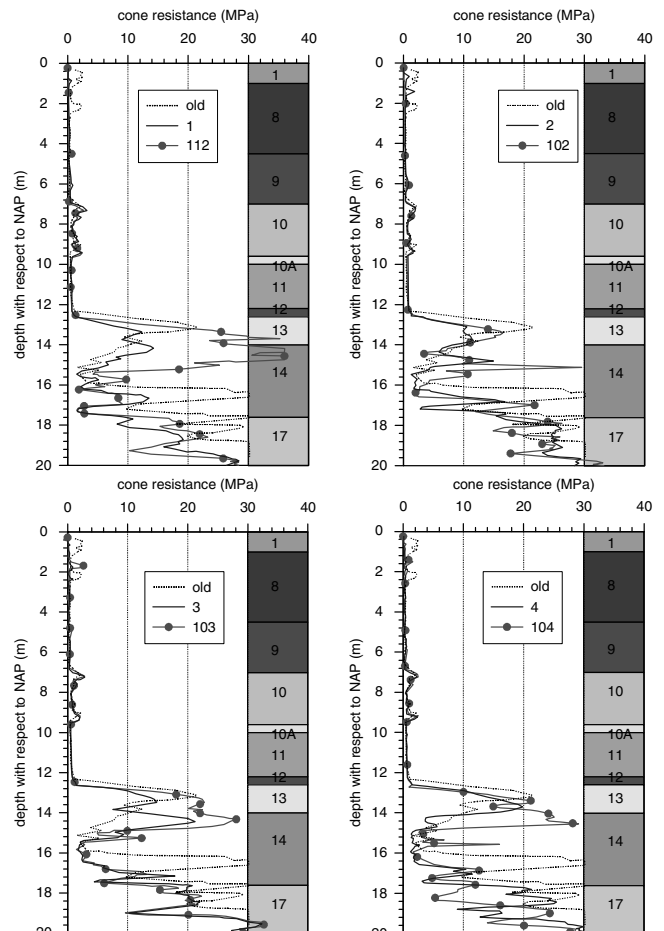
Figure 4: CPTs for location 1, to 4 before (1 - 4) and after (112, 102 - 104) the corrective grouting campaign, but both after the leakage compared with the 'old CPT'. Locations see Figure 3.

The results of the old CPT and the CPTs after the leakage, before and after the corrective grouting campaign are shown in Figure 4.

second sand layer, fine to medium coarse sand. In places where a lot of grout is injected (at the location of CPT 1), there is a very large increase in cone resistance. For CPT 2, where much less grout is injected, the increase in cone resistance is only limited. For CPT 4 the increase in cone resistance was only limited and the increase in cone resistance is mostly located underneath the first sand layer (no.13).

This corrective grouting project was performed in rather disturbed soil conditions. Due to the ground loss through the diaphragm wall there will locally be areas in the first sand layer (the layer that supports the piles) that have a lower density than other areas. It is clear from the CPTs in Figure 4 that the cone resistance has been significantly reduced close to the location of the leakage (CPT 1 and to a lesser extent CPT 2). Also CPT 3 shows a reduction of the cone resistance in the first sand layer. Only for CPT 4 this is not the case.

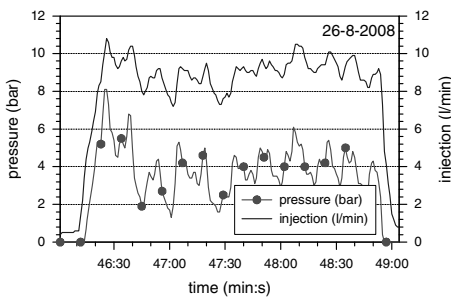
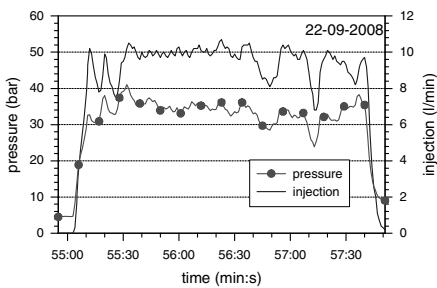
Figure 5. Example of a registration with a low injection pressure.

Figure 6. Example of a registration with a high injection pressure.

Figure 5 and Figure 6 show examples of a pressure registration with a low and a relatively high grouting pressure. Taking into account the pressure loss due to the injection system and the TAM, there is hardly any pressure necessary for the injection shown in Figure 5. Both plots show a pressure that fluctuates with the injection rate.

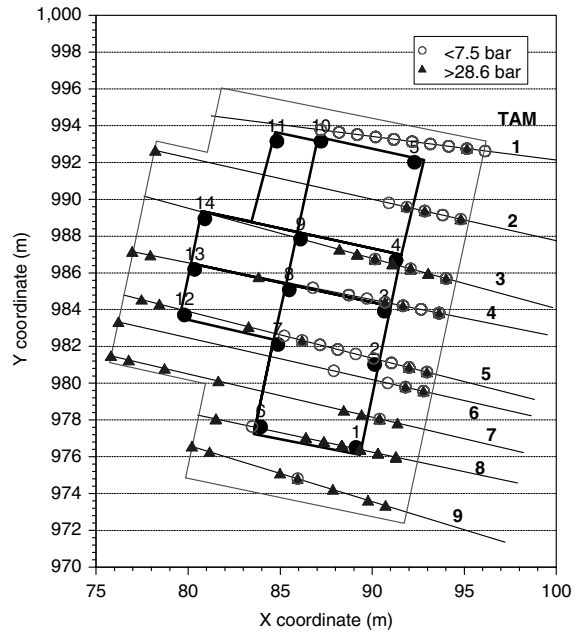
Figure 7. Locations where low and high injection pressures were found.

In addition, it was investigated where the injections with the lowest grouting pressures were found. The 100 lowest and 100 highest pressures found (of the total of 3,535 injections) were selected and their locations are plotted in Figure 7 (some injections with low or high pressure were at the same location, therefore there are not 100 markers for each selection). It shows that from TAM 1 (the highest black line in the plot) a lot of injections were performed with low injection pressures and

hardly any with high pressures. The TAMs 7, 8 and 9 have a lot of injections with the highest pressures.

Still puzzling are the low injection pressures that were found around TAM 1. Compaction grouting should lead to higher injection pressures. It is possible that inhomogeneous soil conditions lead to an easy path for the injection fluid.

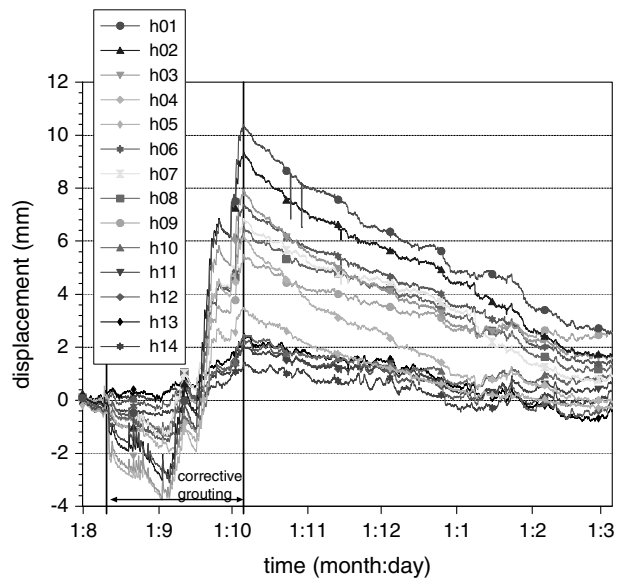
Figure 8. Heave and settlement as a function of time.

Figure 8 shows the heave and settlement measured just before, during and after the corrective grouting campaign. The vertical lines in the figure indicate the period in which grout was injected.

The figure shows that although the grout injections that start at 10-08-2008, it first only increased the settlement rate, probably due to disturbance of the 1st sand layer by the TAM installation and first injections. Most settlement was recorded at the instruments LL3 and LL4 at some distance from the leakage, see Figure 1. The injection of the first 21,000 liters of grout did not directly reduce the settlements but were needed to strengthen the soil and to reduce the progress of ongoing settlements. Grouting in September and the beginning of October of 2008, when another 62,000 litres were injected, led to heave of the buildings. In the periods between the grout injections there was still an ongoing settlement. The settlement more or less continues after grouting

stops. In the few days before grouting there is a settlement rate that is comparable to what is found directly after the injections (approximately 0.05 mm/day for the instruments that settle most). In between the grouting periods a larger settlement of up to 0.2 mm/day was found.

The ongoing settlements of the buildings after finishing of the grouting process were more than expected but the settlement rate seem to decrease after 5 months (see Figure 8). A possible explanation is that during the incident the weight of the building is partly taken by the friction between the piles and the soft soil layers above the first sand layer. When the grouting stops, the soft soil layers will consolidate (these layers were disturbed by the leakage and the grouting) and will develop a negative skin friction on the piles. The pile foundation is still loaded on ultimate bearing capacity and therefore the development of negative friction will lead to extra settlement. This settlement will continue until the consolidation of the soft layers is finished and the friction piles become end bearing piles again.
