# Unconventional seepage control approach for a substructure

S. Kibria

Recently an underground R.C. structure constructed in the saturated ground, in Punjab in Pakistan, developed serious seepage problem. The seepage was so intense that it could be seen from 3 feet thick well-compacted dense concrete exterior walls of the substructure, sitting in fine sand deposits. The initial scrutiny revealed that the design stage damp proofing measures (including use of water-proofing admixture, application of cementitious coating and geomembrane wrap-around) were not implemented carefully during construction.

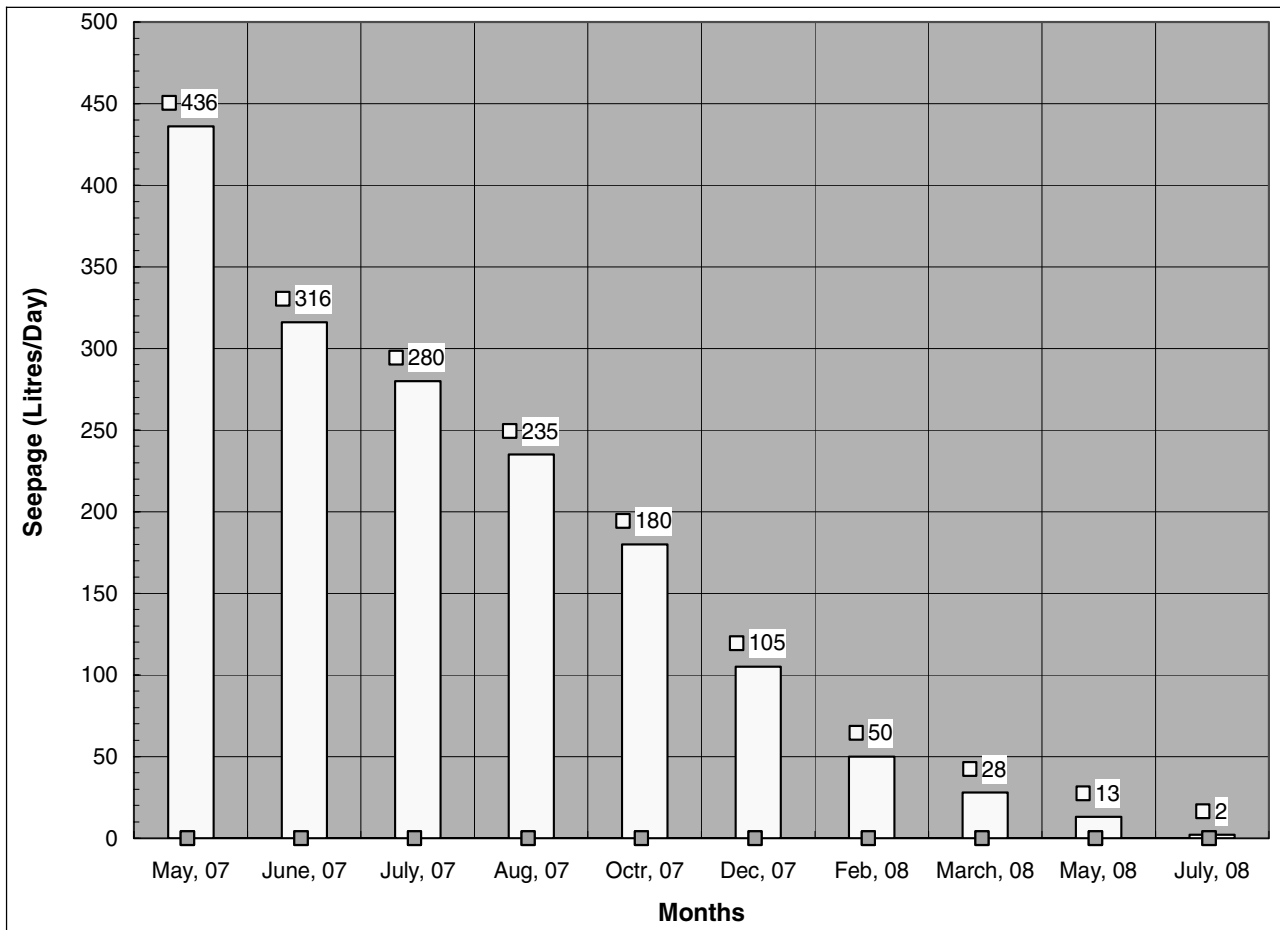
- The seepage points were identified and marked for daily monitoring.
- The overnight flow of water was measured every morning, which was found to reduce gradually as the lime injection proceeded.
- Monitoring of pH value of the seeped water which was enhanced from 7 to 12.

Fig-1 shows a systematic reduction in seepage quantity with time.

Fig. – 1 Seepage Monitoring at an underground structure at Punjab Pakistan
