Remedial works on landslide in complex geological conditions

Ž. Arbanas

Č. Benac

M. Grošić

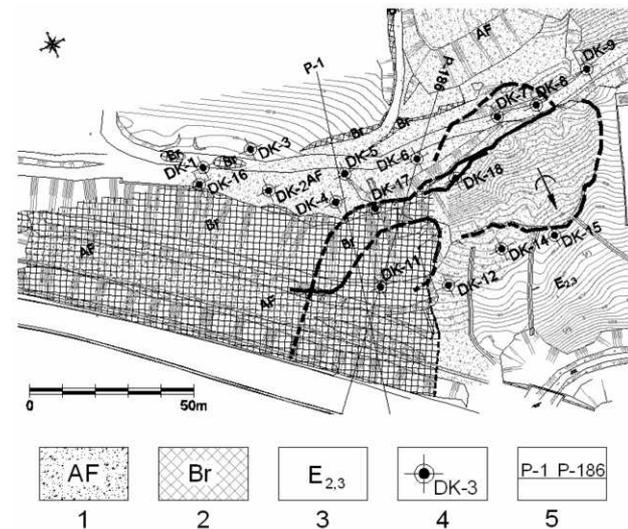
location of landslide. Geological surface mapping were updating the information obtained by field investigation, resulting with adequate geological map (Figure 1) so as geological cross-section to restore competent geotechnical model (Figure 2).

Figure 1. Schematic engineering-geological map of the landslide (1.Fill; 2.Breccia deposit; 3.Flysch deposit; 4.Borehole position; 5.Trace of cross-section).

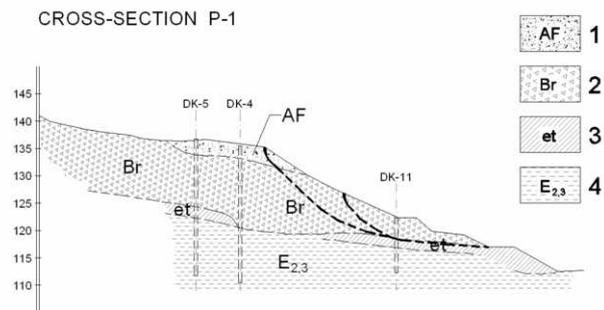
- Fill, anthropogenic mixture of clay, silt, sand and stone fragments so as waste buildings materials;
- Talus breccia, consist of limestone fragments <5 cm bonded with red colored clay, partially completely cemented, partially without binder;
- Flysch bedrock, predominantly consist of homogeny siltstone, yellow to grey to blue colored. The completely weathered zone (CW) of yellow colored siltstone is present on overall location. The moderately weathered (MW), slightly weathered (SW) to fresh siltstone (F) is presented deeper.

Figure 2. Geological cross-section P-1 (1.Fill; 2.Breccia deposit; 3.Weathered flysch zone; 4.Fresh flysch deposit).

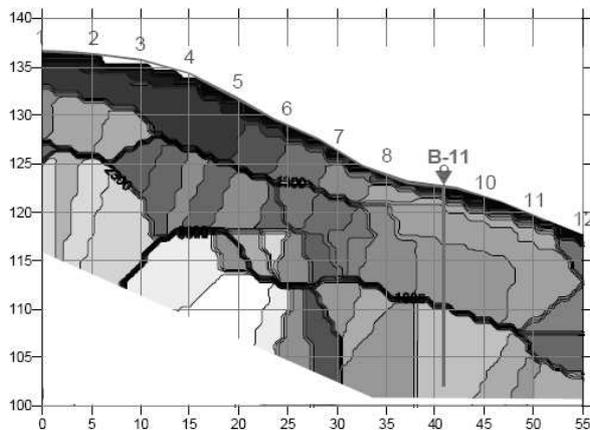
Because of irregular and uneven contact between breccia deposit and flysch bedrock the reconstruction of authentic cross-section was hard and based on results of geophysical measurements. The geophysical methods were especially helpful to identify contact between different layers so as the better bonded zone in breccia deposits (Figure 3).

Figure 3. Geophysical seismic refraction cross-section P-1.

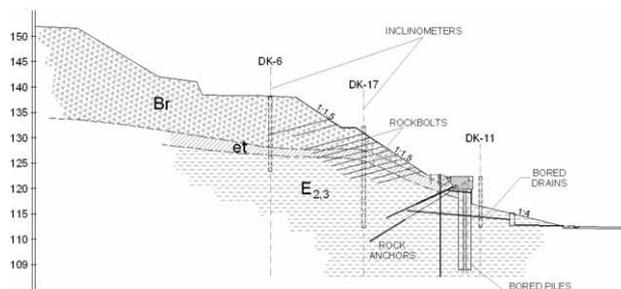
Figure 4. Cross-section of landslide with anchored pile-wall solution.

As an adequate support construction to ensure stability of the highway cut on landslide location the anchored pile-wall construction was chosen. The pile-wall is consisting of bored piles with 1.50 m diameters, length of 18 m, and 10 m bored in siltstone flysch bedrock below future toe of the cut. Pile-wall is connected with head beam anchored in the bedrock with prestressed anchors in the head of each pile. Capacity of anchors was 1000 kN, 25 to 38 m long with 10 m long bond section in siltstone (Figure 4, 5). Between piles in the pile-wall the selfboring drains were performed to ensure lowering of ground water level. To reinforce the upper part of the slope, the rockbolting was used with applied shotcrete structure on the face to prevent possible erosion processes.

To confirm this solution, the stability analyses were performed. The analyses were performed using parameters of rock masses in geotechnical model obtained from back analyses so as usual values for support construction.

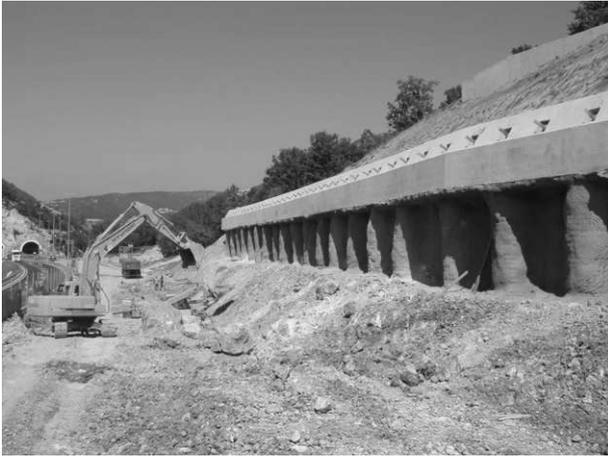
Figure 5. Photo of pile-wall during construction.

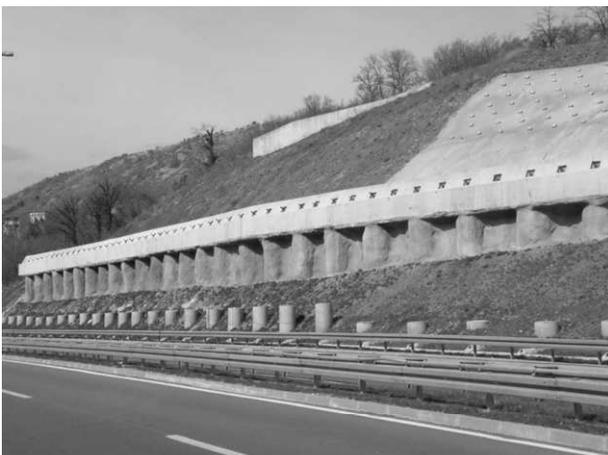
Figure 6. Photo of pile-wall construction in the toe of the landslide.

During the pile-wall construction a monitoring system based on observational method (Nicholson et al. 1999; Kovačević 2003) was established. The monitoring system included measuring of deformation in deformeters and inclinometers, ground water level in piezometers and geodetic surveying. The measured data enabled the control stress-strain back analysis. Based on the results of these back analysis an active design procedure was established (Arbanas 2004; Kovačević 2003) which made possible the required changes in the support construction in cut if the observations indicates on unacceptable deformations. Measured strains on installed measurement equipment showed a good match with the predicted calculated strains and construction was successfully finished in the spring 2007 (Figure 6).
