Timely owner awareness of the importance of geotechnical engineering in dispute resolution

Roger P. Thompson
Consultant

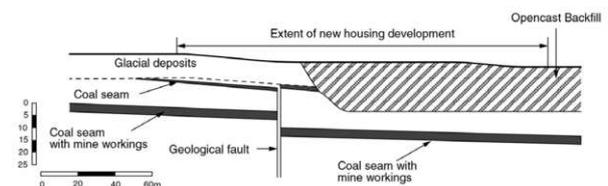
Figure 1. Cross section through clay backfill site

Shortly after houses were built on a new development, some of them began to suffer undue settlement. Tilt was recorded in excess of 200mm. The houses were located on a backfilled opencast coal mining pit with the depth of backfill being about 10m. Shallow pillar and stall type mine workings underlay the opencast pit. The backfill had been placed without controlled compaction. Grout injection had been carried out before the houses were built to stabilise the shallow mine workings. Vibro stone columns were introduced into the fill in an endeavour to improve its bearing capacity and reduce the settlement that might otherwise arise. Figure 1 shows a typical cross-section of the site.

When the settlements occurred, a geotechnical specialist was appointed to review the matter, advise on whether either the stone columns or the grouting might be defective and give guidance on possible remedial works. The first stage was to conduct an investigation of the fill and the underlying solid strata. It was established that the fill consisted of loosely compacted lumps of stiff clay. The depth to the most shallow coal seams was confirmed together with an indication that there were few if any open voids remaining. It was decided to

carry out regrouting as part of a remedial works. It was established that the additional amount and pattern of the further grout takes bore no comparison with the pattern of settlement. Accordingly it was deemed that inadequate grouting was not the cause of the problem.

It was recognised that the stone columns could be acting as vertical drains introducing water into the fill thereby giving rise to inundation collapse. To resolve this it was decided to install piles to underpin the houses, which had solid raft foundations, and then jack them back to level.

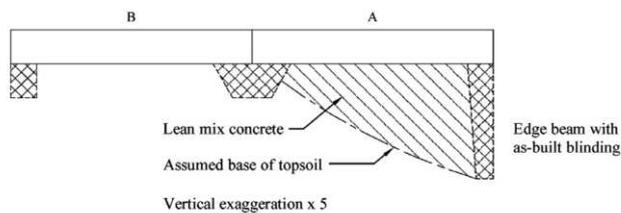
Figure 4. Cross section showing mass concrete backfill

About two years after construction, one pair of semi-detached houses started to show signs of cracking. The cracks were at their widest at ground level adjacent to one of the gable end walls and rose diagonally towards the party wall, gradually reducing in width towards the eaves of the house. In due course the cracks began to widen to about 10mm and the developer decided that piles should be installed to underpin the house structure in an endeavour to prevent further more extensive damage occurring.

been placed on the site of the structure that had suffered damage. Further information also came to light which showed that there had been a large heap of topsoil up to 6m high which was located close to and overlapping one end of the pair of houses.

Trial pit examination revealed that in this area the house A was founded on particularly deep beam foundations while house B was on normal depth foundations. It was apparent that there had originally been a depression which had been backfilled with topsoil and then mounded over. During development all the old topsoil had been removed and the backfilling dug out with the resulting recreated depression backfilled with mass concrete. Accordingly one of the pair of houses was founded on deep mass concrete fill while the other was on clay backfill. The very marked difference in the stiffness of the ground had resulted in the houses effectively 'breaking their back'. A cross section through the pair of houses is shown on figure 4.

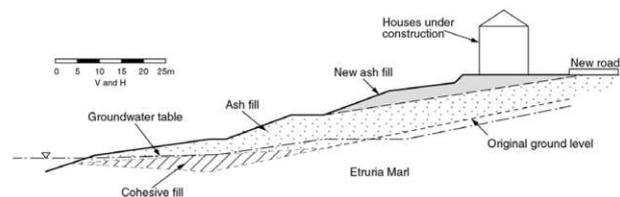
Figure 6. Section through slope regraded for housing

Fill was placed on the uppermost part of a slope to form a site for new housing. When they were partly completed there was a period of heavy rain. The houses began to crack so the developer decided to seek specialist geotechnical advice. Boreholes were put down to allow sampling and testing and groundwater monitoring was undertaken. The original natural ground level was found to be masked by up to about 10m of ash fill as can be seen in figure 6. The clay marl was found to contain polished discontinuities, indicative of relict slope movement. Accordingly the slope failure on the new housing development site was deemed to be a renewal of a former landslide. This assessment was matched by the theoretical analysis of the slope. Remedial works involved regrading the slope to its former profile and introducing gravel filled berms. It was not possible to retain the row of houses that had been planned for this area but the remaining parts of the development were secured.

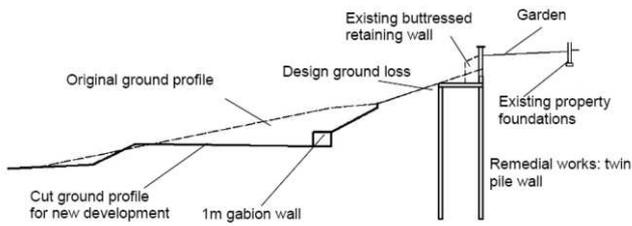
Figure 7. Section showing cutting for housing development

A 4m cutting high was formed for a new housing development at the toe of a slope and a 1m high gabion wall was installed. An existing house, with a rear extension, and a garden were sited behind the crest of the slope. The garden was bounded by a masonry retaining wall. The overall drop in level to the new housing development was about 7m.

Shortly after the cutting was formed part of the garden was found to have subsided by at least 100mm with cracking in the masonry boundary walls. Cracks up to 6mm width were observed to the rear extension. The insurer of the house owner engaged a geotechnical specialist to advise on the problem. The initial interpretation was that the movement was typical of incipient slope failure. Aerial photographs revealed that the original slope was uneven, indicative of the area having

A site investigation identified that ground conditions were loose silty fine sand with layers of soft to firm clay. The groundwater level was found to have seasonal variation of about 2m with the higher, winter, level at 7.5m depth. Perched water, also with a seasonal variation, was identified as overlying the uppermost clay layer, being above the level of the toe of the slope. Laboratory testing established that the clay had a residual strength value, ϕ'_r , of 14° with c' of zero. Analysis showed that the factor of safety fell marginally below unity for a moderately pessimistic assessment of the highest likely water level. Access to the toe of the slope was denied and therefore it was decided to install a twin-pile wall positioned immediately behind the crest of the slope.

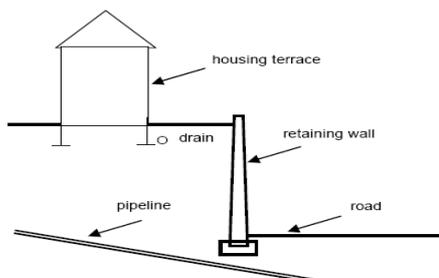
Figure 8. Section showing retaining wall with road and houses

Some 100 years ago a retaining wall up to 5m high was built next to an existing road. The area behind was backfilled and a level site formed for terraced housing. The wall was based on shallow foundations. A pipeline was constructed, presumably before the houses and wall were built, to carry the outflows from the properties. There was also a shallow depth drain running along the front of the houses to collect the surface water run-off. Figure 8 depicts the key features.

About 30 years ago the wall developed a slight outward lean. Monitoring revealed that the movement was progressive and about 25 years later it had reached a lean of about 1 in 10. A survey of the pipeline established that it had various cracks, particularly immediately upstream of the retaining wall. The house owners began to be concerned about the security of their properties which were in danger of becoming damaged if the wall were to move further or, indeed, collapse.

Following discussions between their legal representative and the equivalent representatives for the owners of the pipeline and the road, a geotechnical specialist was appointed to act jointly for all the parties to establish the cause of the problem. An investigation found that the soil conditions beneath the wall foundations comprised sand with occasional bands of clay. Analysis of the wall indicated that it could have a marginal factor of safety against instability, the actual value depending on the water level behind the wall. Various possible causes were considered which included leaking house drains introducing water into the ground behind the wall, the pipeline which was known to be defective and would therefore be leaking, weakening the soil beneath the retaining wall foundation, and vibration from traffic disturbing the wall foundations.

The parties recognised that the uncertain precise cause of the damage could give rise to an uncertain outcome of any Court hearing and therefore decided not to take steps towards costly litigation. Instead progress was made in determining the works necessary to rectify the problem. The pipeline was lined to prevent it from leaking and a tie-back system for the masonry retaining wall was planned to prevent any further outward movement. This example demonstrates how timely introduction of a geotechnical specialist and mutual co-operation between the parties concerned can lead to a particularly satisfactory outcome for all involved.
